**REAL ESTATE TRANSFER - GROUNDWATER HAZARD STATEMENT**

# TIME OF TRANSFER INSPECTION TOT# 10741 ROGER GROTH CERT # 8813

Address: **1957 162nd Ave, Manchester, IA 52057**

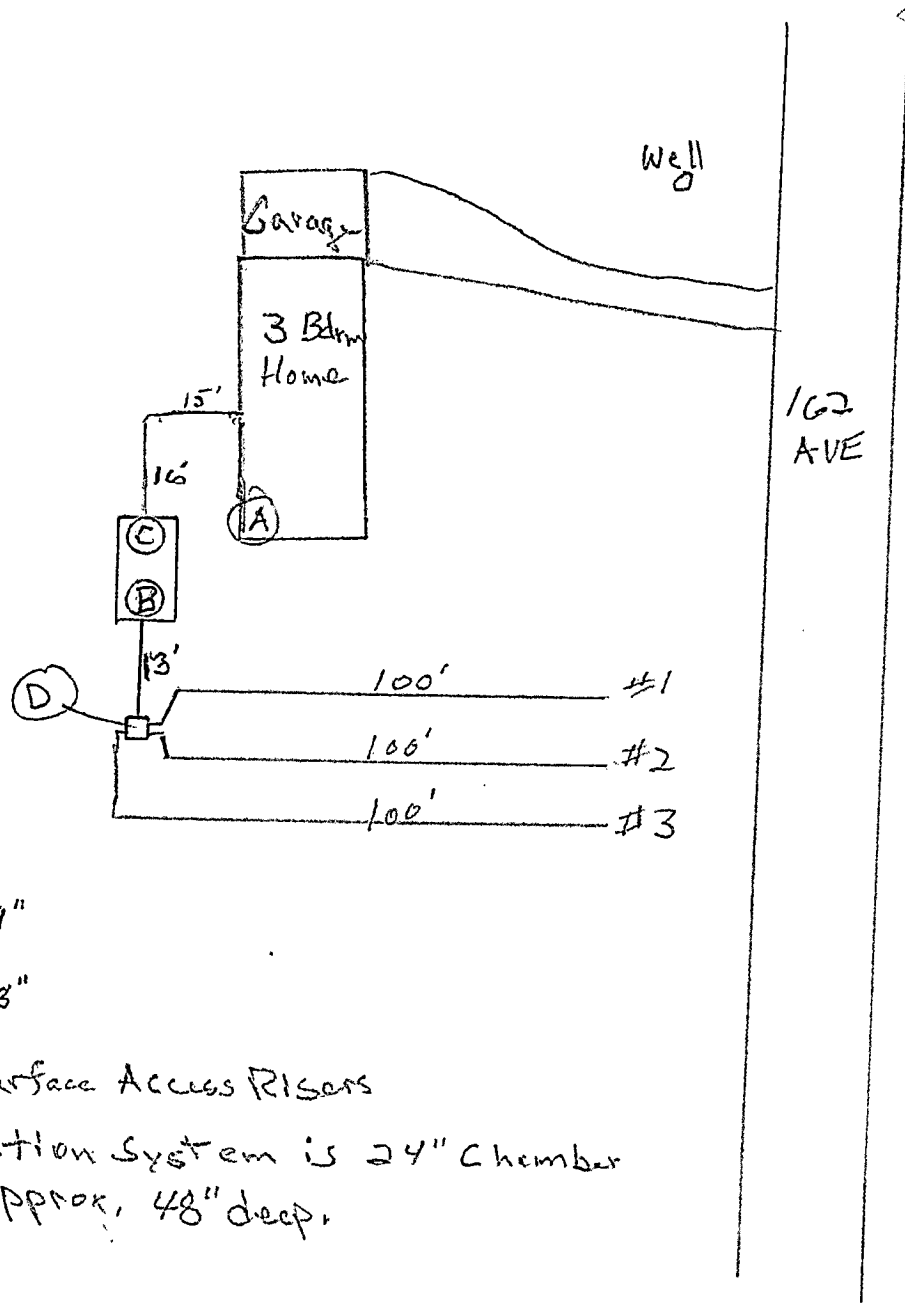
TOT MAP 5/30/2024

$$A-B = 42'9''$$

$$B-D = 13'$$

$$A-D = 48'8''$$

— C-B-D = Surface Access Risers

— Soil Absorption System is 24" Chamber and is approx. 48" deep.
