**REAL ESTATE TRANSFER - GROUNDWATER HAZARD STATEMENT**  
**TO BE COMPLETED BY TRANSFEROR**

## Time of Transfer Inspection Report

## NARRENTIVE INSPECTION REPORT

## TIME OF TRANSFER INSPECTION MAP

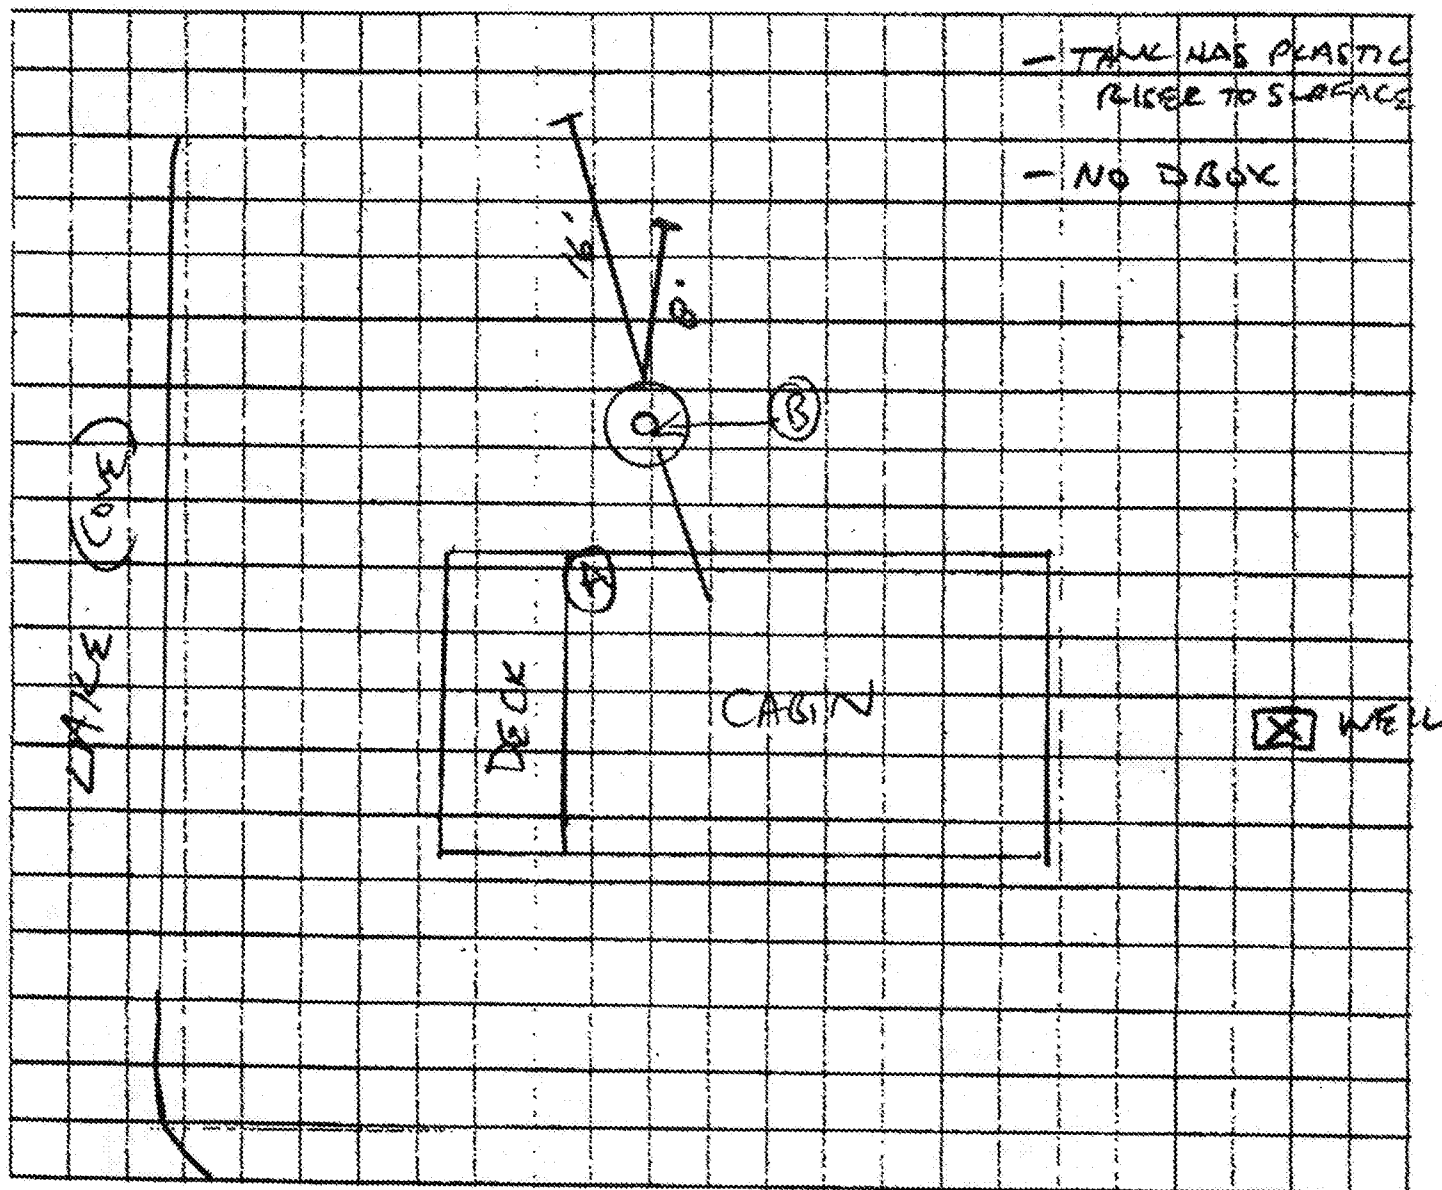
well located East of cabin as shown on attached  
Time of Transfer Inspection Map.

**Distance from Septic tank to well is >87'**

**Secondary treatment is >88'**
