**REAL ESTATE TRANSFER - GROUNDWATER HAZARD STATEMENT**  
**TO BE COMPLETED BY TRANSFEROR**

## Time of Transfer Inspection Report

## NARRENTIVE INSPECTION REPORT

### Annie Kacher Property

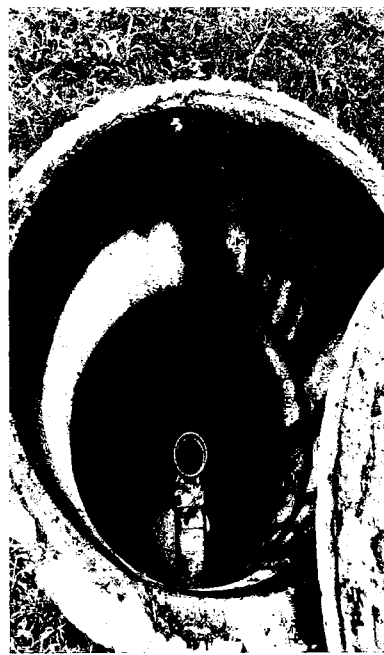
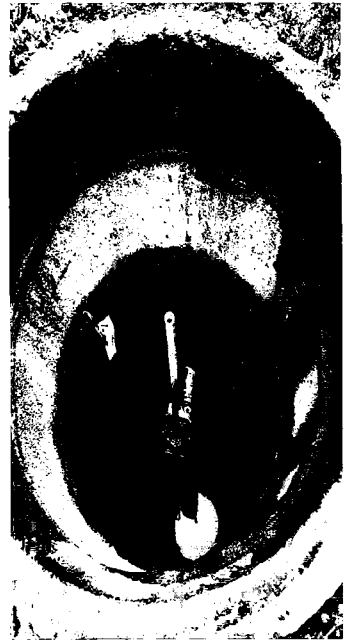
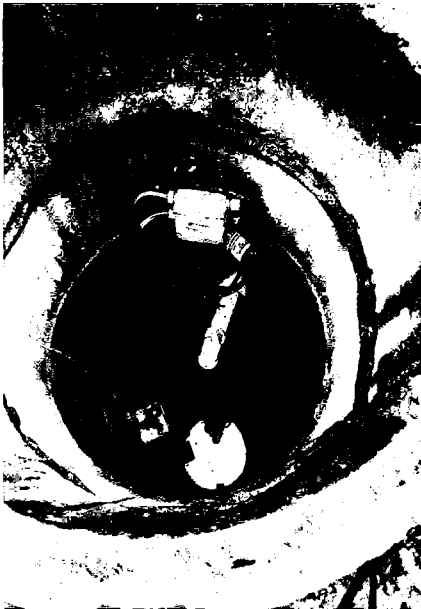
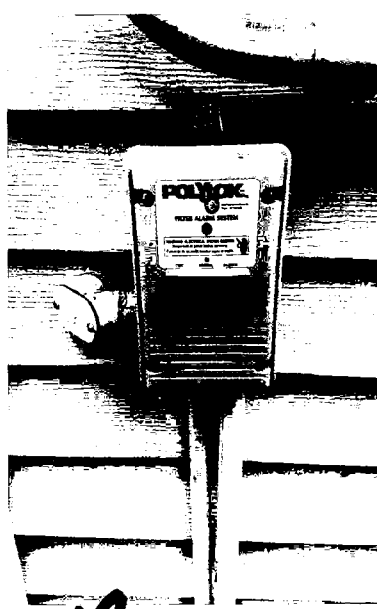
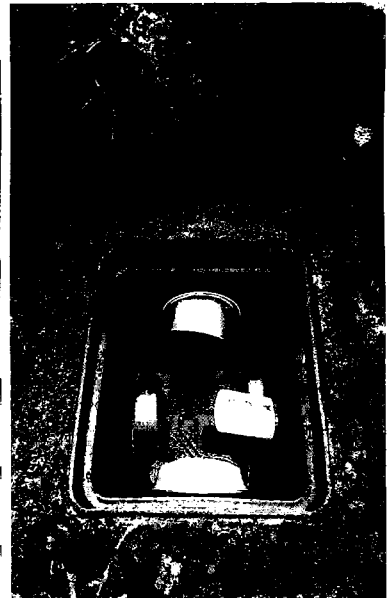
The septic tank was pumped on 6-19-18 which meets the 3 year requirement. There was no scum layer, and very little solids in the tank. The septic tank is suggested to be cleaned every 3 years for the new owner. There are access concrete risers on each chamber of the tank. The tank liquid level was normal on the inspection day. The absorption field was probed and found with no indication of saturation.

The first drop box was hand dug, and appears to be in excellent shape. A hydraulic load test was not completed, as the system has not been occupied recently. There are pictures included in this report of the inspection.
