**REAL ESTATE TRANSFER - GROUNDWATER HAZARD STATEMENT**  
**TO BE COMPLETED BY TRANSFEROR**

## Time of Transfer Inspection Report

## NARRATIVE INSPECTION REPORT

**Craig Schwerdtfeger Property -25719 206<sup>th</sup> Ave., Manchester, IA 52057**

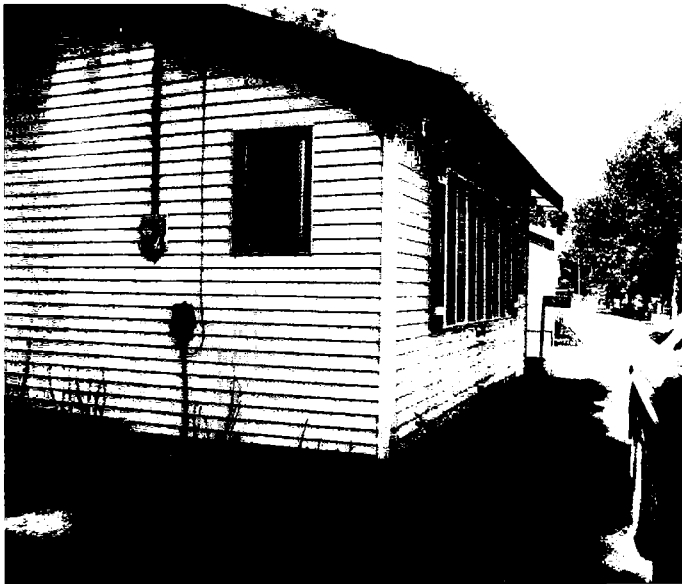
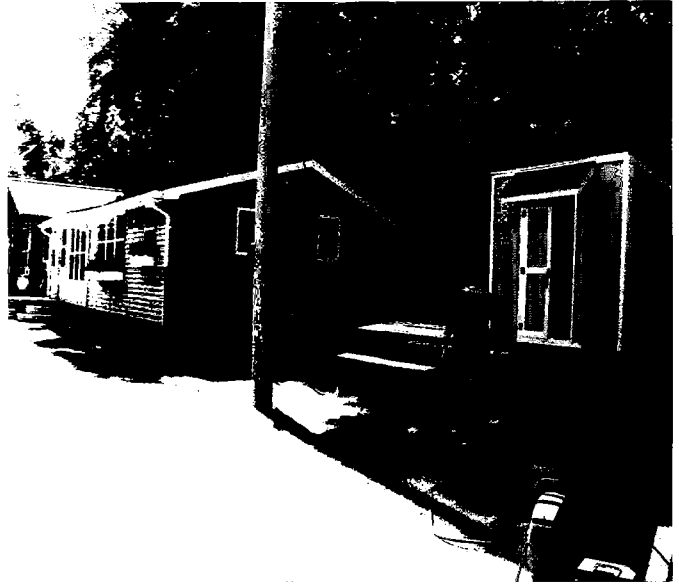
*page 3*

Concrete septic tank was pumped on 8-9-2018 by Welu. Inlet baffle for 25719 is pvc pipe and inlet baffle for 25701 is the original tank concrete in fair condition. The septic tank liquid level was normal when arrived. The septic tank has a 6" pipe access riser to surface, but would highly recommend a proper 20" diameter surface access riser to clean tank properly. The tank had been pumped by Welu but had excessive solids left in tank. The outlet clay pipe had roots intruding severely. Groth Services cut these roots out w/high pressure water jetter.

After jetting outlet line we performed the hydraulic water load test on the secondary treatment system as prescribed. Leech tank accepted test and found no indication of saturation. A map has been drawn with the correct footage's.

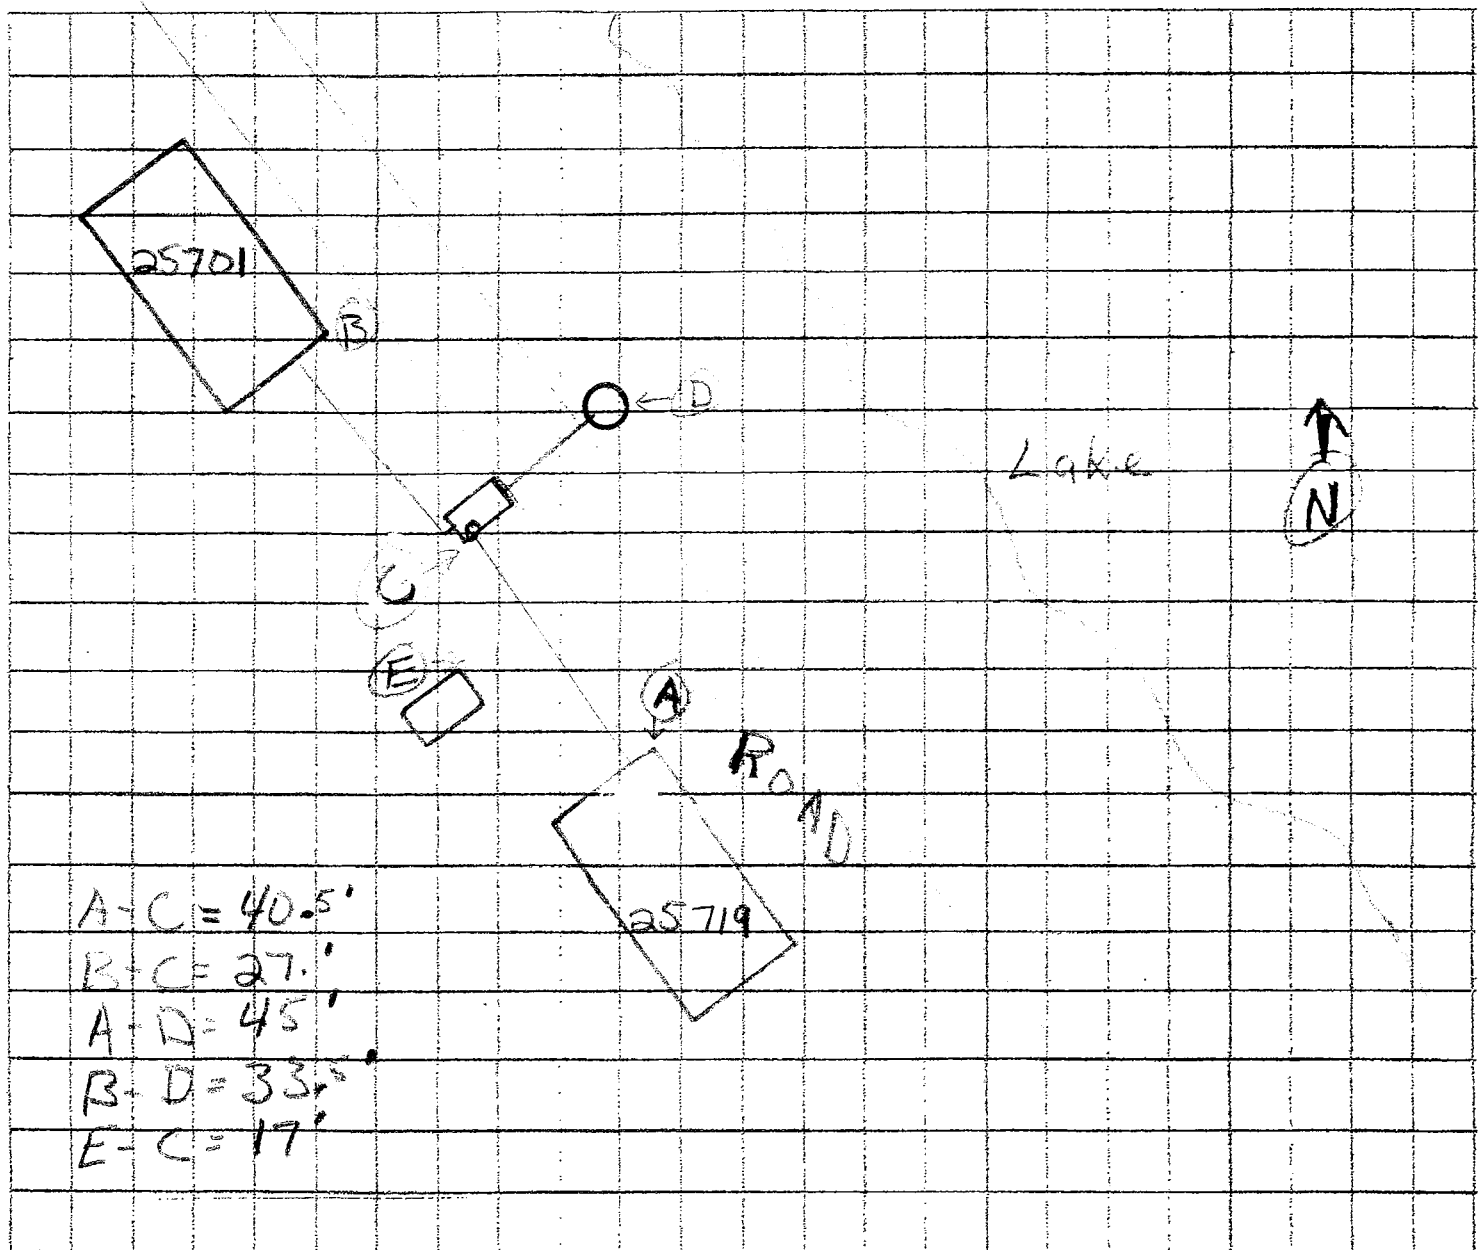
## TIME OF TRANSFER INSPECTION MAP

This is a one bedroom / one bathroom cabin that is shared with 25701 one bedroom / one bathroom cabin on Lake Delhi. Both cabins are seasonally used. Neither cabin has a basement. The wastewater drains via gravity to septic tank, Listers brand, single compartment concrete septic tank. The septic tank is located between the two cabins. There is a 6" diameter access pipe for clean-out riser. There is no effluent filter on the outlet in the septic tank. The gravity sewer effluent line exits under the roadway towards the lake approximately 10' to a concrete leech tank.

**Distance from Septic tank to shared well is >100'**

**Secondary treatment is >100'**
