**REAL ESTATE TRANSFER - GROUNDWATER HAZARD STATEMENT  
TO BE COMPLETED BY TRANSFEROR**

## Time of Transfer Inspection Report

## NARRATIVE INSPECTION REPORT

## TIME OF TRANSFER INSPECTION MAP

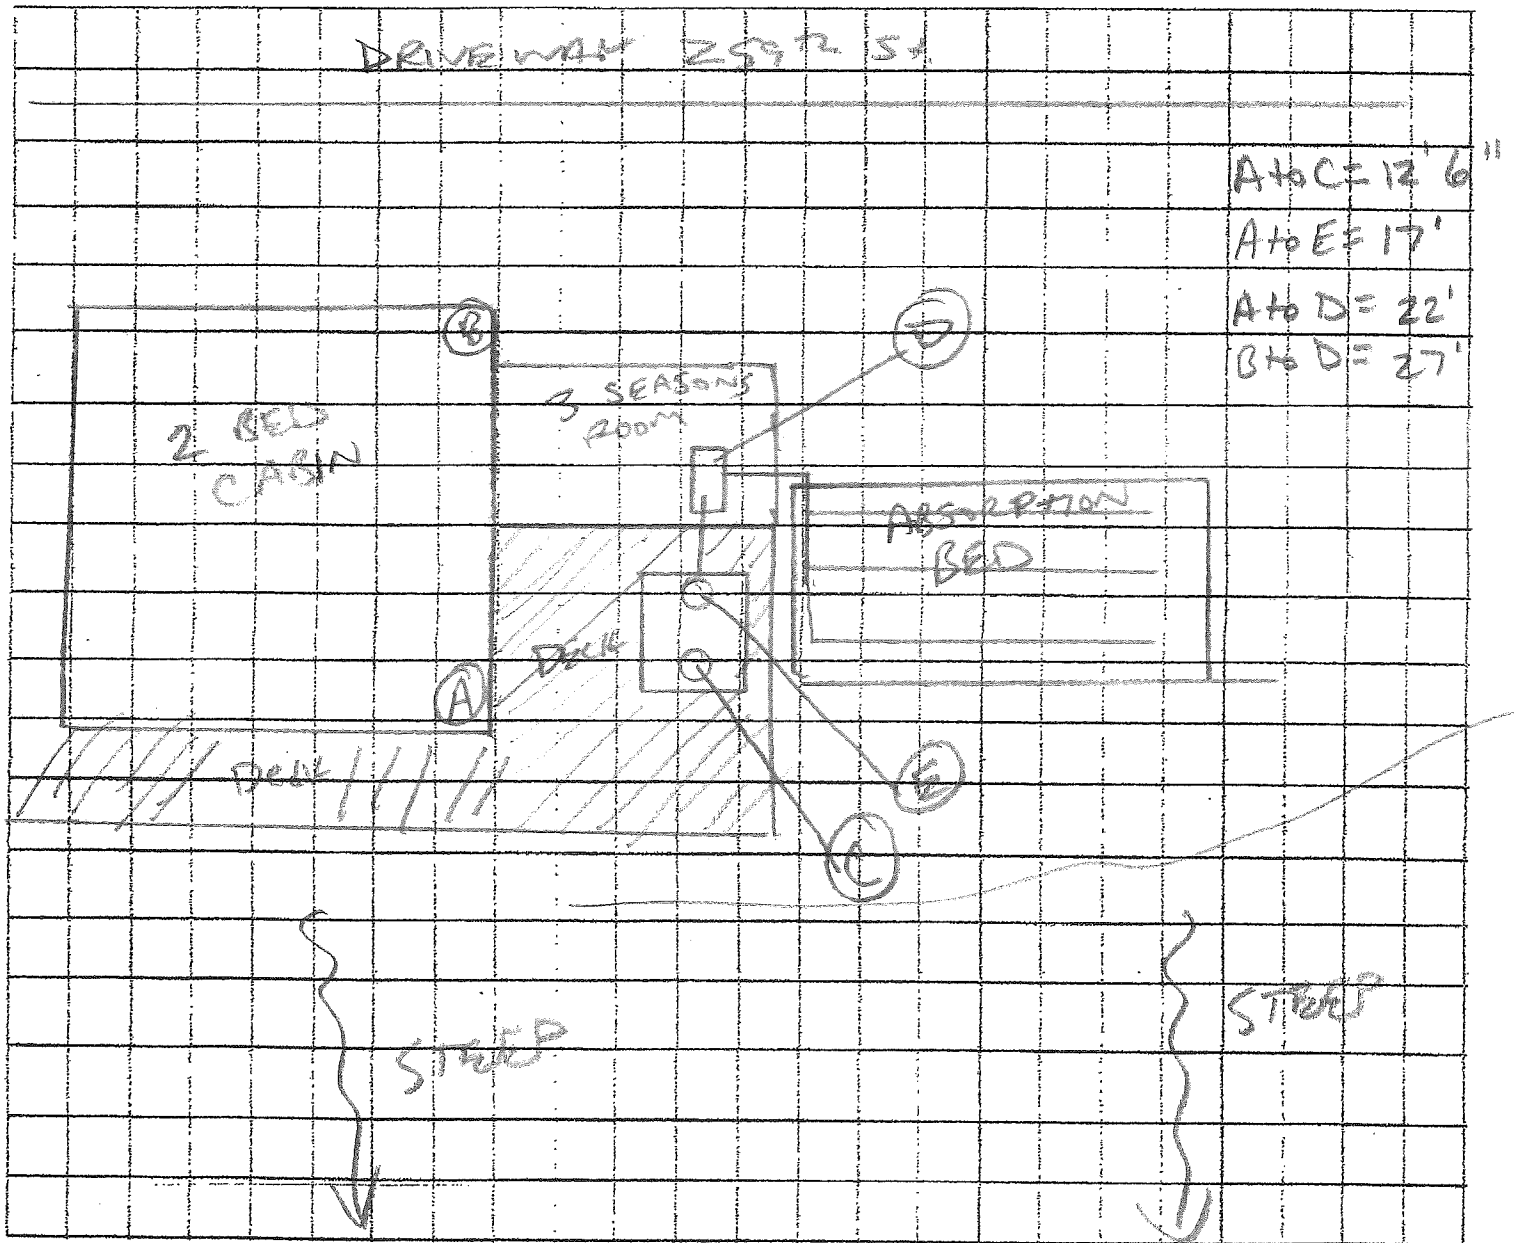
**Distance from Septic tank to well is >50'**  
**Secondary treatment is >100'**

DATE 9-20-18 SELLER KERRY TULIER BUYER RANDY OLBERDMAN

ADDRESS 21580 259<sup>th</sup> ST. CITY DELHI @ CAMPO
