**REAL ESTATE TRANSFER - GROUNDWATER HAZARD STATEMENT**  
**TO BE COMPLETED BY TRANSFEROR**

## Time of Transfer Inspection Report

## NARRATIVE INSPECTION REPORT

## TIME OF TRANSFER INSPECTION MAP

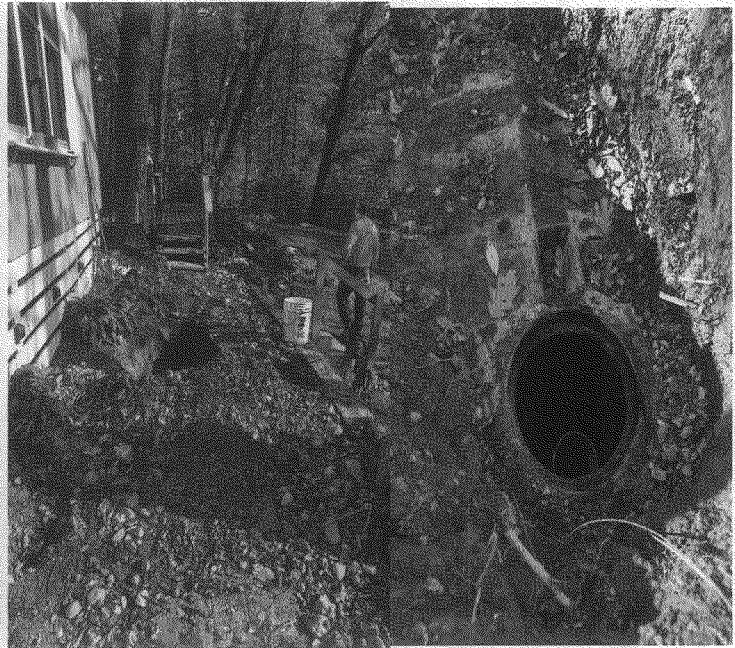
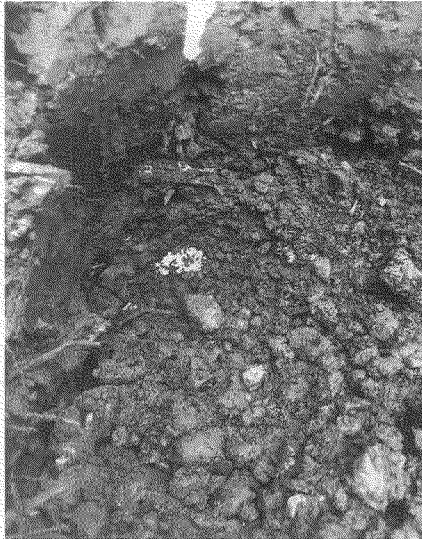
The septic tank has been pumped, 1" scum layer and 90% solids. The tank is suggested to be cleaned much more frequently, every 2 years because of its small size. There are no access risers on the septic tank, it will need to be dug up by hand each time for maintenance. The tank liquid level was normal on the day of inspection.

The end of the absorption line was dug by hand by Mr. Manley after I verified the location with the sewer camera. A hydraulic load test was completed for a two bedroom home, 5.3 GPM for 38 minutes from the outside facet. The absorption line accepted all the water without any sign of problems. There are pictures included in this report of the system components. Also a map with footage's has been drawn as part of this inspection.(Tank capacity was verified by Digital Tank Gauge)

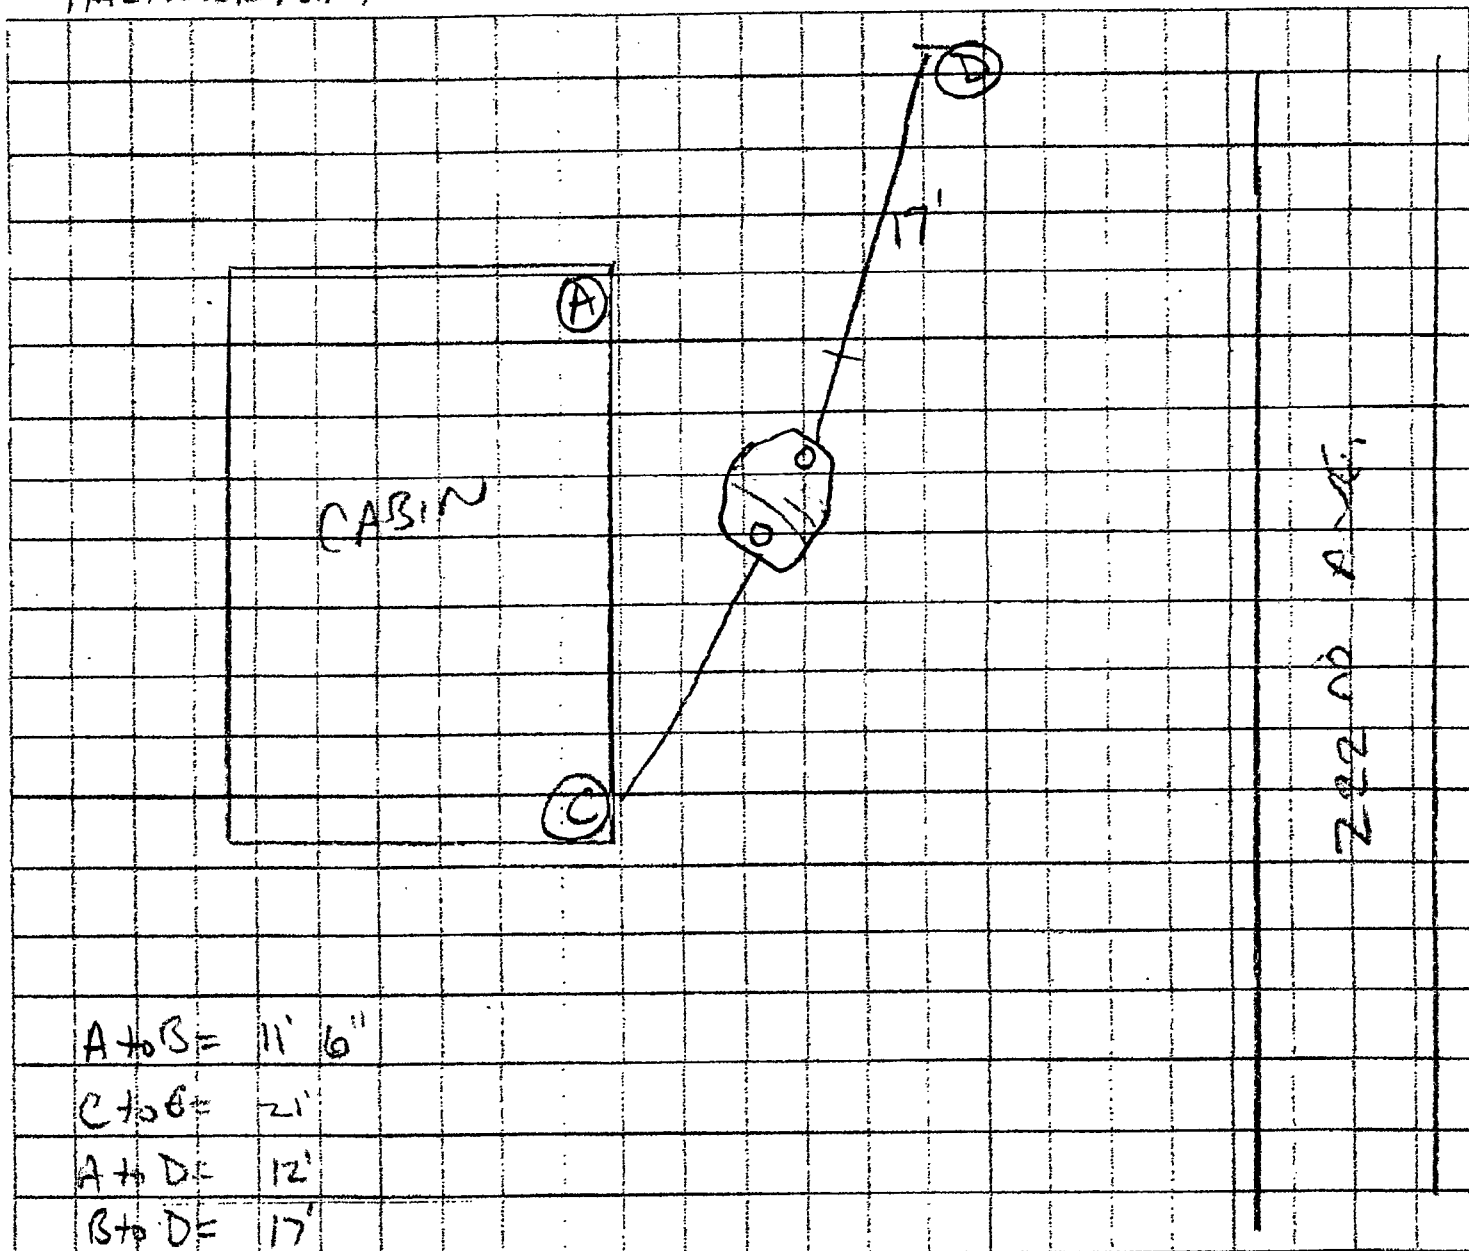
This is a certified Time of Transfer Inspection for a septic system with a total of two bedrooms, and one bathroom. There is no basement, just a dirt crawl space. There is no water softener or garbage disposal that drains into the septic system. The sewer line exits the crawl space towards the east yard and drains to a 500 gallon single compartment plastic septic tank by gravity. There is no effluent screen on outlet side of the tank, and the baffles are in fair condition. This is the primary treatment of the system. The outlet of the septic tank goes directly to a single absorption line using rock and pipe. This single absorption line completes the secondary treatment, although only 17' in length it is grossly undersized even for a seasonal cabin.

**Distance from Septic tank to well is >50'**  
**Secondary treatment is >100'**
