## Time of Transfer Inspection Report

## NARRATIVE INSPECTION REPORT

Pat Krapfl Property

## TIME OF TRANSFER INSPECTION MAP

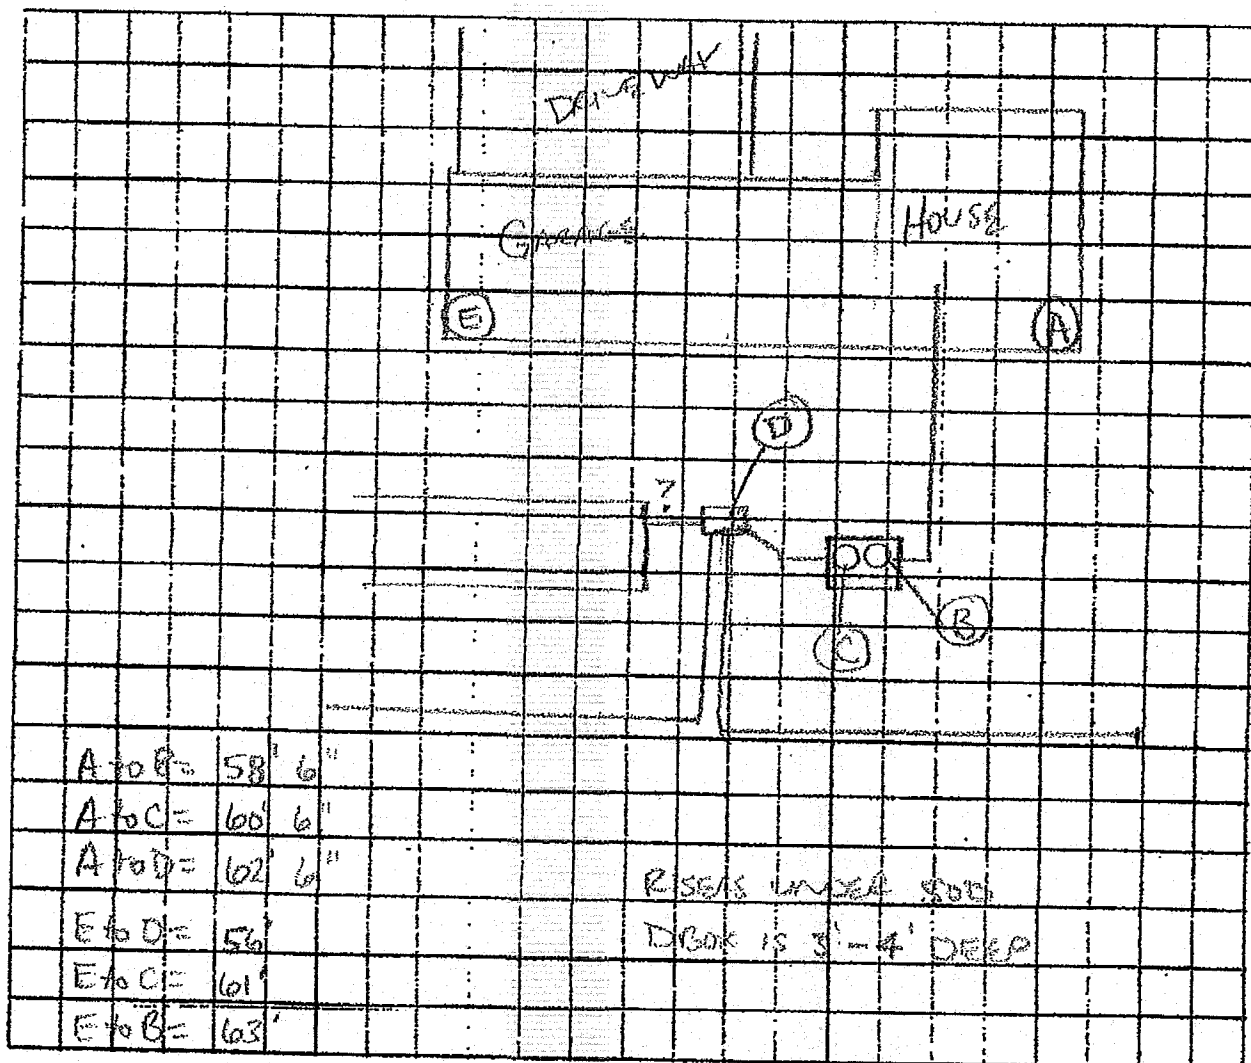
Distance from Septic tank to well is >50'

Secondary treatment is >100'

The distribution box was dug by machine after finding it with the sewer camera. A hydraulic load test was completed for a four bedroom home, 5 GPM for 88 minutes from the outside facet. The absorption system accepted all the water without any signs of problems. There are pictures included in this report of the system components. Also a map with footage's has been drawn as part of this inspection.  
(Tank capacity was verified by Digital Tank Gauge)
