**REAL ESTATE TRANSFER - GROUNDWATER HAZARD STATEMENT**  
TO BE COMPLETED BY TRANSFEROR

## Time of Transfer Inspection Report

## NARRATIVE INSPECTION REPORT

## TIME OF TRANSFER INSPECTION MAP

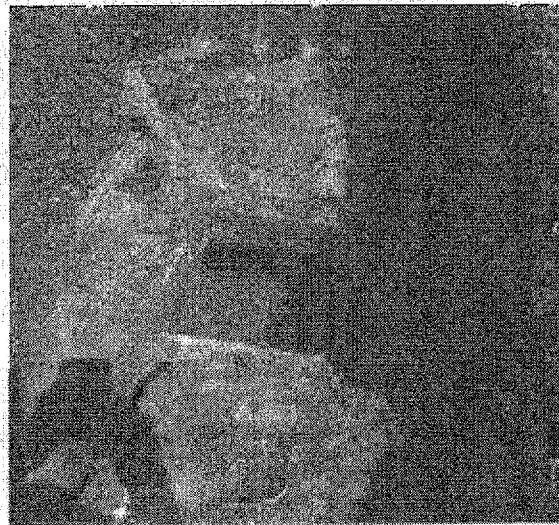
The septic tank was found with a sonde, dug up with a backhoe and pumped out- it was overfull of solids at 100%. This septic tank pumping took six times the normal time to vacuum the contents because of the lack of regular maintenance. Normal septic tank cleanings are required every 2-4 years in order to keep these solids from flowing out into the absorption field. The septic tank is designed for storage of solids in the first compartment and pumped out according to the size and use of each home. The tank now has concrete risers to the surface to ensure easy access for future maintenance septic cleaning. The concrete baffles are in fair condition.

A hydraulic load test was calculated and completed for a four bedroom home, 4.6 GPM for 76 minutes from the inside laundry facet. The leech tank was located by sonde from the outlet of the septic tank and also dug up, it was about 20" deep to the top of the lid. This leech tank also was pumped out and contained 100% solids, the seller should disclose that the septic system has not had regular maintenance. There are pictures included in this report of the system components. Also a map with footage's has been drawn as part of this inspection. (Tank capacity was verified by Digital Tank Gauge)

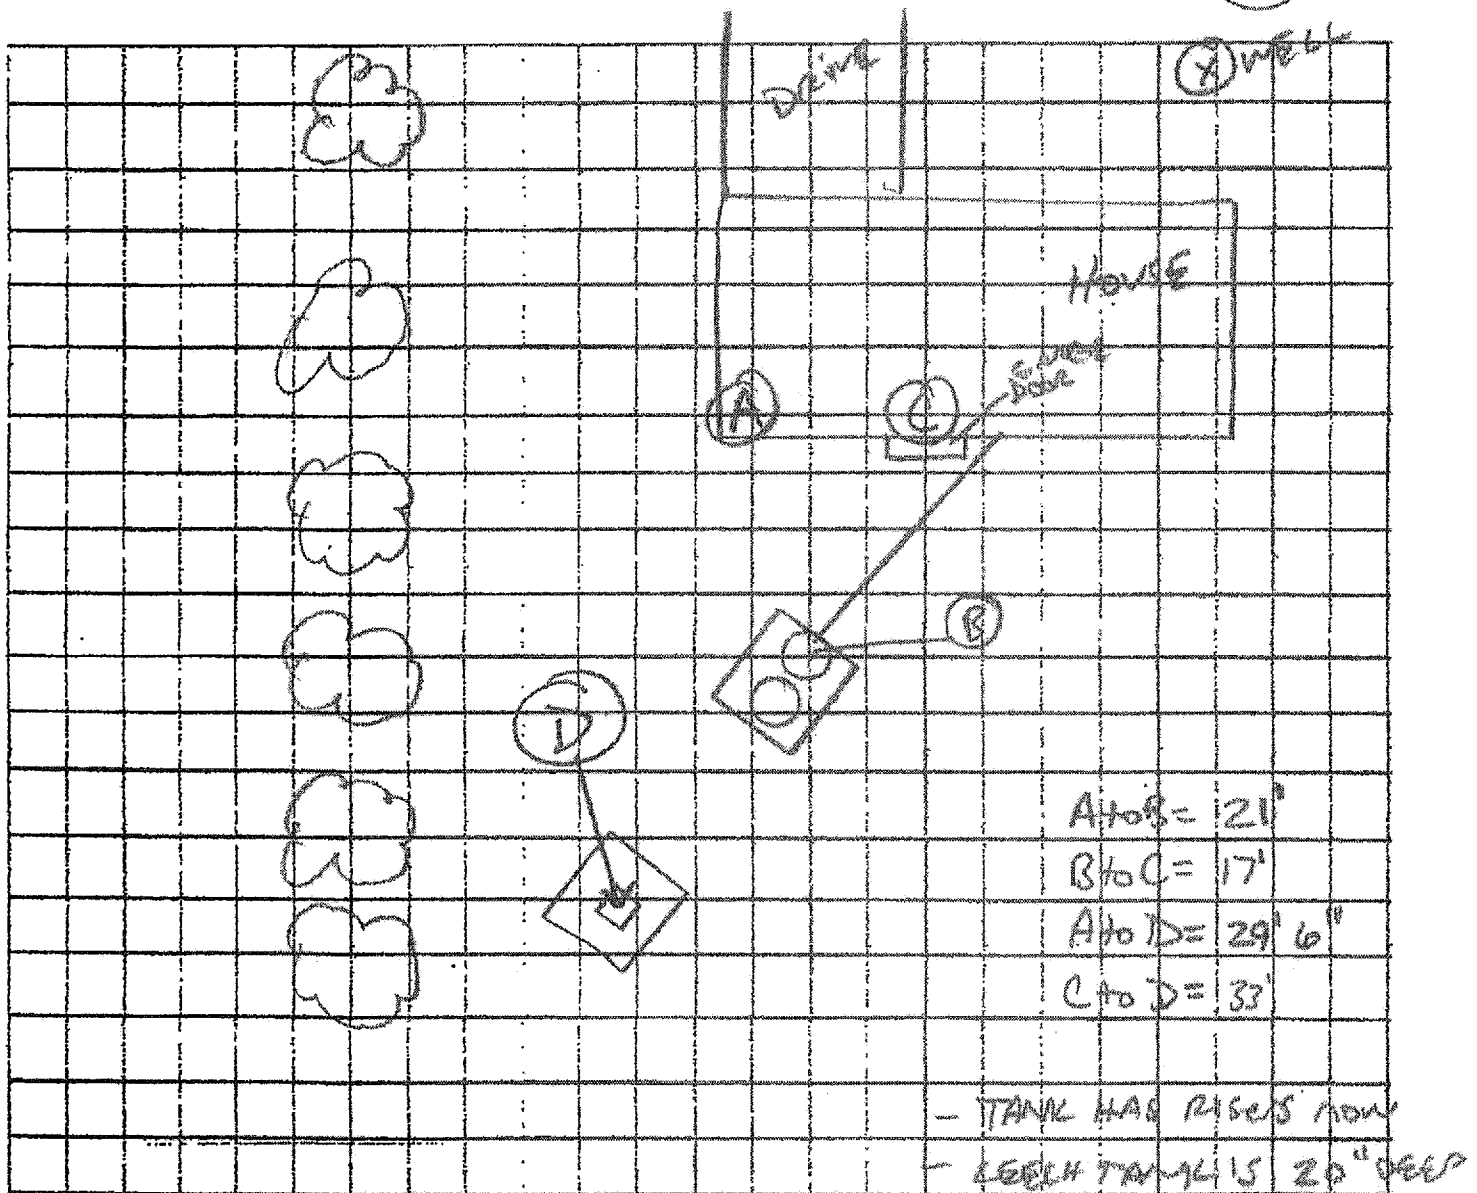
**Distance from Septic tank to well is >50'**

**Secondary treatment is >80'**
