## Time of Transfer Inspection Report

## NARRATIVE INSPECTION REPORT

Jacob Boge Property - 411 W 3<sup>rd</sup> St., Earlville, IA 52041

## TIME OF TRANSFER INSPECTION MA

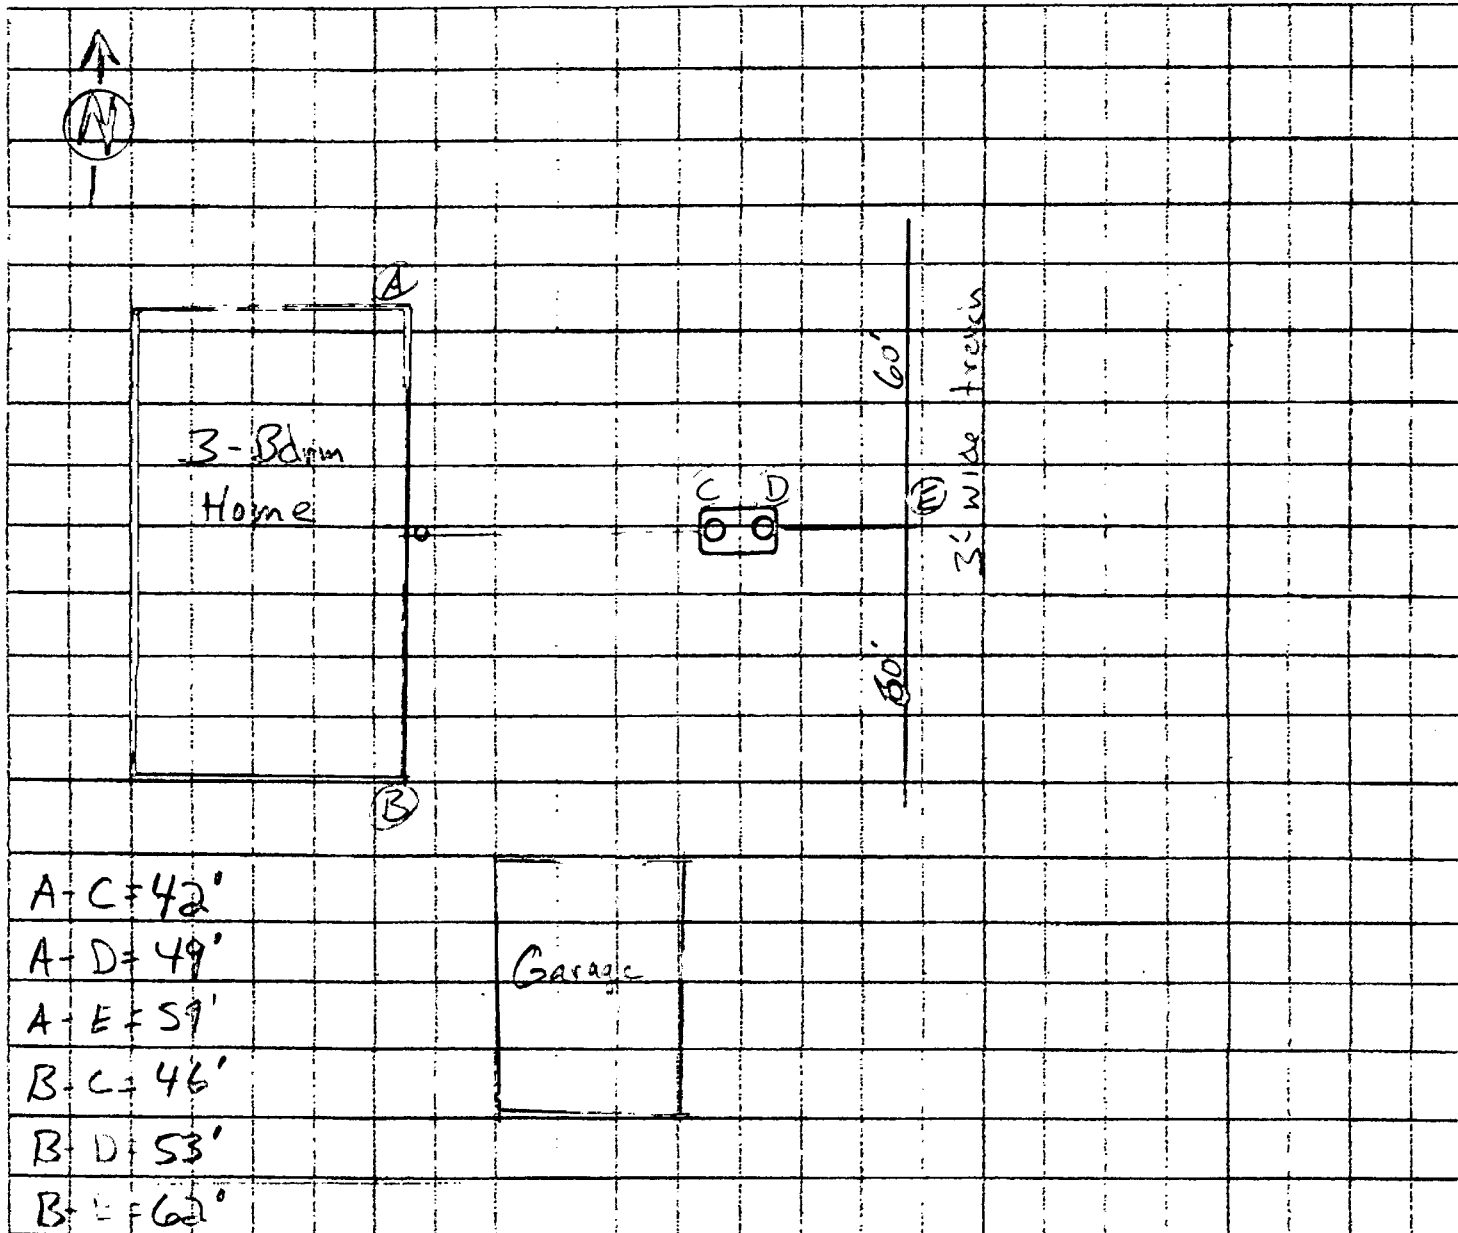
This is a three bedroom home w/o a kitchen garbage disposal. There is a water softener. Wastewater drains via gravity to septic tank. The gravity sewer line exits towards the east yard and drains to a 1250 gallon concrete, dual compartment septic tank. There are surface access risers on both the inlet and outlet side of septic tank w/20" diameter access lids. There is no effluent filter on the outlet in the septic tank. Machine dug for distribution box to inspect, but only found a 4-way tee w/straight on capped which left a right and a left line. It was very difficult to probe in the hard clay loam soil w/frequent rocks. It seems like the trenches are 3' wide by 60' long each. 120' total. Rock & pipe soil absorption lines.

**Distance from Septic tank to well is >65'**

**Secondary treatment is >100'**
