**REAL ESTATE TRANSFER - GROUNDWATER HAZARD STATEMENT  
TO BE COMPLETED BY TRANSFEROR**

## Time of Transfer Inspection Report

## NARRATIVE INSPECTION REPORT

**Jim Boeckenstedt Property -21741 276<sup>th</sup> Ave, Earlville, IA 52041**

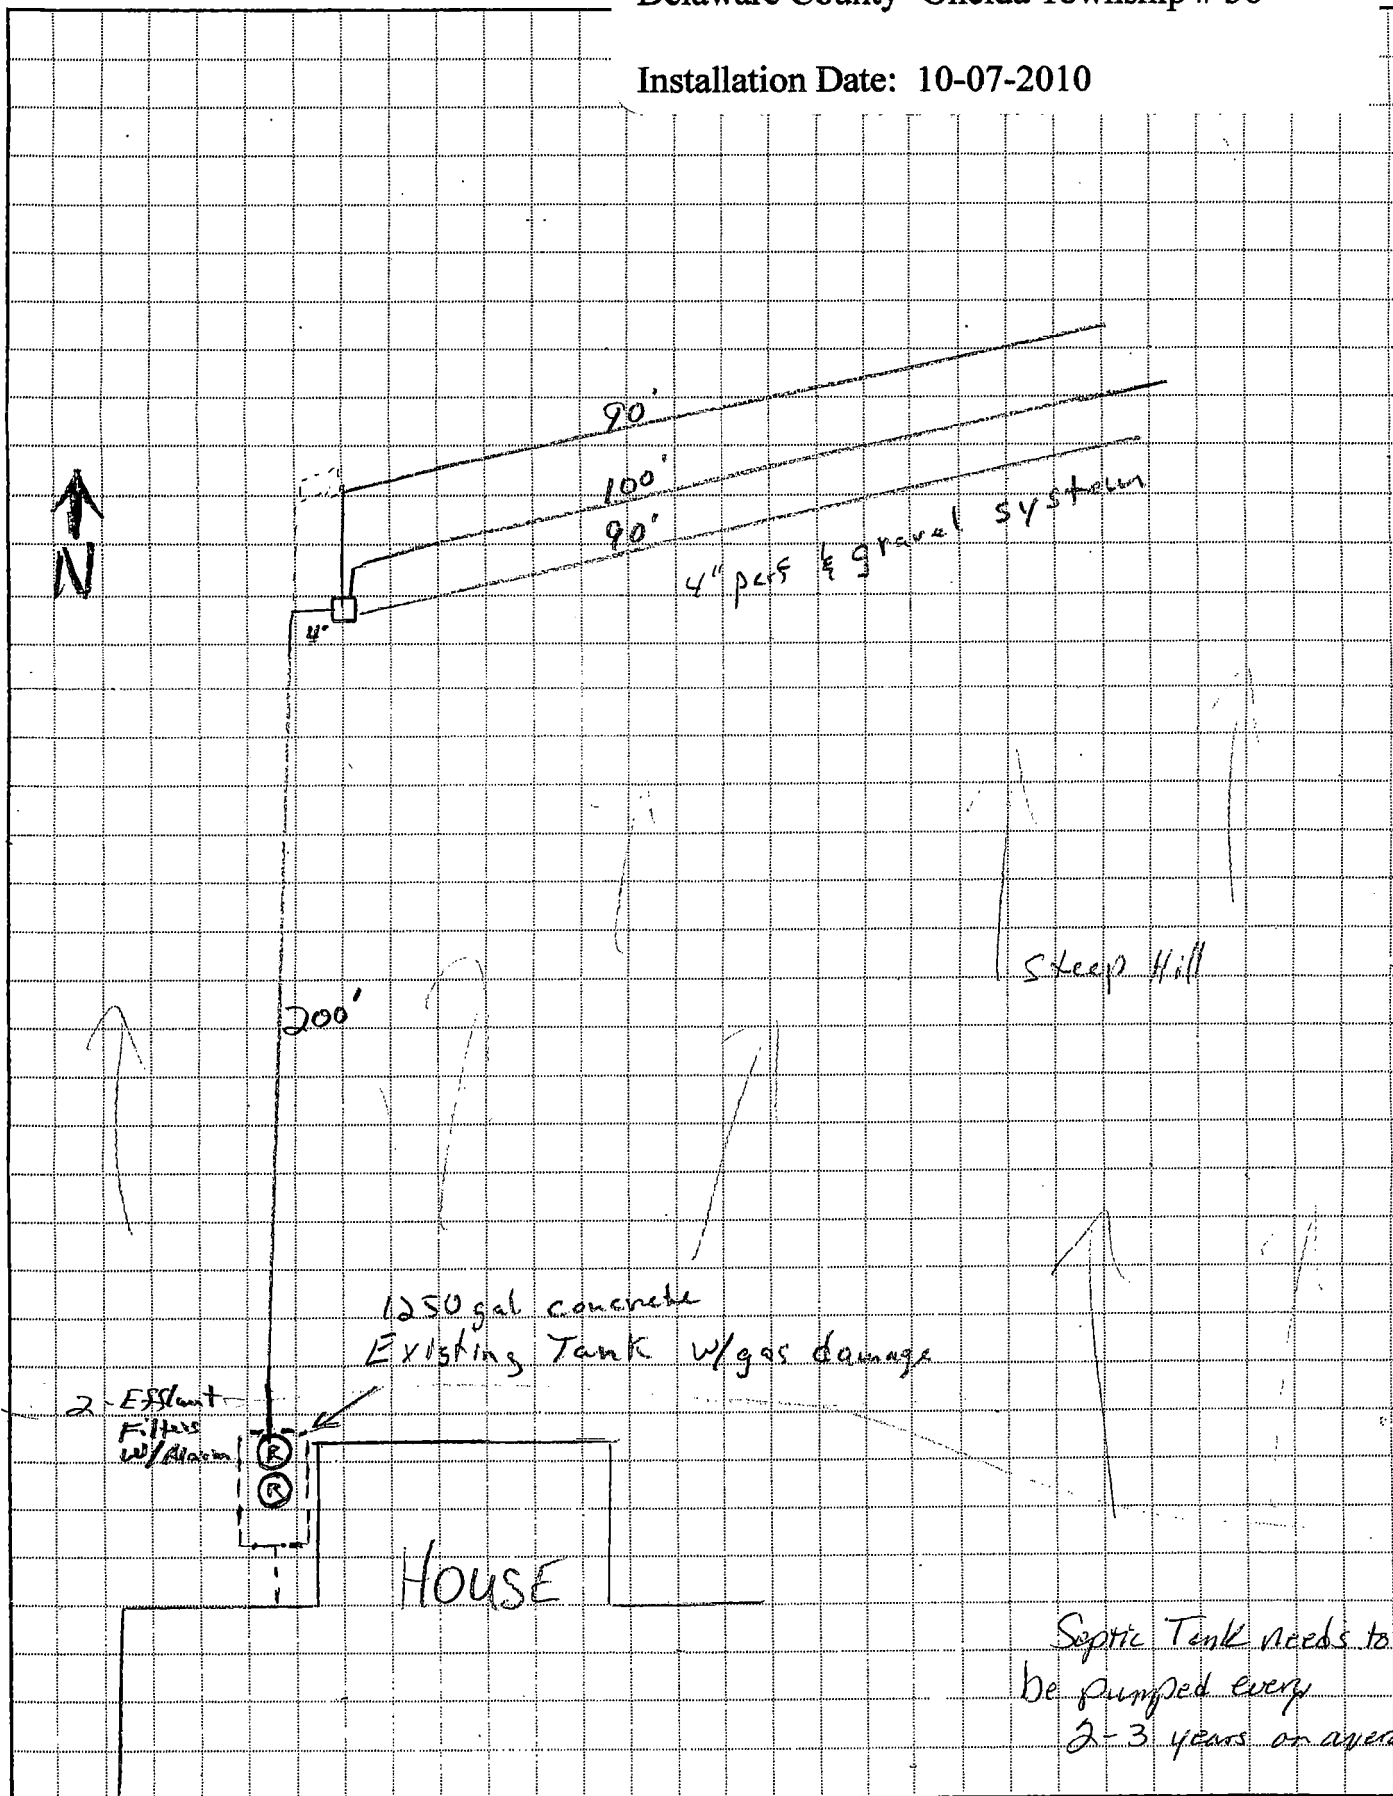
# GROTH SERVICES

This is a four bedroom home w/a kitchen garbage disposal and a water softener. Wastewater drains via gravity to septic tank. The gravity sewer line exits towards the north yard and drains to a 1,250 gallon concrete, dual compartment septic tank. There are 2-24" diameter risers for access to both compartments and the 2-effluent filters. The effluent line goes north from the septic tank to the yard down steep hill approx. 200' to the distribution box. The secondary treatment is rock & pipe soil absorption lines, 280' linear feet total.
