## Time of Transfer Inspection Report

## NARRATIVE INSPECTION REPORT

Ducladel Property -2249 245<sup>th</sup> Ave., Manchester, IA 52057

## TIME OF TRANSFER INSPECTION MAP

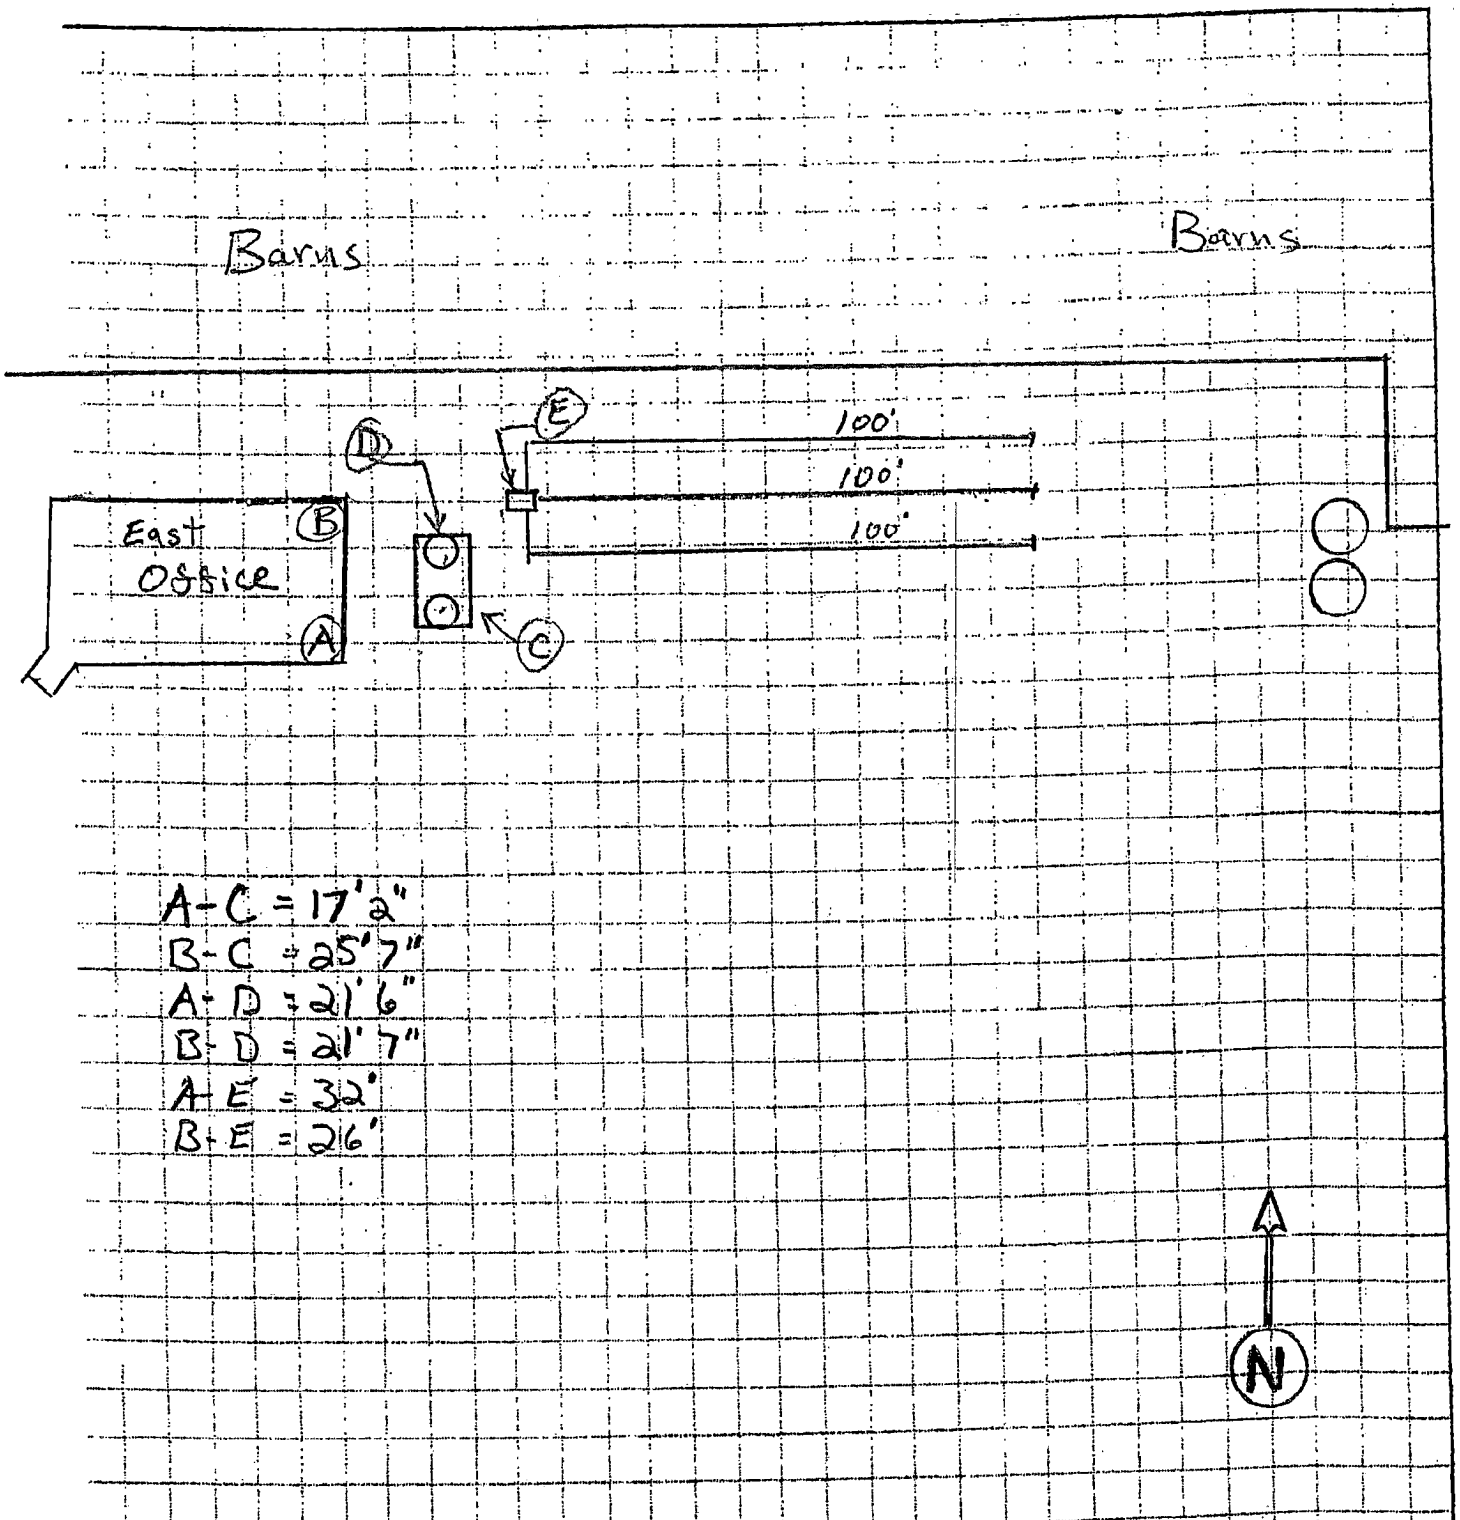
This is a commercial site with a hog confinement operation. Waste water consists of 2-toilets, 3- showers, 1- laundry, and a water softener. Wastewater drains via gravity to a 1,250 gallon, dual compartment concrete septic tank. The septic tank does not have surface access risers, but is very close to surface, 6"- 10". There is a HD concrete/plastic distribution box and 3-100' Infiltrator soil absorption lines.

Distance from - Septic tank to well is >50'

Secondary treatment is >100'
