**REAL ESTATE TRANSFER - GROUNDWATER HAZARD STATEMENT**  
**TO BE COMPLETED BY TRANSFEROR**

## Time of Transfer Inspection Report

## NARRATIVE INSPECTION REPORT

## TIME OF TRANSFER INSPECTION MAP

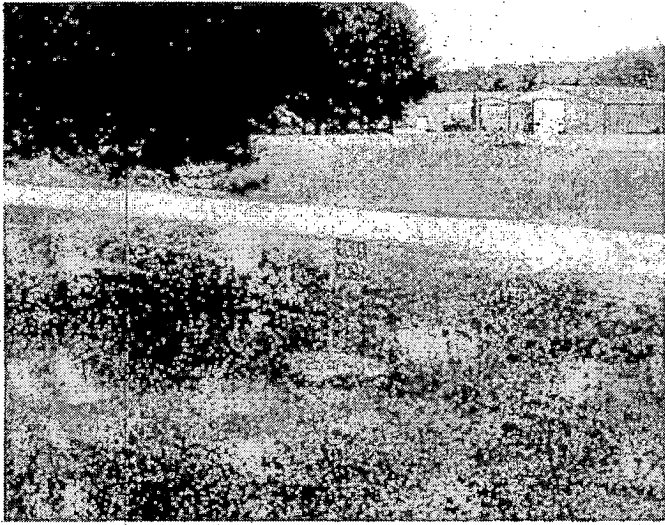
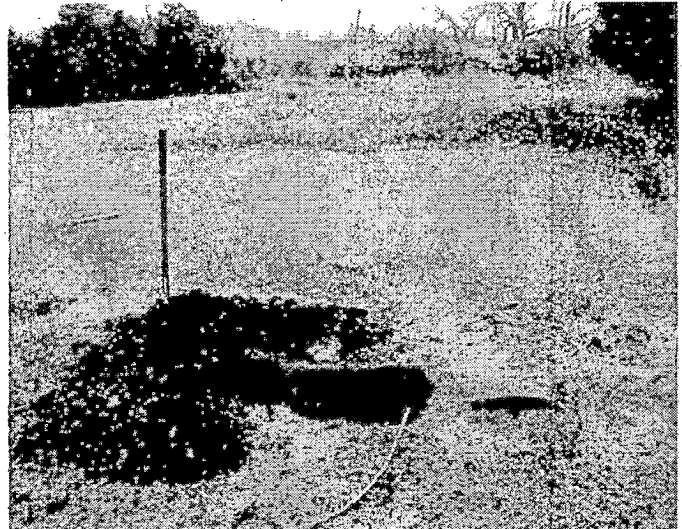
Groth Services LLC, pumped the septic tank on 12-20-2021. The concrete tank in good condition. Inlet baffle is good and the outlet effluent filters were cleaned. The distribution box is in good condition. I performed the hydraulic water load test from Distribution Box. The secondary treatment system accepted the prescribed 250 gallons of water and seems to be functioning properly.

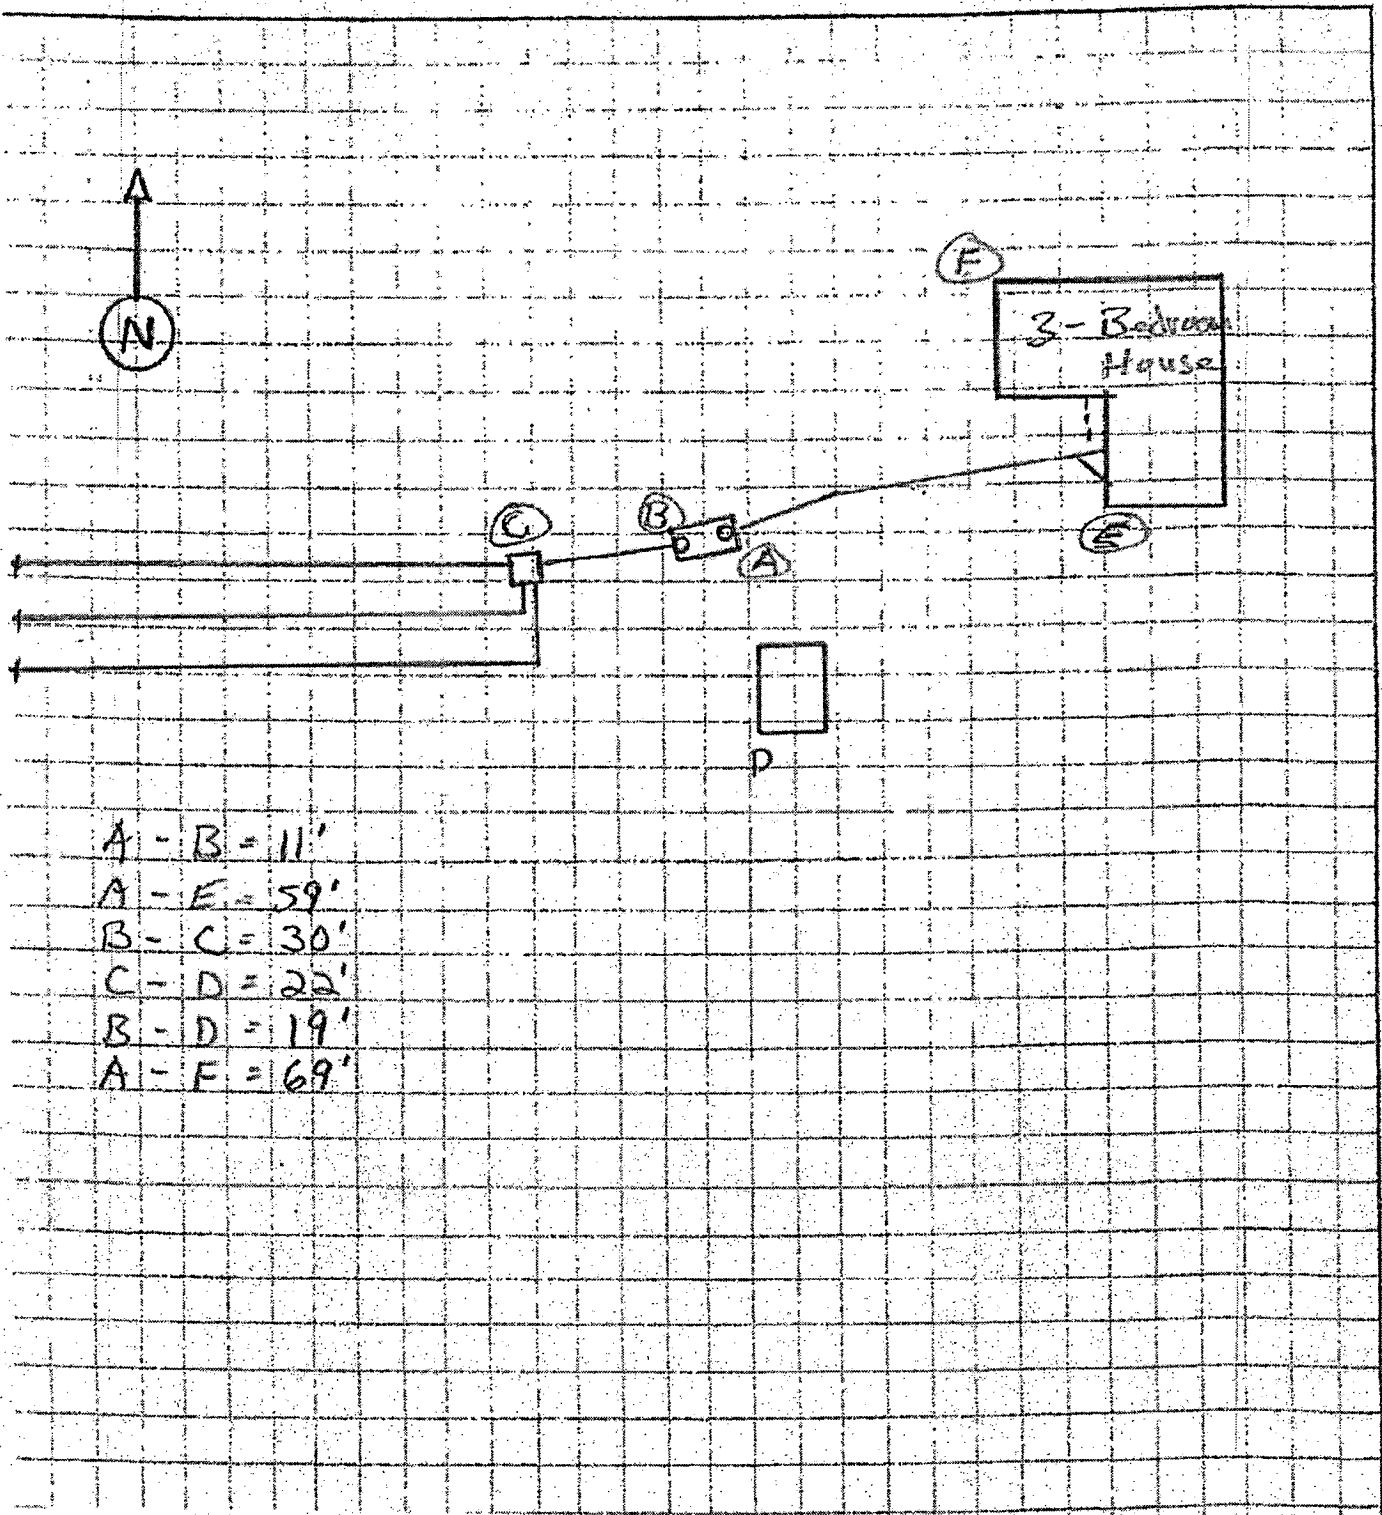
This is a three (3) bedroom home. There is no kitchen garbage disposal in the kitchen. There is a water softener. There is no sump pump. The basement floor drain does not connect to the septic system. It flows out to the south pasture. All other wastewater drains via gravity to a 1500' septic tank. The gravity sewer line exits towards the west yard. The septic tank is approx. 60' from house. There are 2 surface access risers. The septic tank is a concrete, dual compartment, 1,500 gallon tank. There are two HD effluent filters with a high water alarm. The secondary treatment system consists of a HD distribution box with three (3) 100' lines, all running west. Distance from Septic tank to well is > 100' +

Secondary treatment is > 150' +
