**REAL ESTATE TRANSFER - GROUNDWATER HAZARD STATEMENT**  
**TO BE COMPLETED BY TRANSFEROR**

## Time of Transfer Inspection Report

## NARRATIVE INSPECTION REPORT

## TIME OF TRANSFER INSPECTION MAP

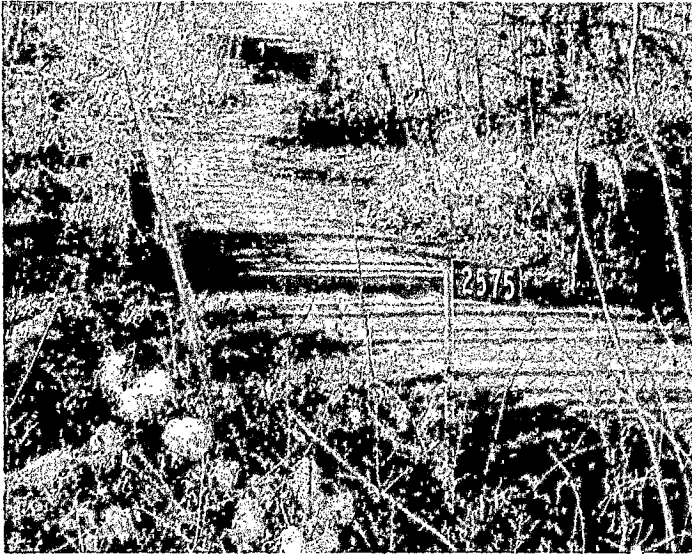
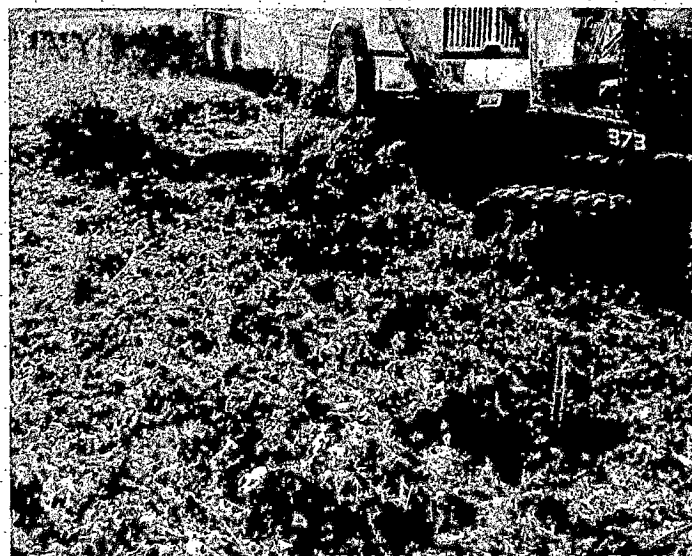
Groth Services LLC, pumped the septic tank on 12-2-2021. The surface access concrete riser lid is in poor condition. The contents in the tank was 100% sludge, very thick, could not backwash, had to wash down with water hose. The concrete tank seemed to be in good condition, but the 2<sup>nd</sup> compartment concrete wall has heavy gas damage. I checked inlet and outlet baffles with a mirror and flashlight, the inlet baffle seems to be ok and the outlet baffle is plastic pipe, ok. The distribution system consists of a series of 3 plastic drop boxes, all are in good condition. The first drop box was approx. 12" deep, the 2<sup>nd</sup> box was approx. 10" deep, and the 3<sup>rd</sup> was approx. 8" deep. The 1<sup>st</sup> soil absorption line did not take any water and proceeded to the 2<sup>nd</sup> & 3<sup>rd</sup> boxes. The secondary treatment system accepted the prescribed 250 gallons of water for the hydraulic load test and seems to be functioning properly with notation of line # 1.

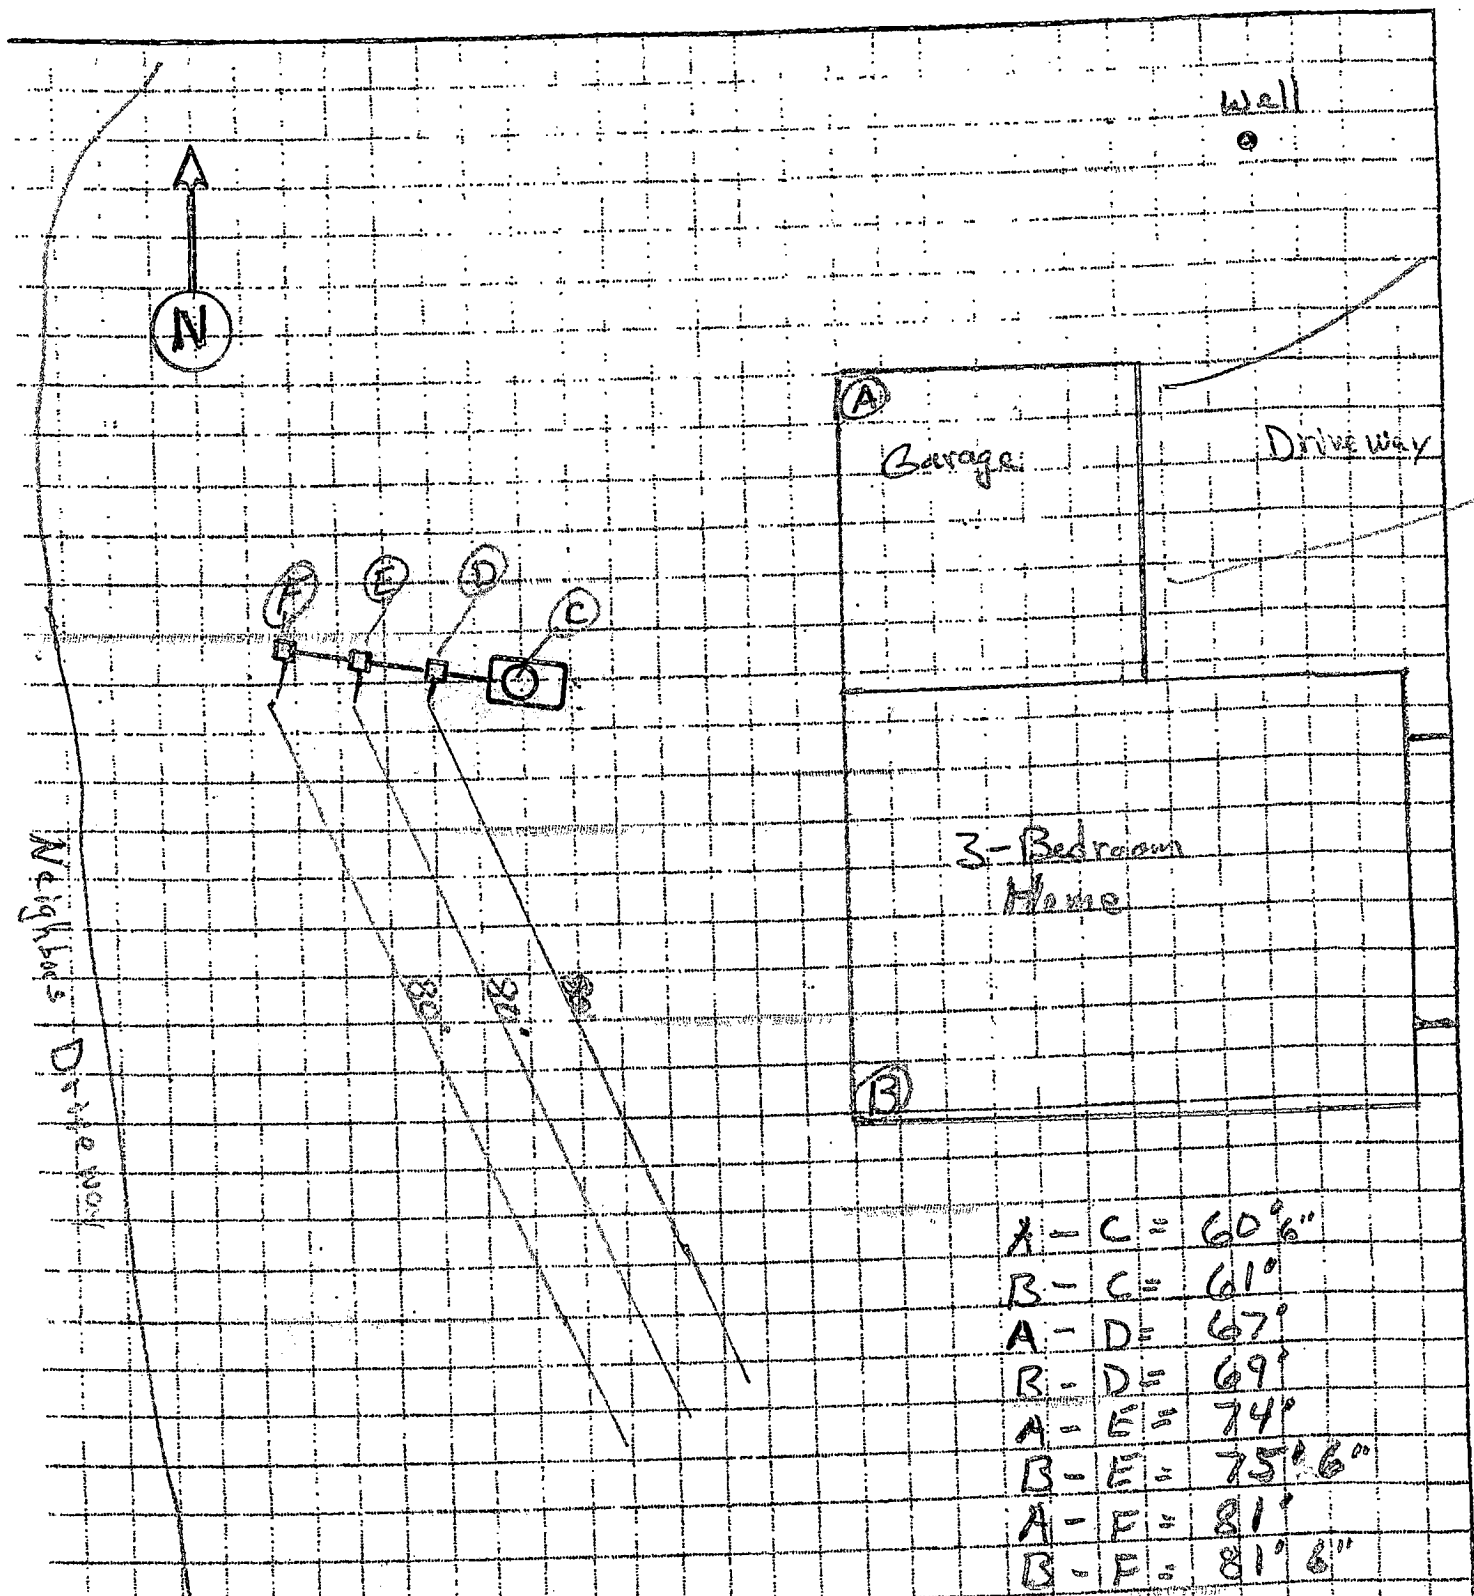
This is a three (3) bedroom / 3 bathroom, home. There is a kitchen garbage disposal in the kitchen. There is a water softener. There is no sump pump. All wastewater drains via gravity to a 1500 septic tank. The gravity sewer line exits towards the west yard. The septic tank is approx. 30' from house to center of the riser. The single riser is above grade and positioned over the dual compartment wall in septic tank. The septic tank is a concrete, dual compartment, 1,500 gallon tank according to pumper truck (permit says 1,000 gals). The secondary treatment system consists of 3 plastic drop boxes with three (3) 80' lines, all running southerly, in a sloping yard.

Distance from Septic tank to well is > 100' +  
Secondary treatment is > 150' +
