**REAL ESTATE TRANSFER - GROUNDWATER HAZARD STATEMENT**  
**TO BE COMPLETED BY TRANSFEROR**

**Time of Transfer Inspection Report (DNR Form 542-0191)**Property informationCurrent owner Chris AmmeterBuyer \_\_\_\_\_ Realtor Rossi Babington @ Pinnacle Realty

## NARRATIVE INSPECTION REPORT

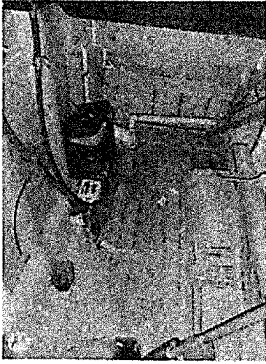
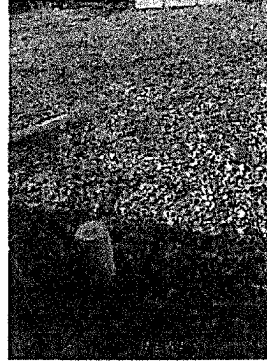
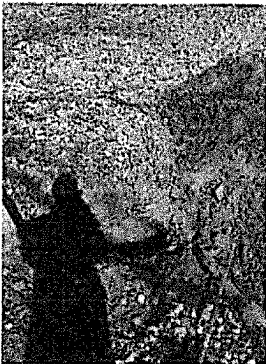
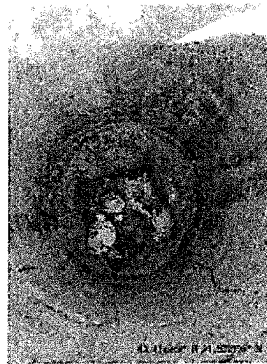
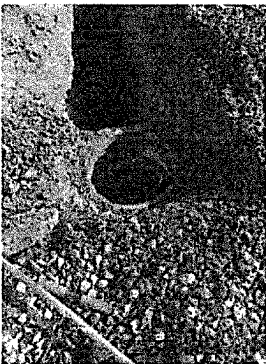
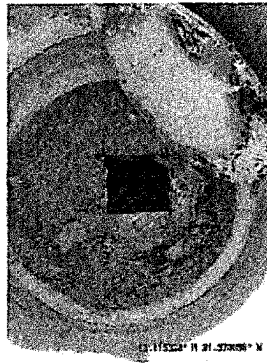
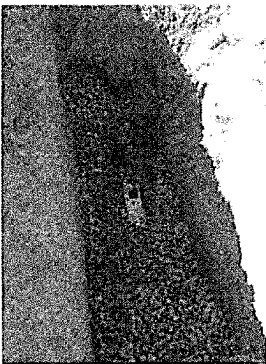
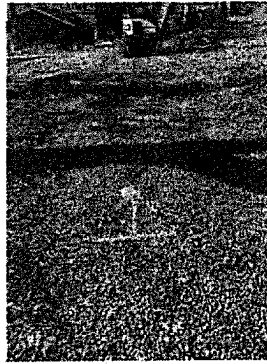
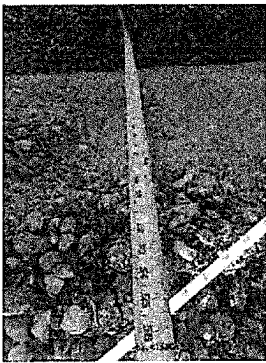
## Septic Inspection Photos

The septic tank was pumped on Nov. 11, 2021 by Groth Services and satisfies the three year requirement for this inspection. Normal septic tank cleanings are recommended in order to keep these solids from flowing out into the absorption system every 1.5 years. The septic tank access risers were not sealed and were replaced while onsite. The inlet baffle is concrete and the outlet was a plastic tee are functioning as designed. There is no distribution box on this site, but the header was found 50" deep with a sonde locator. A hydraulic load test was not completed, due to the cabin being vacant for more than 60 days. There were no wet spots found in the yard. This septic system is not in a desirable location, as it is being driven across by vehicles. There is only one cabin now connected to this system, 21671 has been removed. The system is grossly undersized to today's standards.

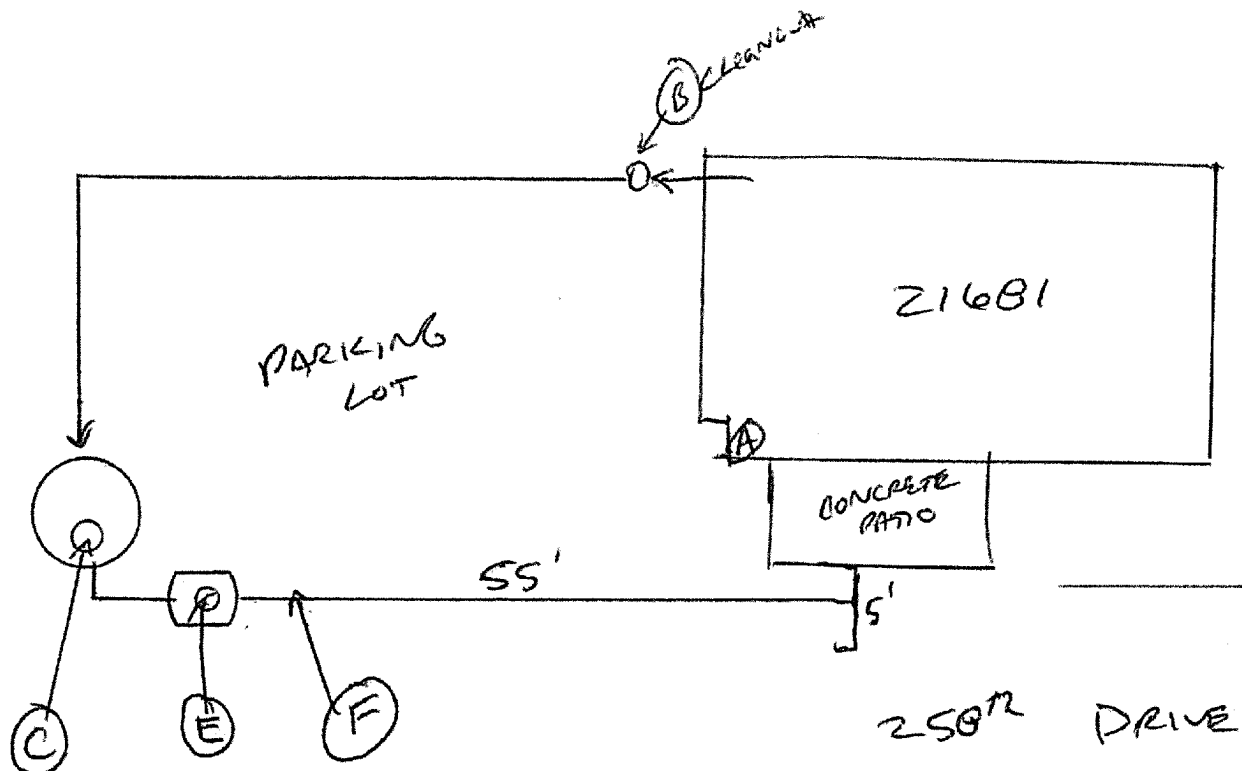
Contact IowaTOT.com for GPS/measurements

A to C =

B to C =

A to E =

B to E =

Tank depth
