**REAL ESTATE TRANSFER - GROUNDWATER HAZARD STATEMENT**  
TO BE COMPLETED BY TRANSFEROR

## Time of Transfer Inspection Report

## NARRATIVE INSPECTION REPORT

Dale Paulsen Property -18863 173<sup>rd</sup> Ave. , Manchester, IA 52057

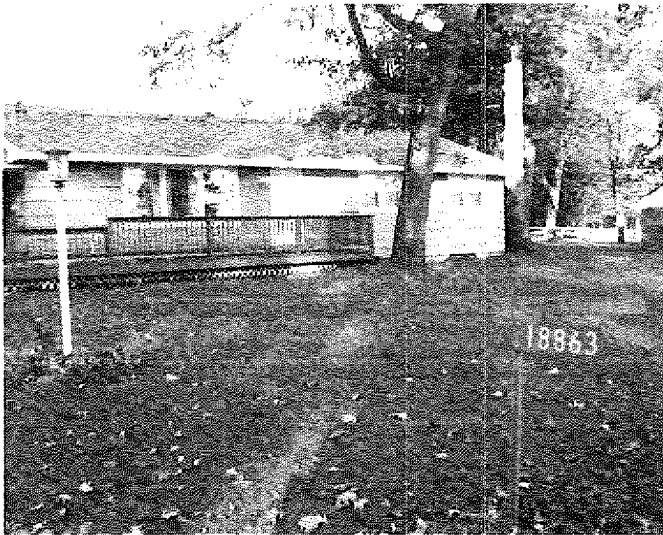
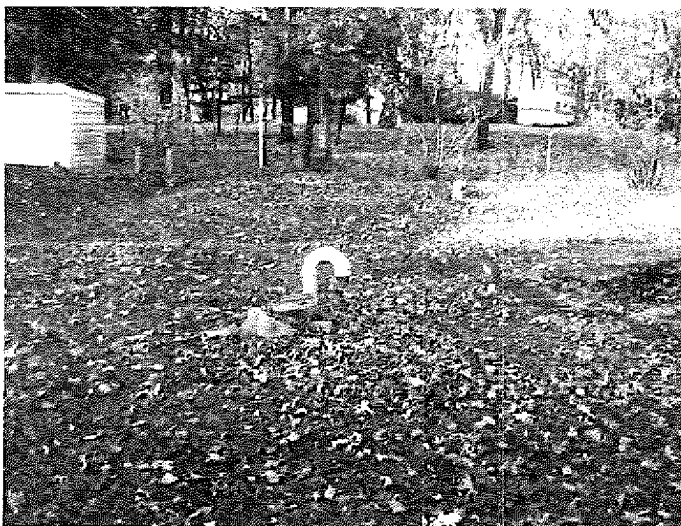
Concrete septic tank was pumped. The septic tank was at normal level on the day of inspection, but the system had not been maintained, control panel was in alarm mode. There had not been a service provider or service contract in place for one year. The seller agreed to re-establish an Orenco service contract with us, Groth Services LLC, at this time. The bio-tube filter was completely plugged and the pump/filter vault was floating. I cleaned the bio-tube filter and all maintenance performed on the unit as prescribed. I performed the hydraulic water load test of 250 gals. at the outlet at the re circulation valve and it accepted with no backups or slowness.

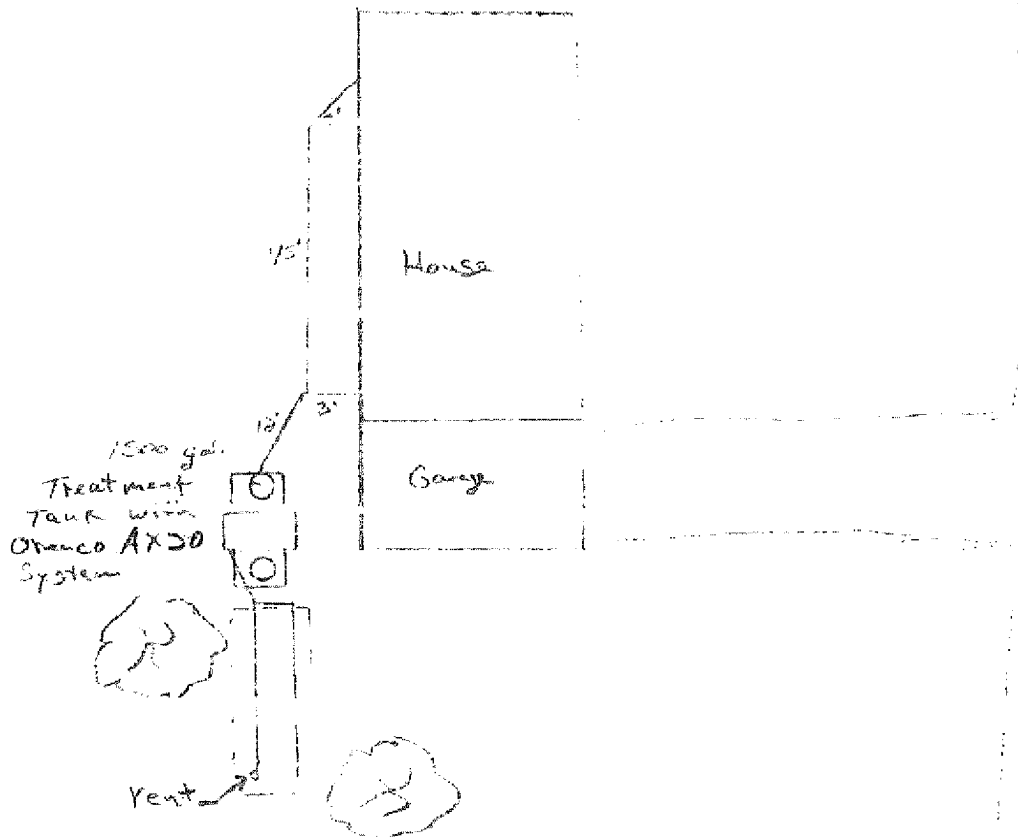
## TIME OF TRANSFER INSPECTION MAP

This is a three bedroom ranch style home with full basement. Wastewater drains via gravity out basement wall to a 1,500 gallon concrete, dual compartment treatment tank. The basement floor drain goes to the sump pump drain which drains to the west/northwest yard, completely separate and away from septic system. There are surface access risers on both compartments. The effluent exits the tank through the filter pod and re-circulation valve to the 300 sq ft soil absorption bed.

Distance from Septic tank to well is >50'

Secondary treatment is >100'
