REAL ESTATE TRANSFER - GROUNDWATER HAZARD STATEMENT

Time of Transfer Inspection Report- Amended

NARRATIVE INSPECTION REPORT

Jerry & Sharon Zbornik Property -23102 263rd St., Delhi, IA 52223

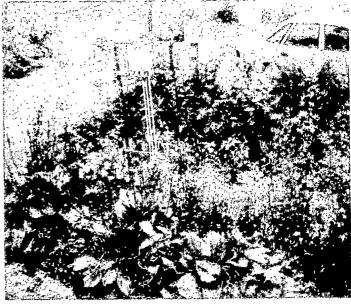
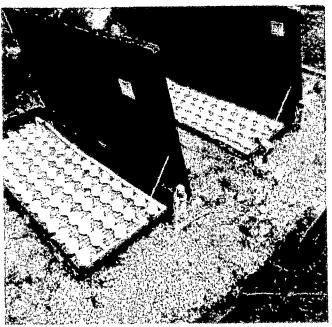
INSPECTION MAP

This is a two bedroom seasonal cabin w/o water softener. Cabin has no basement. Wastewater drains via gravity to a 6,000 gallon concrete, dual compartment septic tank w/surface access risers. There are 10 seasonal cabins connected to this middle system (263 St.-23082, 23094, 23102, 23110, 23116, 23124, 23157, 23164 and 264th St.-23168, 23105). The septic tank was at normal level on the day of inspection, there was no signs of being overfull previously. The effluent exits the tank through a large filter, to the 2,000 gal. treatment tank and 2-Orenco AX20 filter pods. There is 300 sq.ft. Tertiary soil absorption system w/open vent.

Concrete septic tank was pumped on 10-31-2019. The concrete tank is in good condition. Inlet and outlet baffles are intact and in good condition. The septic tank liquid level was normal when arrived. All components were working as designed. The tertiary outlet vent was dry.
