REAL ESTATE TRANSFER - GROUNDWATER HAZARD STATEMENT TO BE COMPLETED BY TRANSFEROR

TIME OF TRANSFER INSPECTION TOT# 1482 ROGER GROTH CERT # 8813

TIME OF TRANSFER INSPECTION MAP

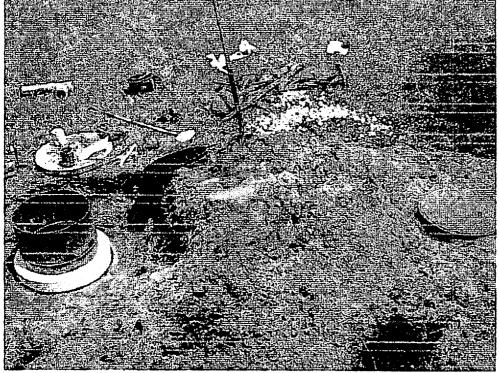
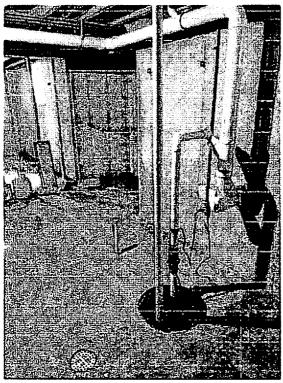
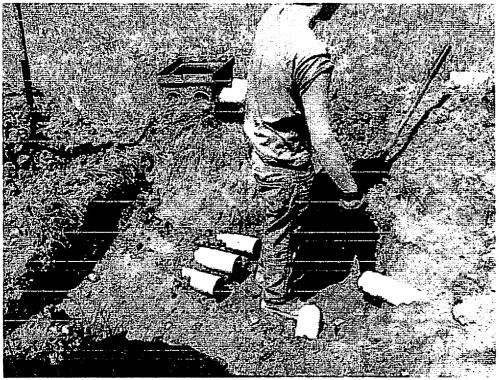
TOT inspection Report Overall Narrative Comments. This is a 6-bedroom home with a kitchen garbage disposal and a water softener. All plumbing fixtures connect to septic system, all main floor fixtures via gravity and the basement fixtures connect to a sewage lift pump in the basement floor. The sump pump is not connected to the septic system. After pumping the septic tank, which was very solid from lack of maintenance pumping, we re-installed new watertight riser to the surface. We also added an effluent filter on the outlet.

We found the distribution box approximately 78' north of the septic tank, excavated and found the plastic box was partially crushed and the bottom was broken. We installed a new concrete/plastic d-box and connected the 4 lateral lines. The d-box and lateral field is in the pasture with no points to measure, so we added a steel post as a permanent marker. We performed the water load test from the d-box for a 6-bedroom home, 400 gallons, and all lines accepted without any slowness or backup.

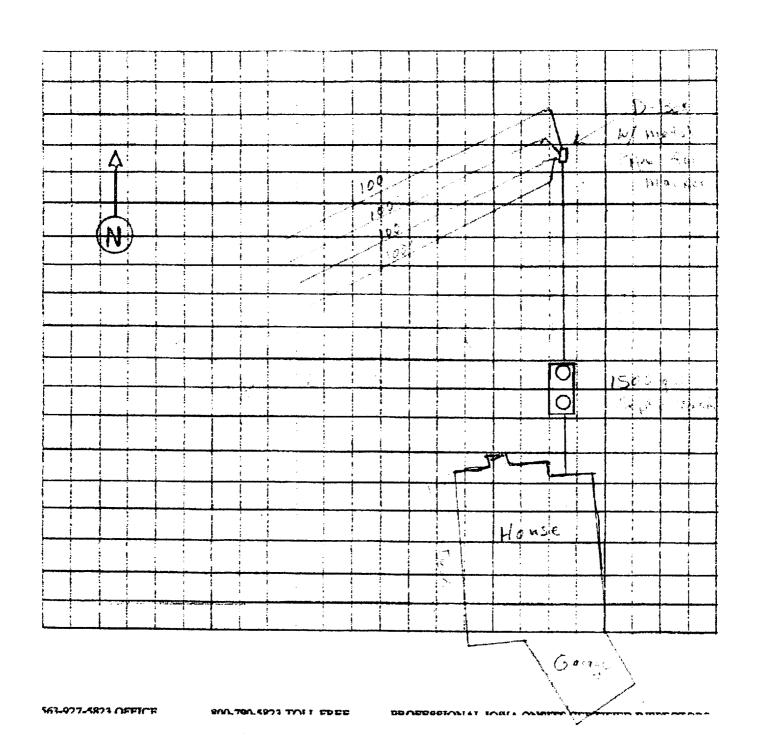
General Distribution System Comments: D-box and soil absorption system is in the pasture, so I added a steel marking post
