**REAL ESTATE TRANSFER - GROUNDWATER HAZARD STATEMENT  
TO BE COMPLETED BY TRANSFEROR**

## Time of Transfer Inspection Report

## NARRATIVE INSPECTION REPORT

## TIME OF TRANSFER INSPECTION MAP

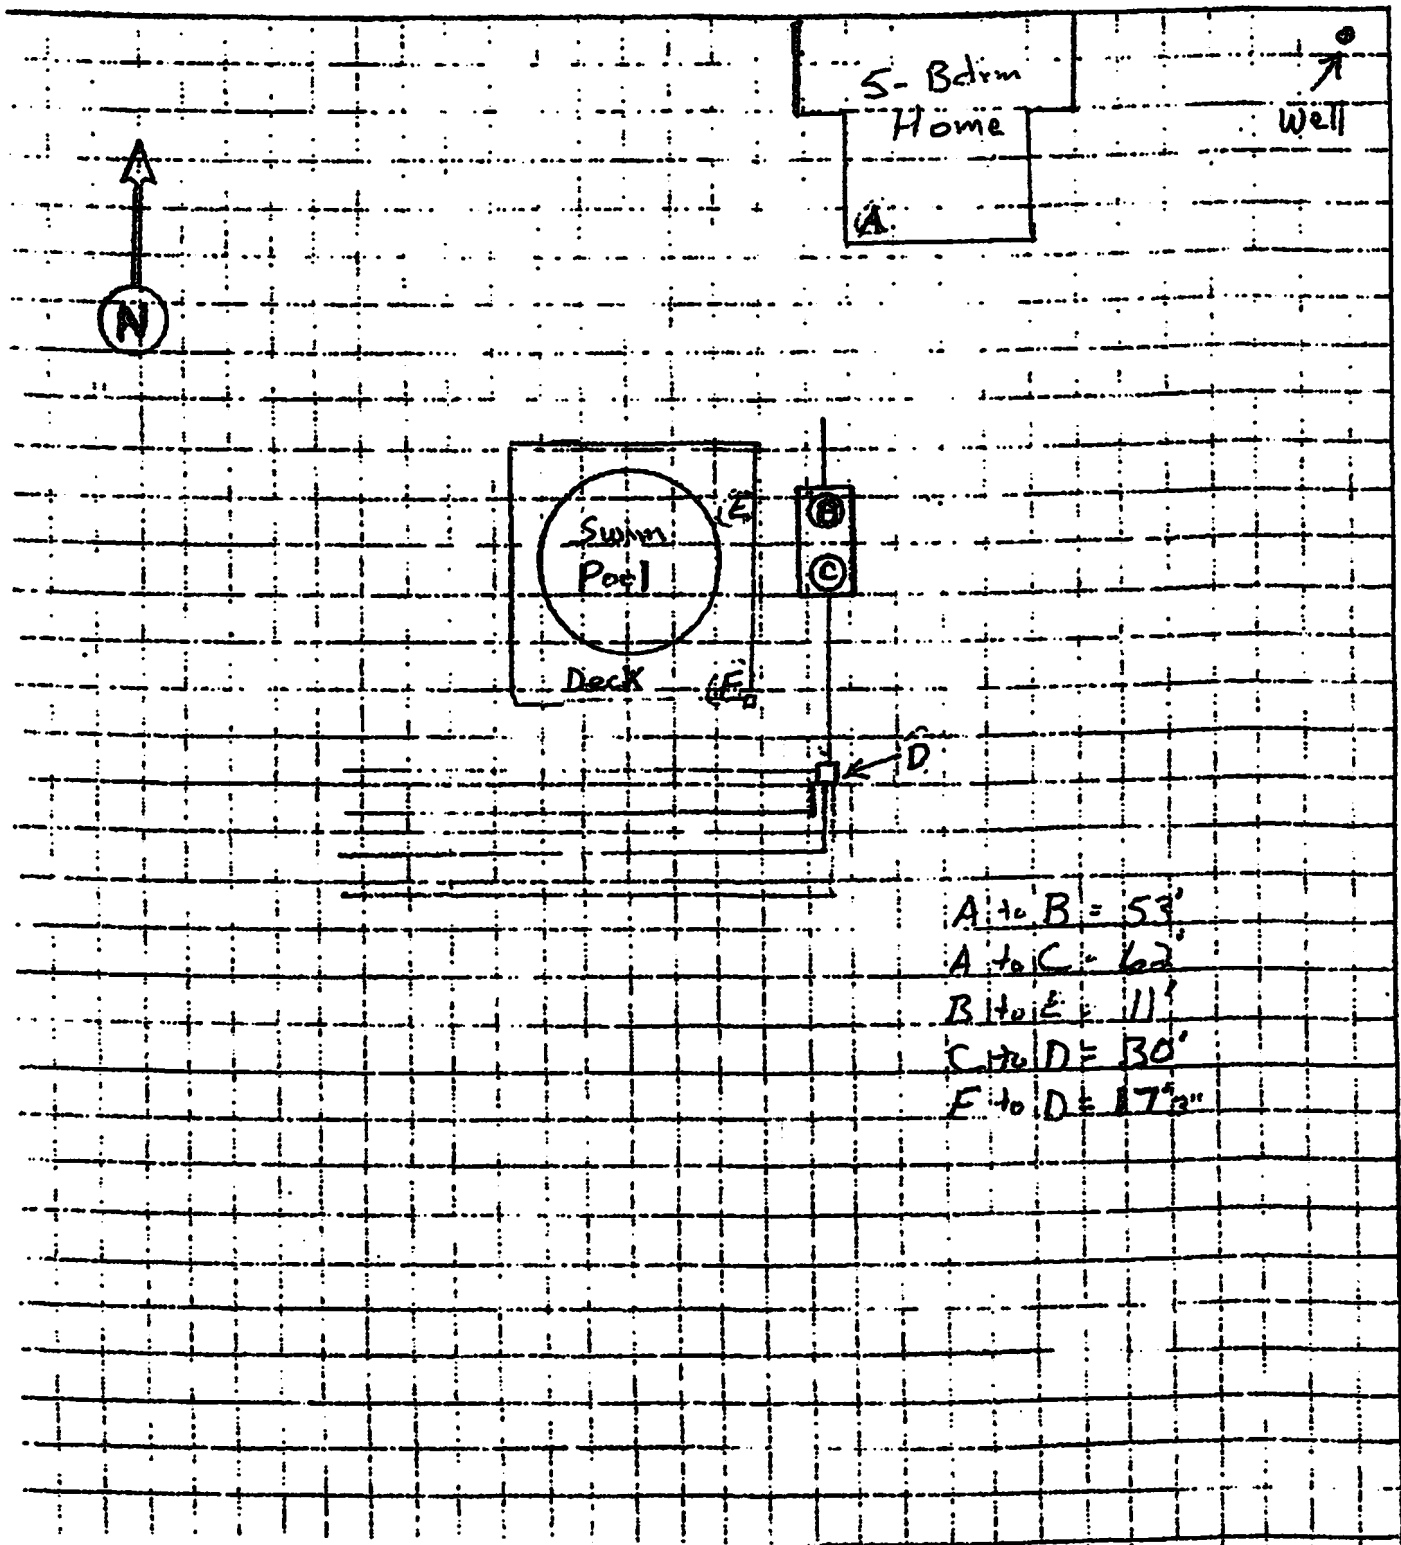
This is a five (5) bedroom / 4 ½ bathroom, home with a walk out basement. There is a kitchen garbage disposal in the kitchen. There is a water softener in the basement. The sump pump drains to the east yard. All wastewater drains via gravity to septic tank. The gravity sewer line exits towards the south yard. The septic tank is approximately 53' from house to center of the first riser. Both new risers are above grade. The septic tank is a concrete, dual compartment, 2,000 gallon tank. The secondary treatment system consists of a plastic lined, concrete distribution box with four (4) 100' lines, all running westerly. The County permit states installation approval on 8-15-2008.

Distance from Septic tank to well is > 100' +  
Secondary treatment is > 150' +
