**REAL ESTATE TRANSFER - GROUNDWATER HAZARD STATEMENT**  
TO BE COMPLETED BY TRANSFEROR

# TIME OF TRANSFER INSPECTION TOT# 6322 ROGER GROTH CERT # 8813

Address: **23110 263rd St., Delhi, IA 52223**

Rocky Nook Association  
Middle System

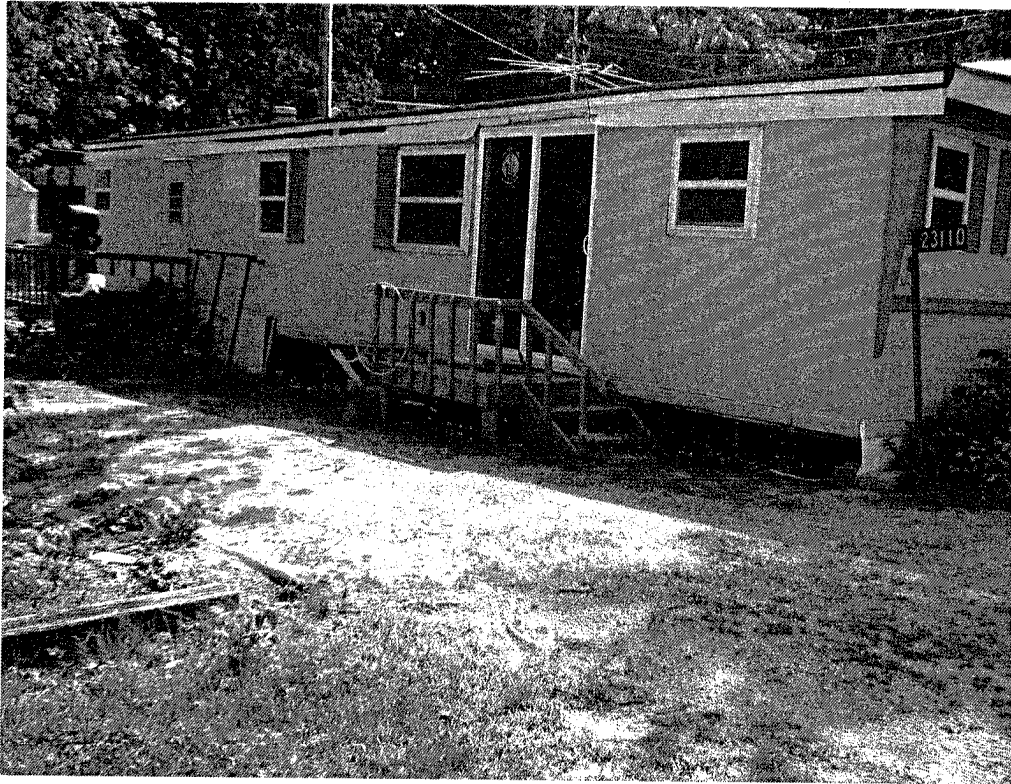
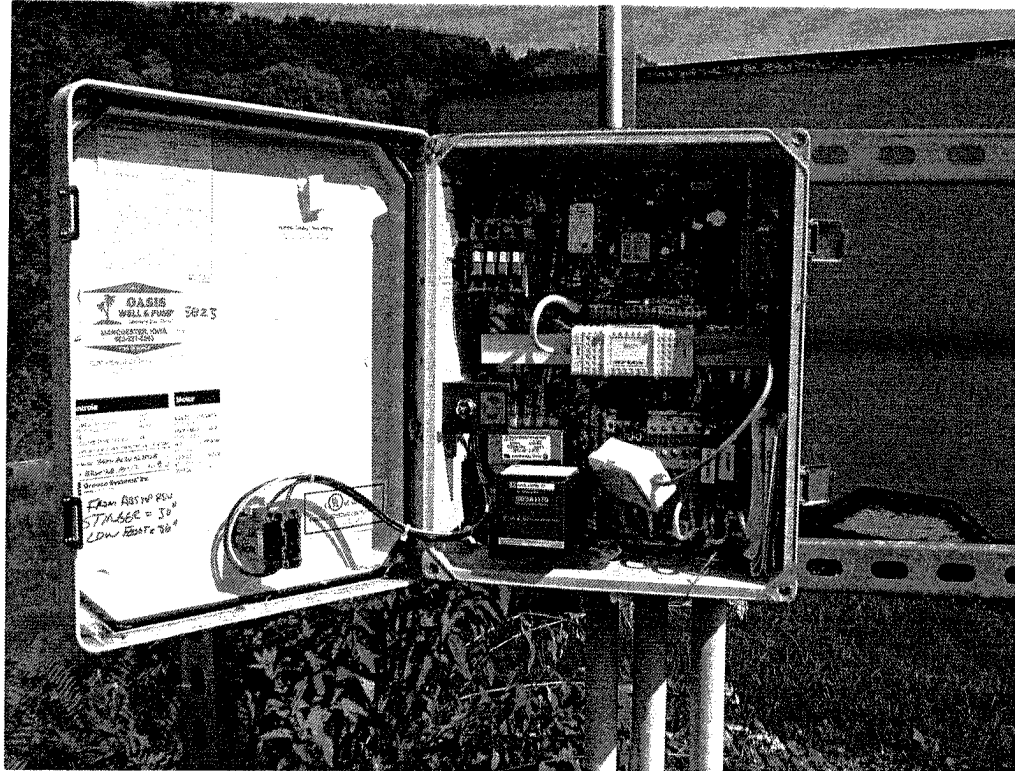
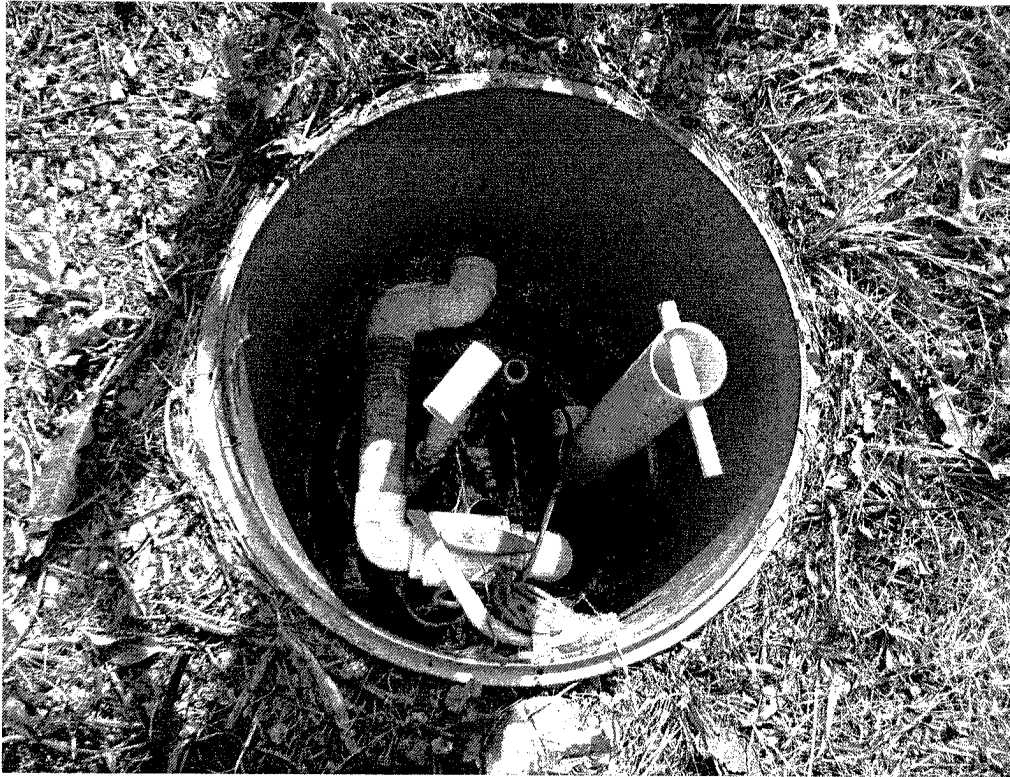
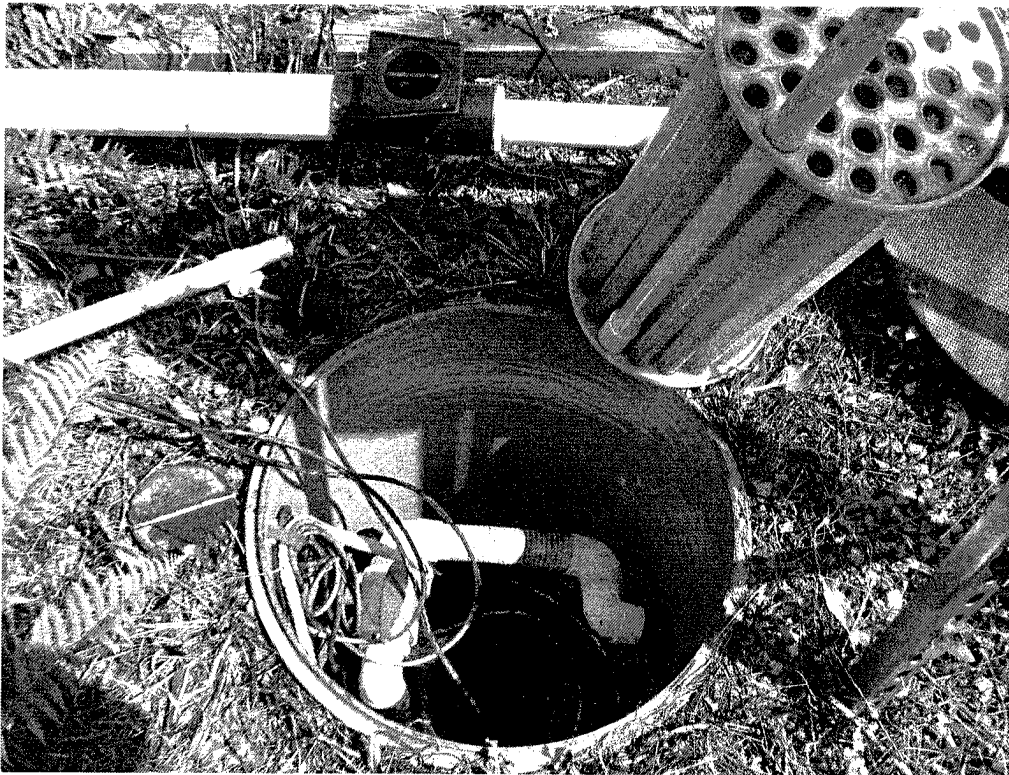
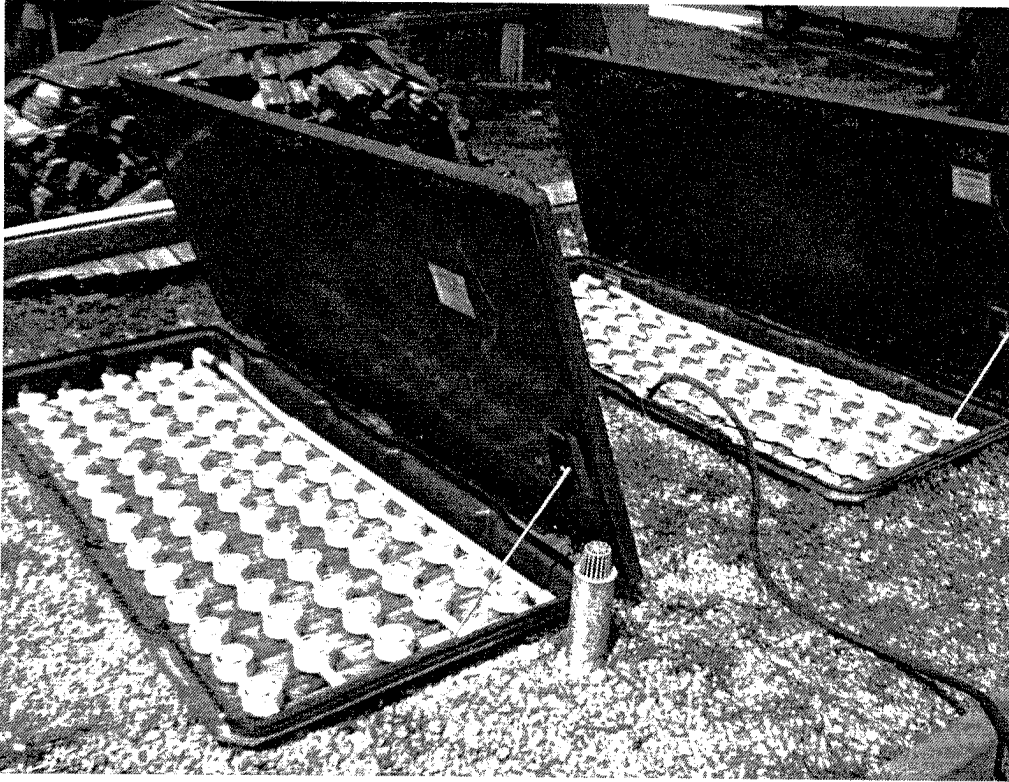
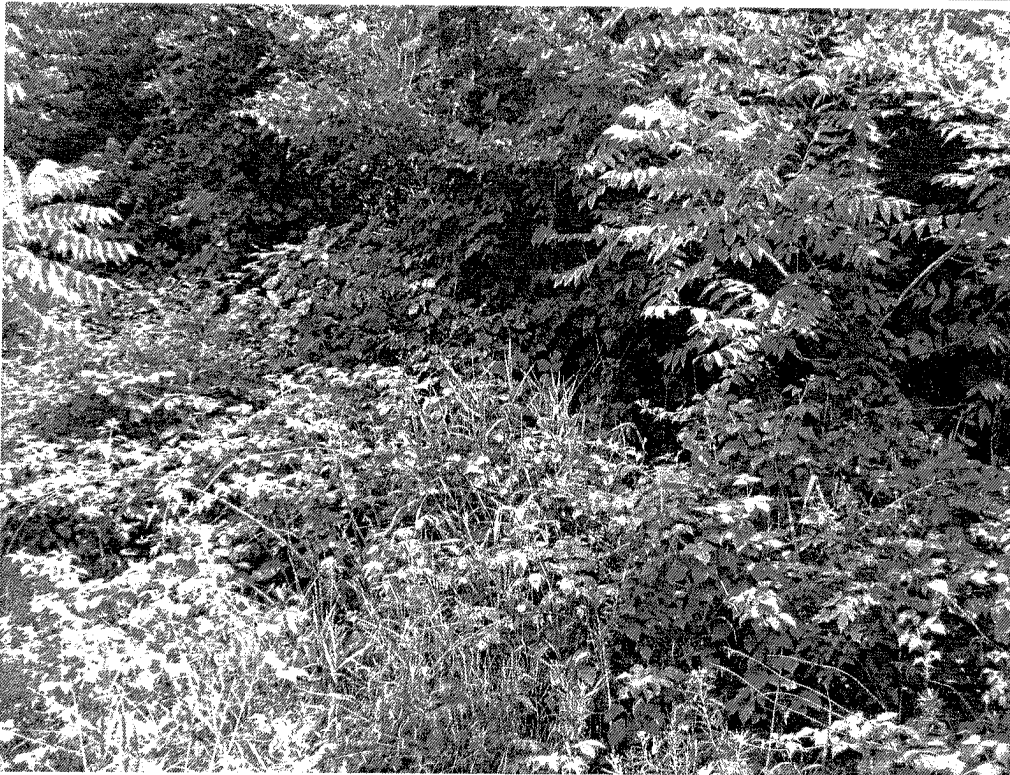
TOT Inspection Report Overall Narrative Comments: **This is a two-bedroom seasonal cabin near Delhi Lake. There is no basement, no water softener, and no kitchen garbage disposal. This system is part of a multi property collection sewer main called Middle system which flows to an Orenco dual pod AX-20 treatment system There are 10 seasonal cabins connected to this "middle system". They are 23082, 23094, 23102, 23110, 23116, 23124, 23157, 23164 - all on 263rd St., and 23168, 23105, on 264th St.**

**The Large 6,000 gal. septic tank for the middle system was pumped on 7/21/2023 for time of transfer inspection. There is a large effluent filter on the outlet which then flows to the 2,000-treatment tank, or recirc tank for the AX 20, dual pod treatment system. After this treatment the effluent flows through a small 300 sq. ft. tertiary, rock and pipe bed. There is a vent/outlet, plumbed above the distribution system in the tertiary bed to the open outlet.**
