**REAL ESTATE TRANSFER - GROUNDWATER HAZARD STATEMENT**  
TO BE COMPLETED IN FULL BY TRANSFEROR

# TIME OF TRANSFER INSPECTION TOT# 7511 ROGER GROTH CERT # 8813

Address: **1840 120th Ave, Manchester, IA 52057** County: **Delaware**

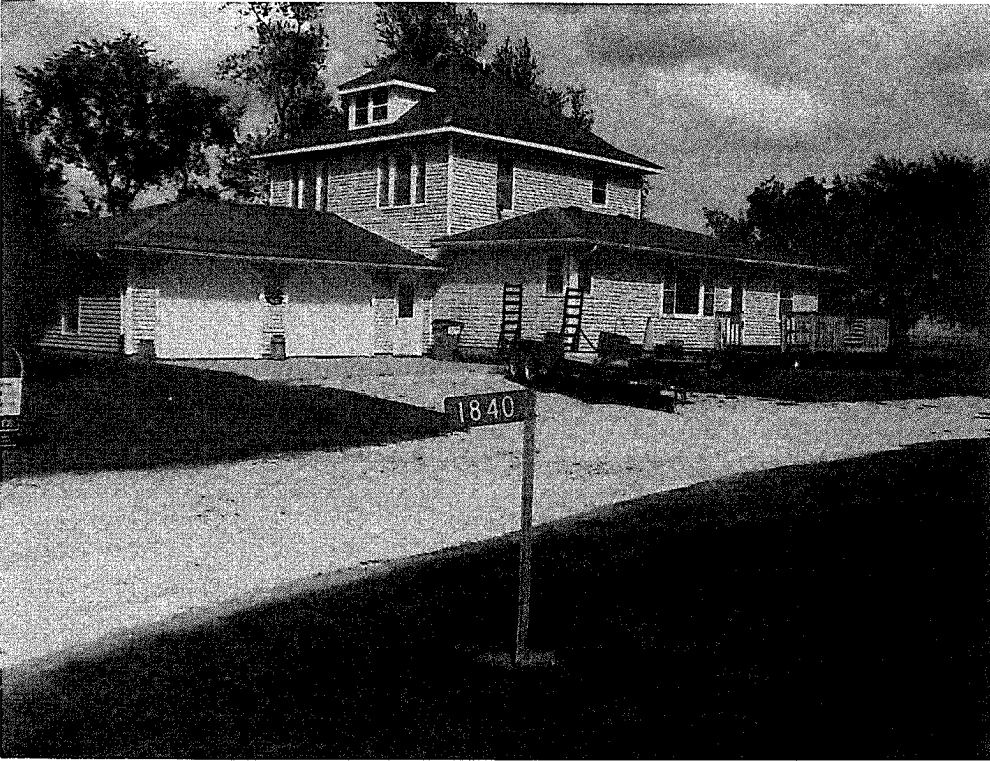
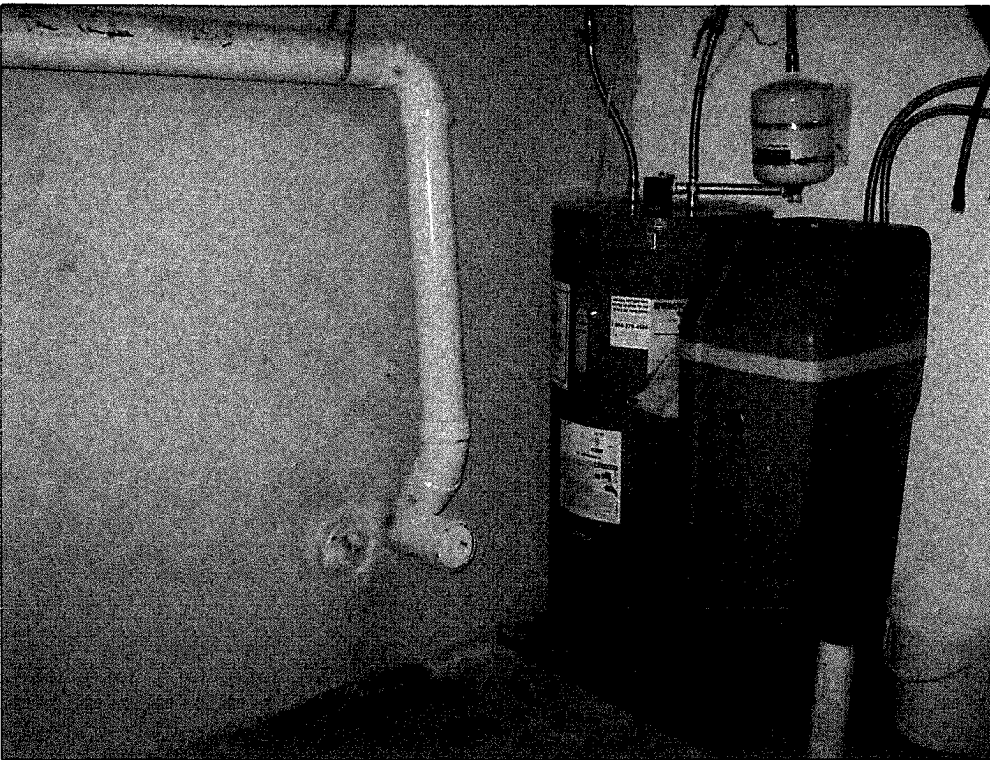
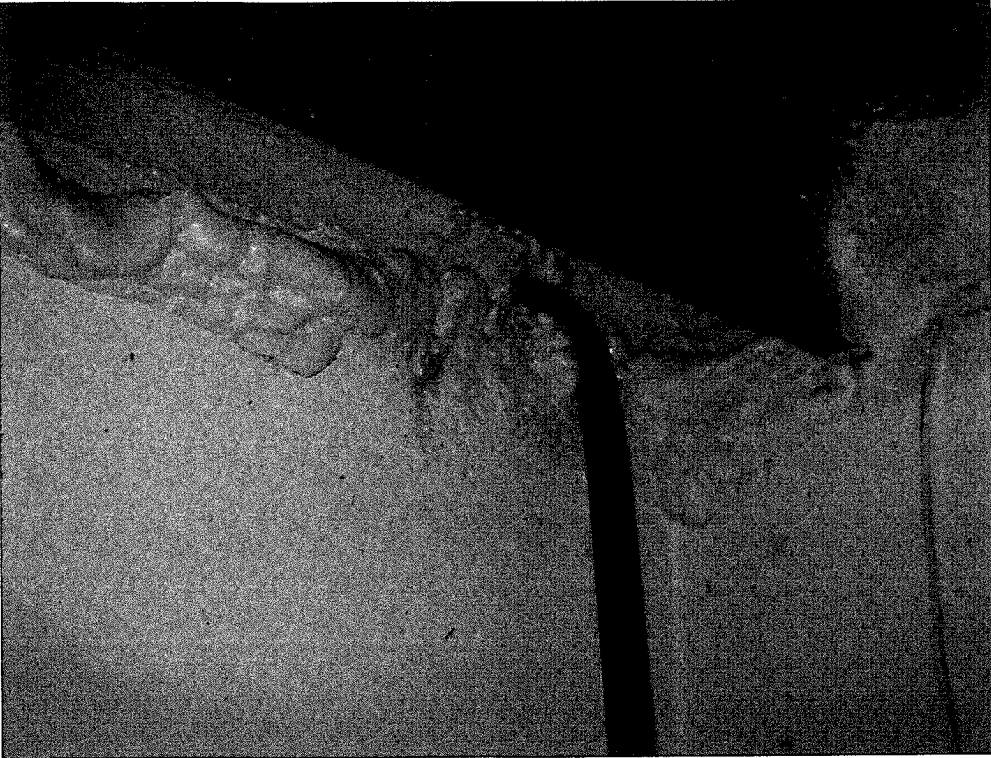
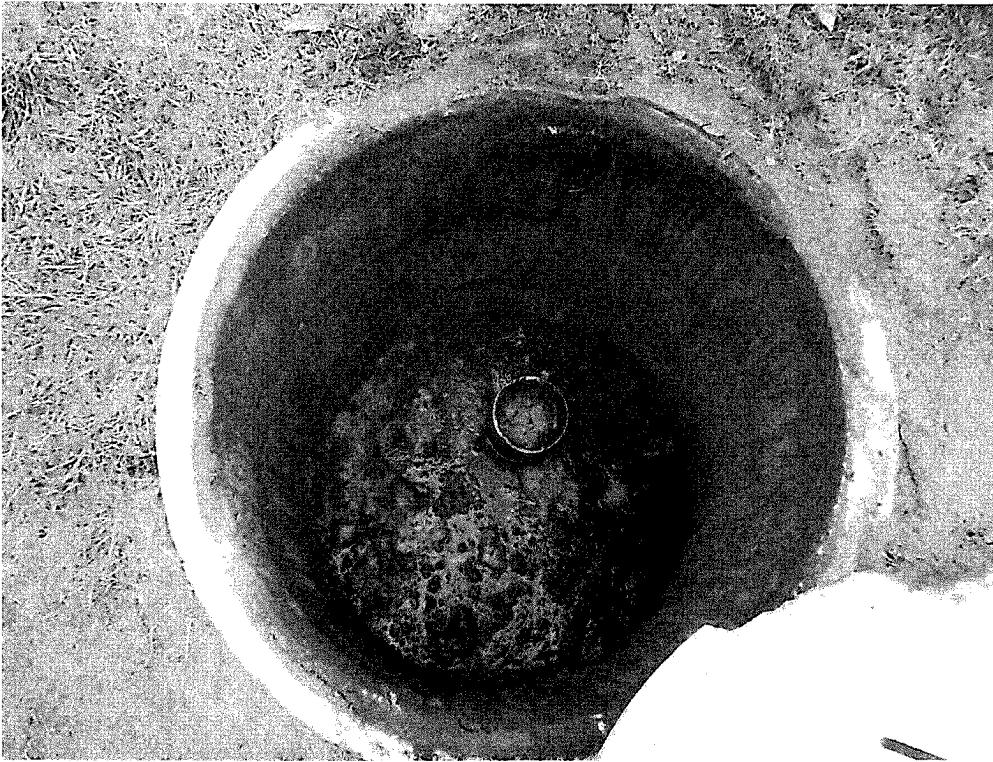
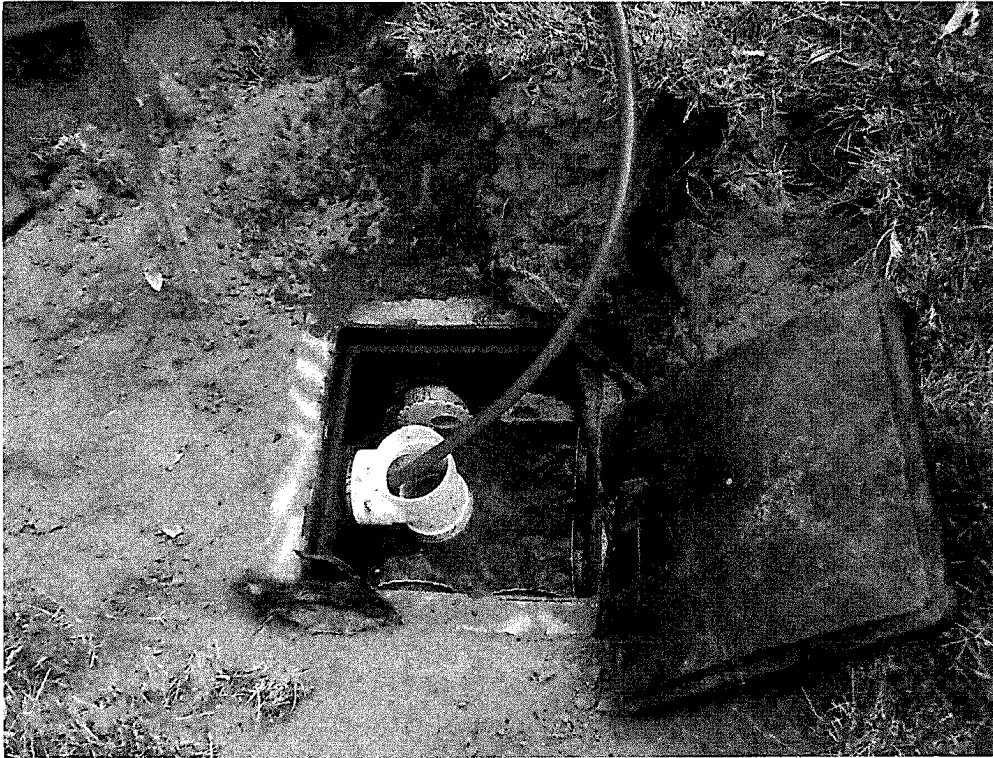
Tank Comments: **The septic tank level was approximately 5" overfull, the effluent filter was plugged. We pulled and cleaned the effluent filter after pumping tank.**

TOT Inspection Report Overall Narrative Comments: **This is a 5-bedroom farmhouse with 2 full bathrooms and a basement. There is a water softener and an iron filter with waste discharge to the sump pump which drains to the surface near NE corner of house. The 1,500 gal. septic tank was 200 gals. overfull because of the clogged effluent filter. We pumped the septic tank and cleaned the effluent filter. We probed and found the D-box, dug it up and performed the water load test at 350 gals. for a 5-bedroom home. The soil absorption system accepted this with no slowness or backups.**
