REAL ESTATE TRANSFER - GROUNDWATER HAZARD STATEMENT
TO BE COMPLETED BY TRANSFEROR

**TIME OF TRANSFER INSPECTION TOT# 9105 ROBB HARTER CERT # 9343****Site Information**Parcel Description: **160360101800**Address: **27133 218th Street, Earlville, IA 52041**County: **Delaware****Owner Information**Property is owned by a business: **No**

TIME OF TRANSFER INSPECTION TOT# 9105 ROBB HARTER CERT # 9343

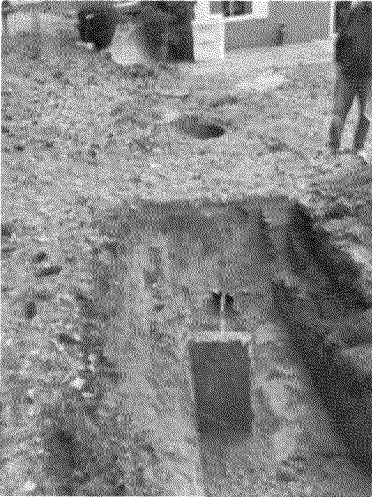
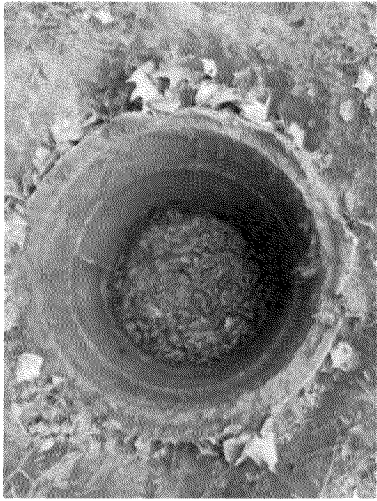
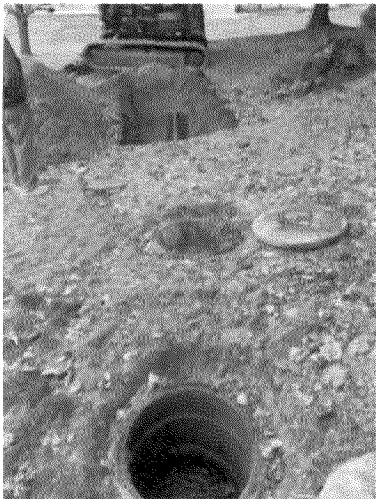
Primary Treatment**Tank**Tank Name: **Tank**Type: **Septic Tank**Tank Size (Gal): **1250**Tank Material: **Concrete**Tank Corrosion Type: **Slight**Liquid Level Type: **Normal**No. of Compartments: **2**Pump Tank Chamber: **Yes**Licensed Pumper Name: **Harter**Date Pumped: **3/11/2024**Meets Setback to Well: **Yes**Well Type: **Private**Distance To Well (Ft): **100+**Is Accessible: **Yes**Lid Intact: **Yes**Risers Intact: **Yes**Effluent Filter Present: **No**Watertight: **Yes**

Tank/Vault Pumped: **Yes** Inlet Baffle Present: **Yes** Outlet Baffle Present: **Yes** Functioning as Designed: **Yes**
Tank Comments: **This property has a shared well.**

Label: Distribution Box	Material Type: Concrete	Accessible: Yes
Box Opened: Yes	Baffle Present: Yes	Speed Levelers Present: No
Watertight: Yes	Functioning As Designed: Yes

General Distribution System Comments : **Concrete has some flaking in the d-box.**

Distribution Type: Distribution Box	Material Type: Rock and PVC Pipe	Trench Width: 24
Lines: 2	Total Length of Absorption Line: 220	System Hydraulic Loaded: Yes
Gallons Loaded: 300	Meets Setback to Well: Yes	Well Type: Private
Distance To Well (Ft): 100+	Lateral Lines Probed: Yes	Saturation or Ponding Present: No
Grass Cover Present: Yes	Lateral Lines Equal Length: Yes	System Located on Owner Property: Yes
Easement Present: N/A	Functioning as Designed: Yes	
Comments: Field is undersized for this home.

TOT Inspection Report Overall Narrative Comments: **System in good working condition. Concrete D-box has some flaking. Lateral field is undersized for size of residence. Well is shared with a neighbor and is over 100 feet from system. Pump tank every three years.**

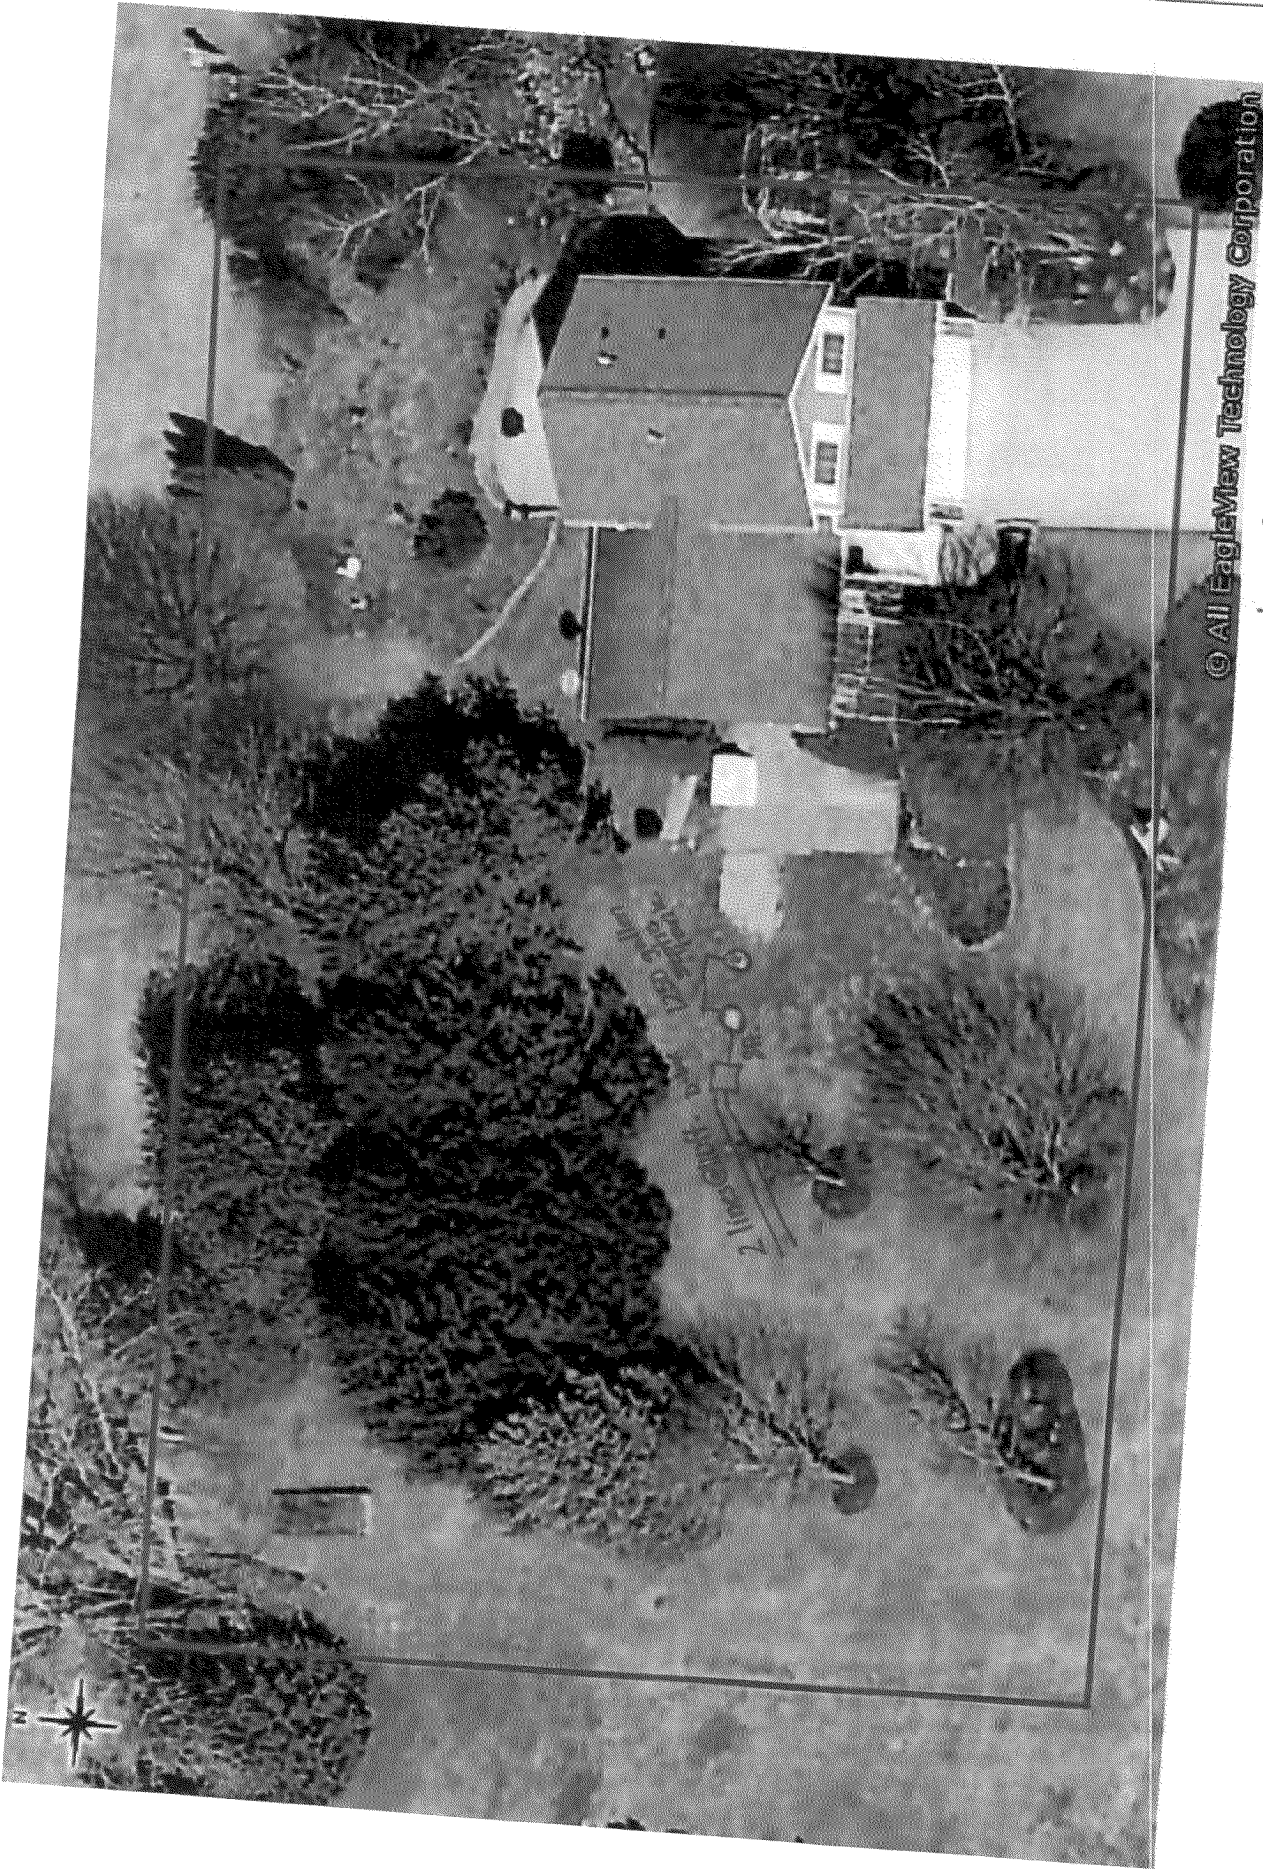
shared wall to NE of
property on neighbor's
property
