**REAL ESTATE TRANSFER - GROUNDWATER HAZARD STATEMENT
TO BE COMPLETED BY TRANSFEROR**

26047 216th Avenue, Delhi, Iowa 52223

TIME OF TRANSFER INSPECTION TOT# 9850 ROGER GROTH CERT # 8813

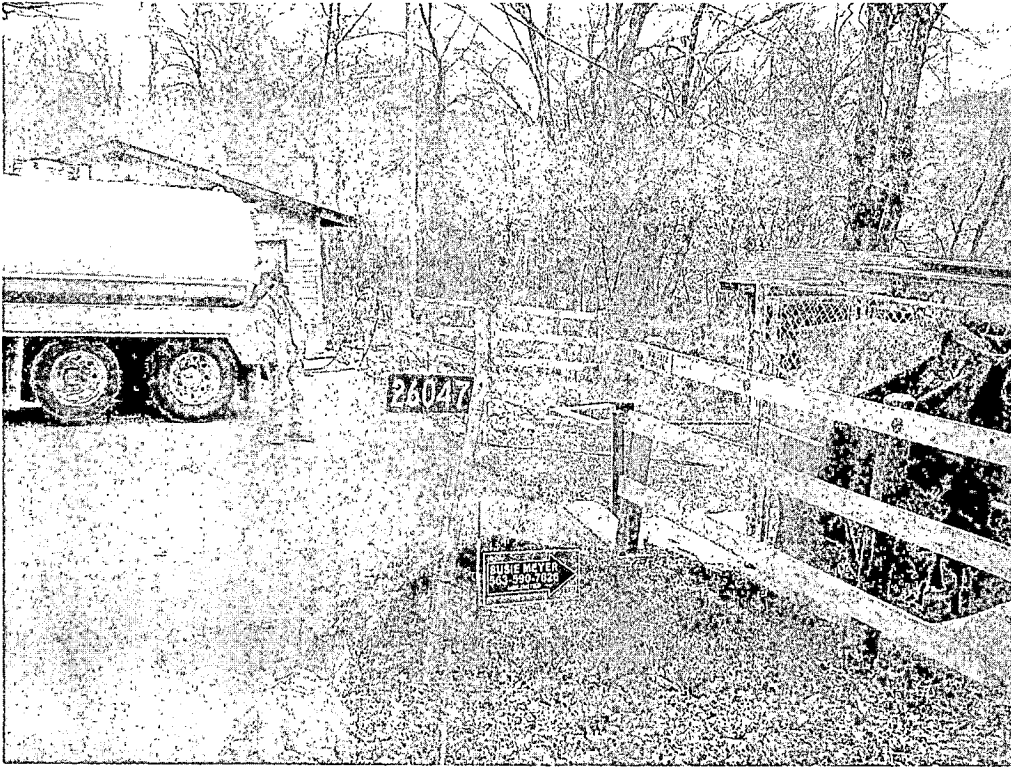
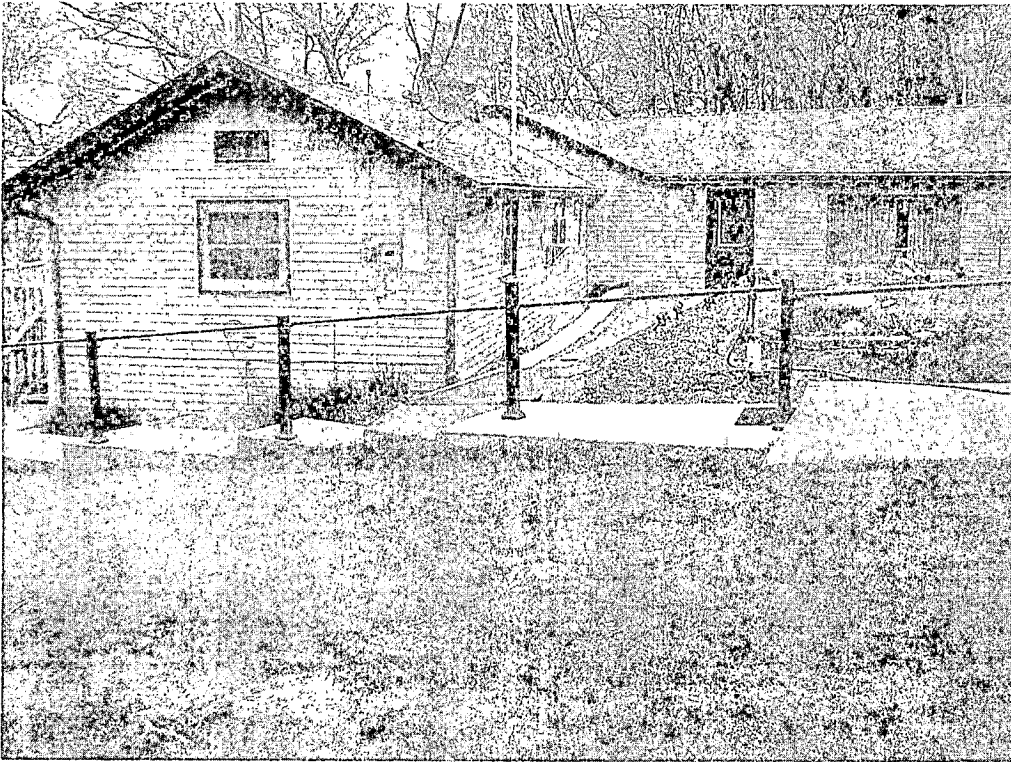
TOT Inspection Report Overall Narrative Comments: **This is a 4-bedroom cabin on Lake Delhi. There is no basement. All plumbing fixtures connect to the sewer system. There is no sump pump or water softener. The main sewer line exits to the front yard into a 300 gal. lift tank with a HD sewage pump throttled back with a recirc valve. This recirc valve allows for controlled volume to the Multi-Flo Unit and also emulsifies the solids and introduces oxygen to the influent. The pump takes the sewage to the upper side yard to a 600 gpd Multi-Flo Unit. The sewage enters the Multi-Flo Unit through a tall goose neck to prevent back siphoning. The effluent then flows to a 60 sq. ft. tertiary system. There is an overflow outlet pipe. This outlet has always been dry. I did not perform the hydraulic water load test because the cabin has not been occupied for several months.**

This system requires a yearly maintenance contract mandated by the County and State.

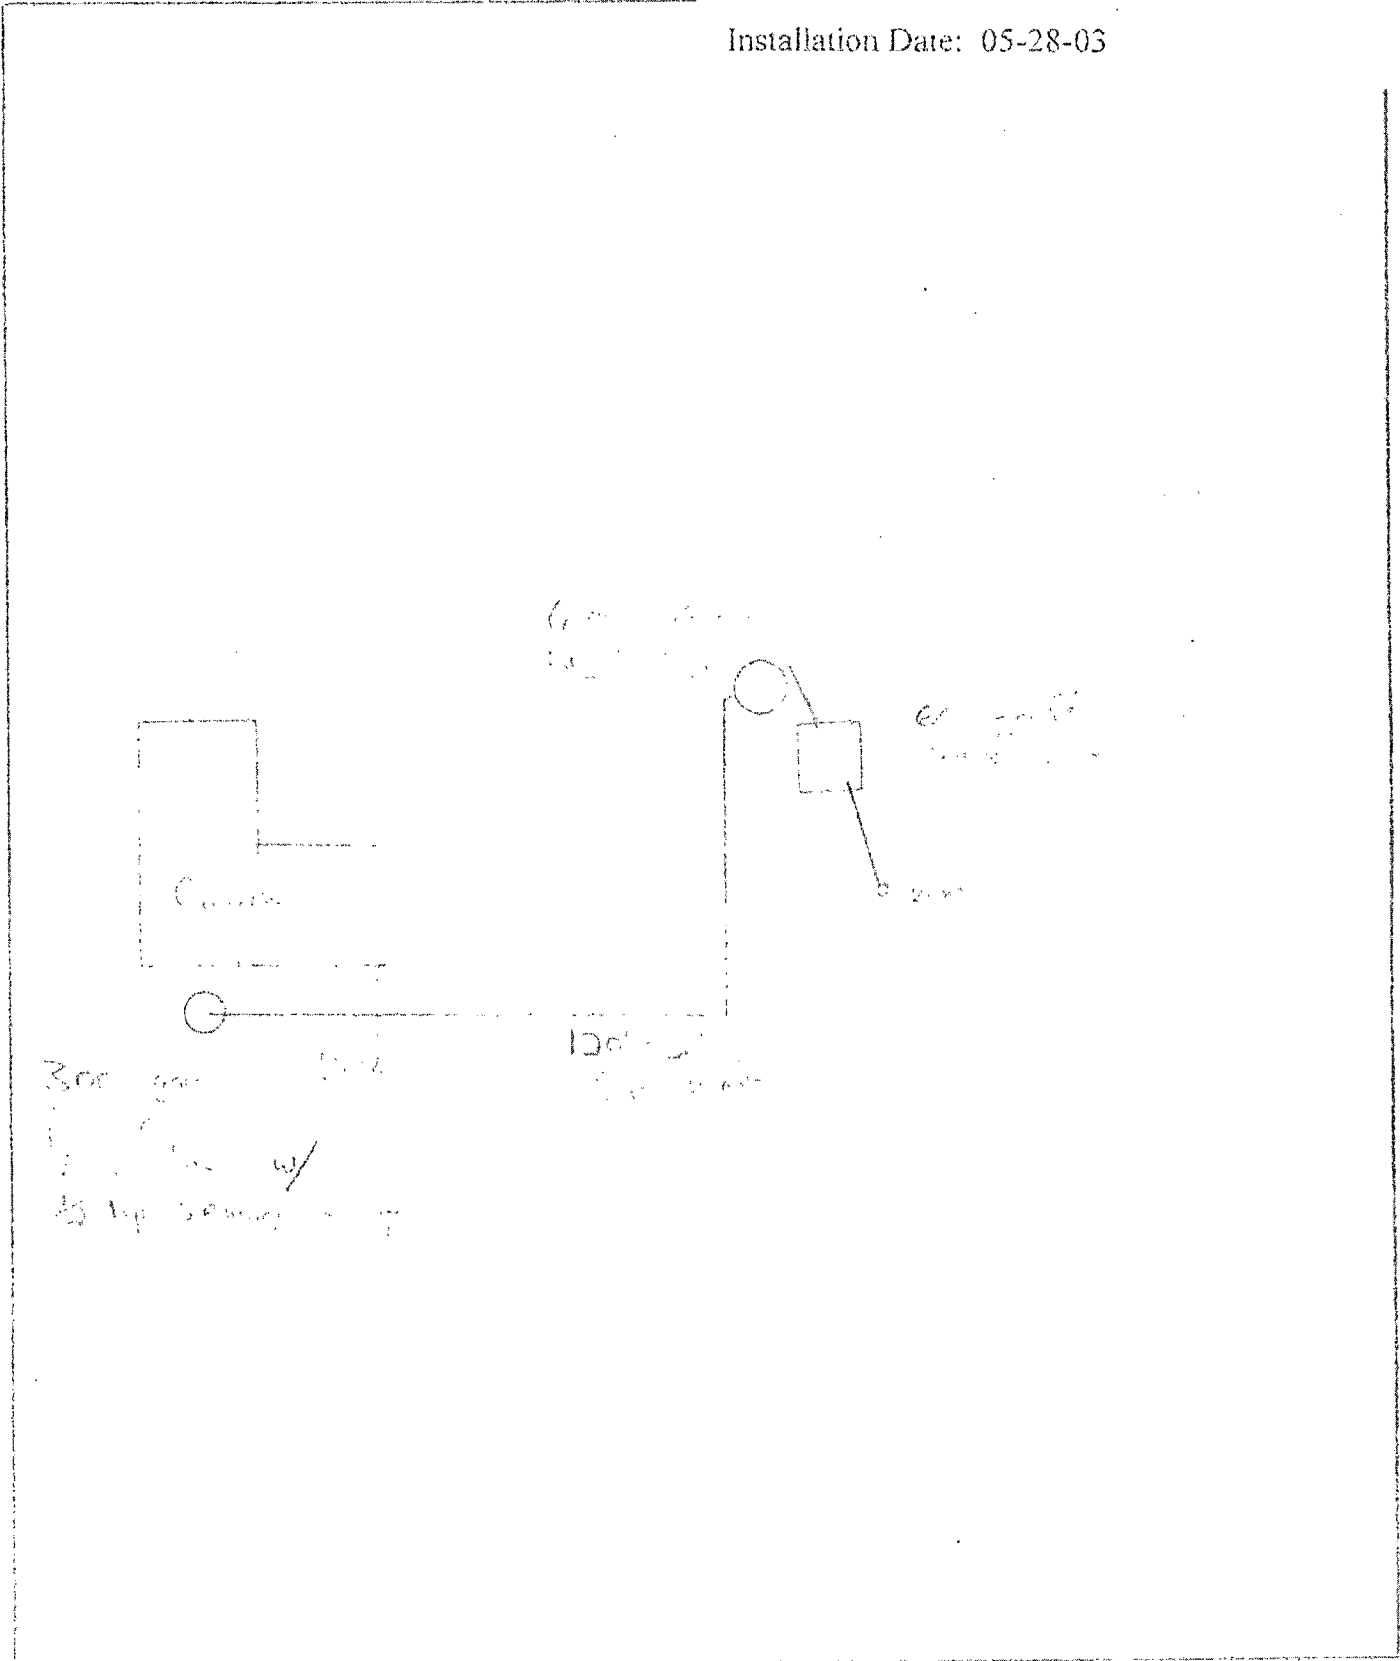
Deleware County- Milo Township #25

Installation Date: 05-28-03
