REAL ESTATE TRANSFER - GROUNDWATER HAZARD STATEMENT
TO BE COMPLETED IN FULL BY TRANSFEROR

TIME OF TRANSFER INSPECTION TOT# 21012 ROGER GROTH CERT # 8813

Address: **1950 221ST St., Manchester, IA 52057** County: **Delaware**

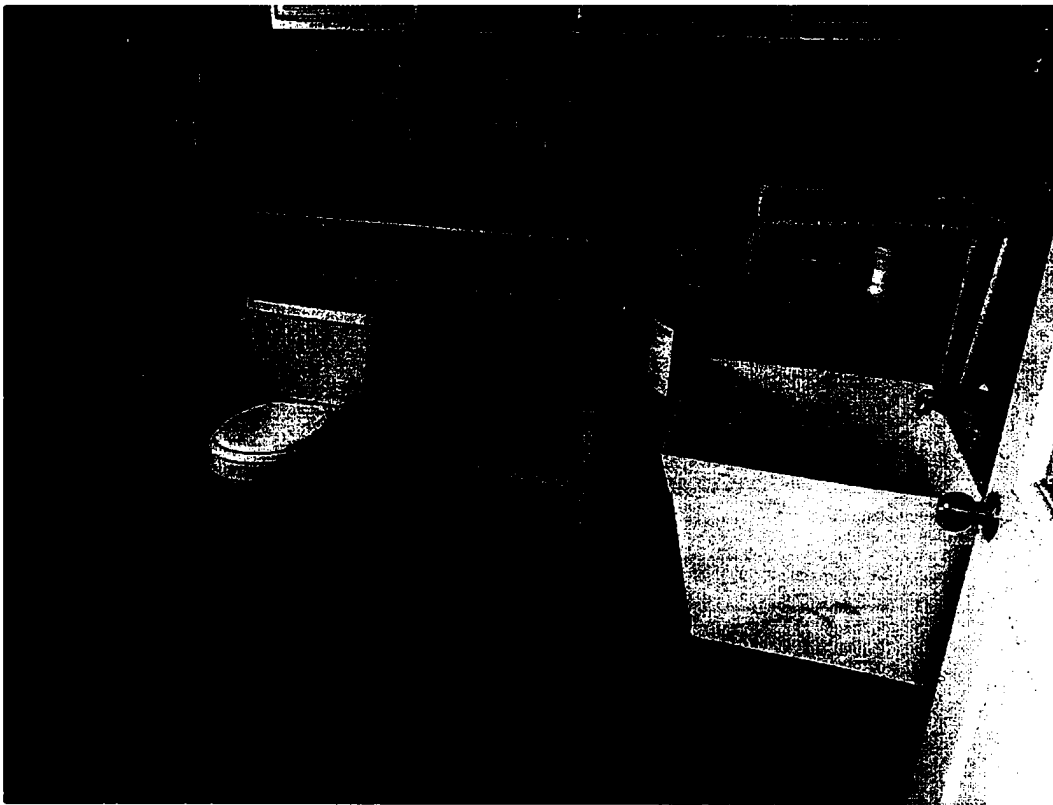
Concrete Septic tank lid in 2nd compartment area is excessively corroded. Concrete riser that sits on top of 2nd compartment, is also excessively corroded.

General Distribution System Comments : **Distribution Box is a 9 Hole D-Box. The plastic liner in D-Box is excessively malformed. D-Box lid was very difficult to open and was not able to replace the lid right side up. Had to set lid on D-Box upside down. This was very tight seal.**

We televised down the outlet line to find the distribution box and dug it up. The D-Box was a 9-hole D-Box, (a little unusual for a 4-header pipe distribution). The 9-hole box is not square but rectangular which will usually and eventually mis-form the plastic liner. This will lead to a lid that is very difficult to reset. This did happen on this box, but we were able to set the lid on upside down to get a nice tight seal.
