REAL ESTATE TRANSFER – GROUNDWATER HAZARD STATEMENT

Time of Transfer Inspection Report (DNR Form 542-0191)

NARRATIVE INSPECTION REPORT
Brent Gassman Property

TIME OF TRANSFER INSPECTION MAP

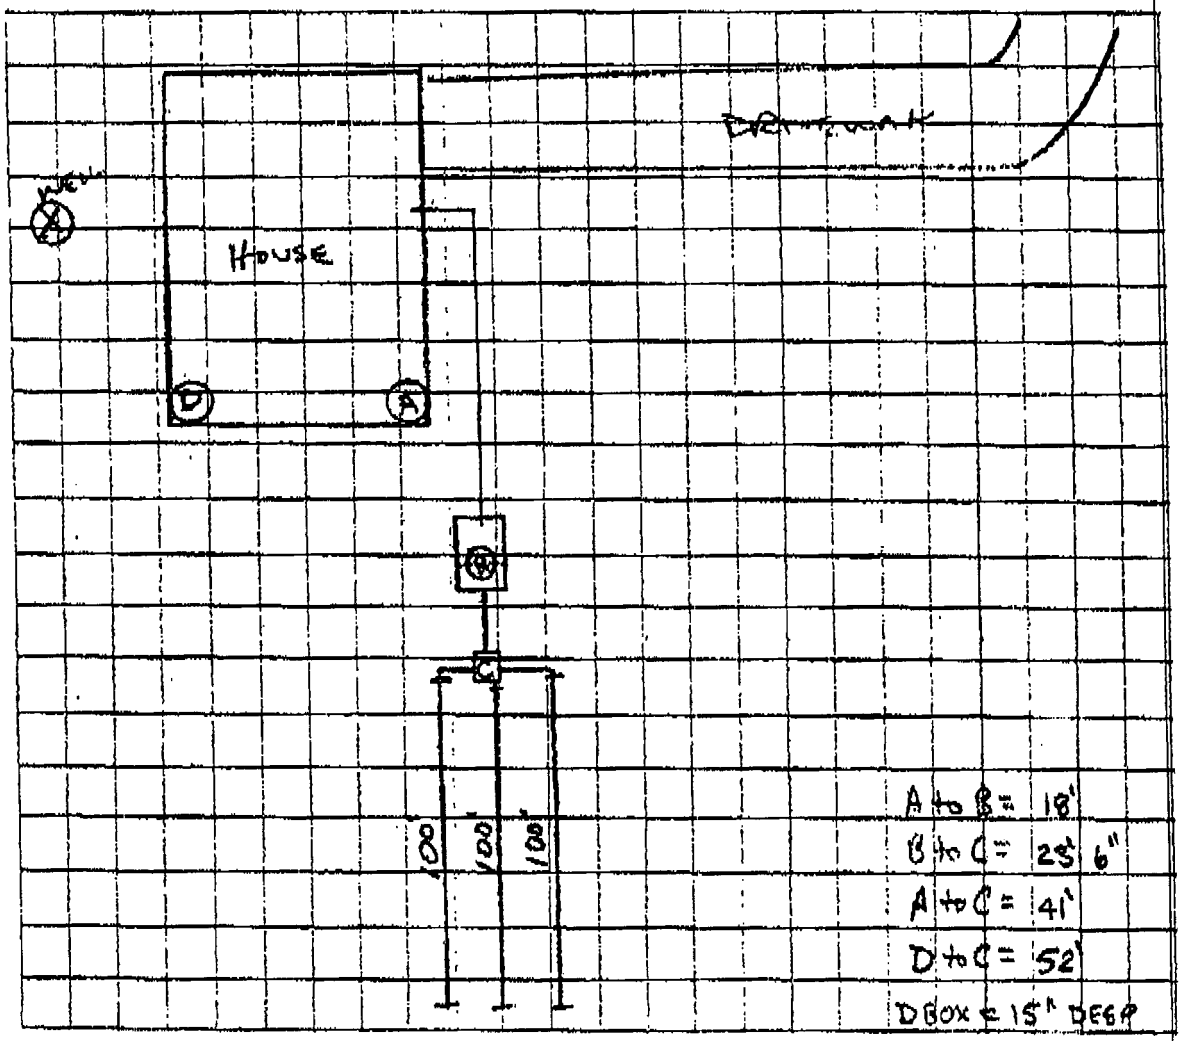
This is a ranch style home with three bedrooms and three bathrooms. It does not have a garbage disposal. There is a full finished basement with a small sewage in floor lift pump, and a separate sump pump discharge. The sewer waste line exits out the basement wall towards the southeast and goes to a 1250 gallon dual compartment concrete tank. The septic tank does have one surface access riser over the second compartment wall. There is a plastic distribution box, and a total of 300 linear feet of leech line.

Distance from septic tank to well is >50'.
Distance from leech bed to well is >100'.
