REAL ESTATE TRANSFER - GROUNDWATER HAZARD STATEMENT

26378 212th Avenue, Manchester, Iowa 52057

Septic Inspection

Time of Transfer Inspection Report (DNR Form 542-0191)

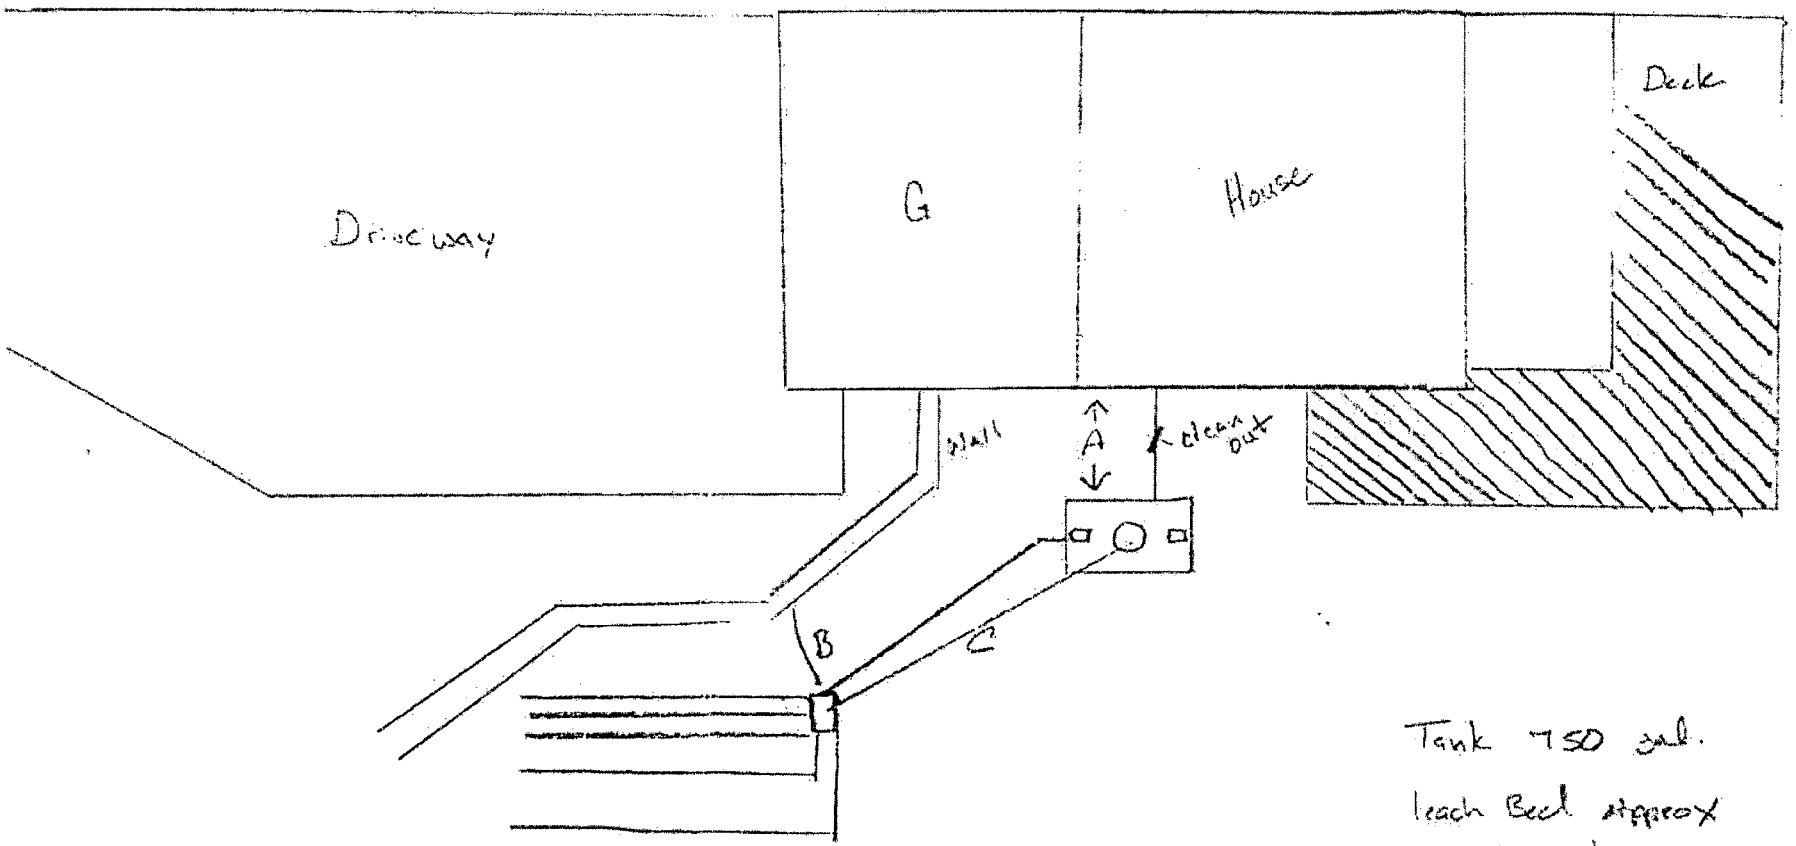
A 5'
B 6' 5"
C 24'

Tank 750 gal.
leach Bed approx
16'x 30'
