**REAL ESTATE TRANSFER - GROUNDWATER HAZARD STATEMENT**

# TIME OF TRANSFER INSPECTION TOT# 10741 ROGER GROTH CERT # 8813

Address: **1957 162nd Ave, Manchester, IA 52057**

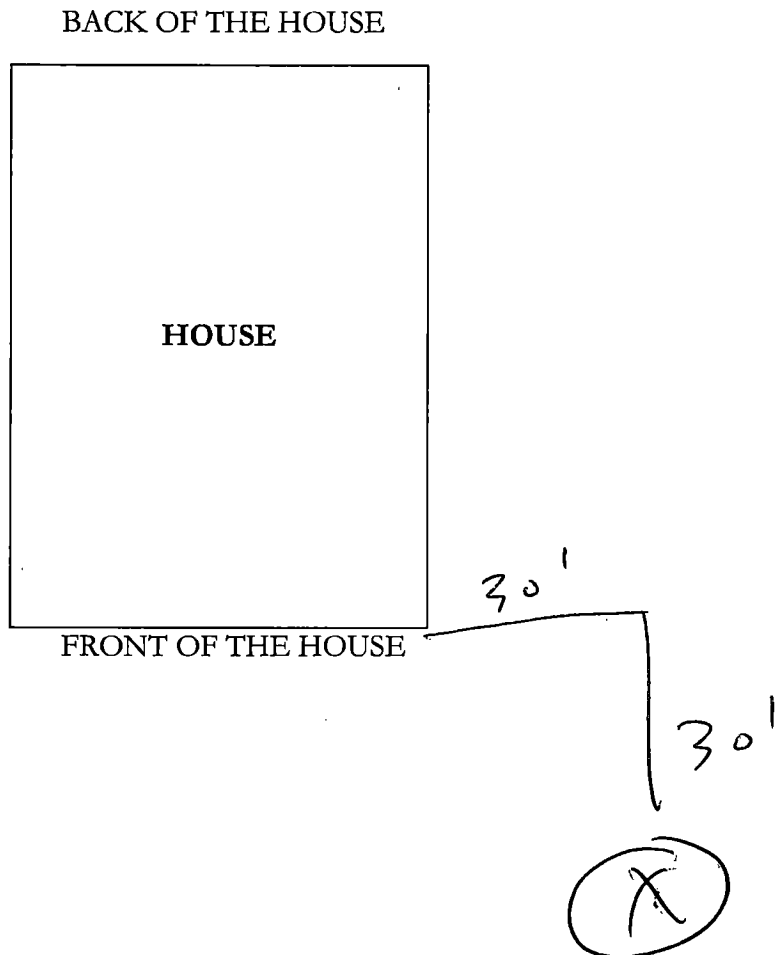
- 1) What type of well do you have? Drilled X Dug \_\_\_\_\_ Sand Point \_\_\_\_\_
- 2) Is the well active or inactive? Active
- 3) How far is the well from the home? 30' or 30' feet / \_\_\_\_\_ yards
- 4) Please draw an **X** on the diagram below where the well is located.
