**REAL ESTATE TRANSFER - GROUNDWATER HAZARD STATEMENT**  
**TO BE COMPLETED BY TRANSFEROR**

### Time of Transfer Inspection Report

## NARRATIVE INSPECTION REPORT

### Dave Kretz Property

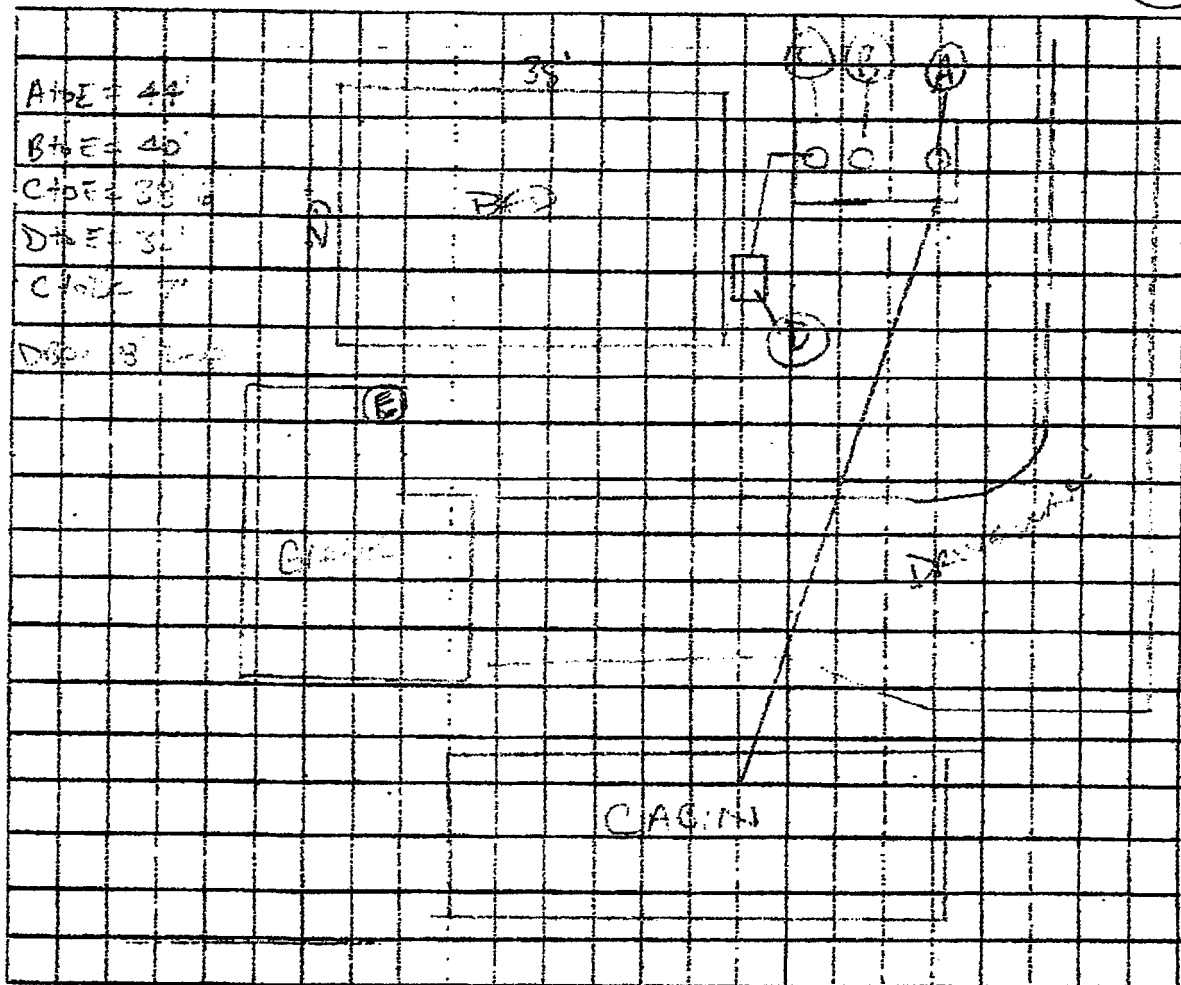
# TIME OF TRANSFER INSPECTION MAP

This is a certified Time of Transfer Inspection for a septic system on Lake Delhi with a total of three bedrooms, and two bathrooms. There is no basement, just a crawl space in this home. There is a water softener and a garbage disposal. The sewer line exits the home floor towards the north yard and drains to a 1000 gallon three compartment septic tank by gravity. There is a single effluent screen on outlet side of the tank, and the baffles are in good condition. This is the primary treatment of the system. The outlet of the septic tank goes to the third chamber for the effluent pump. The pump in the lift tank takes it to a plastic distribution box. There are 6 lines that gravity drain to small chamber bed consisting of 700 square feet completing the secondary treatment.

Distance from Septic tank to well is >100'  
Secondary treatment is >100'
