REAL ESTATE TRANSFER - GROUNDWATER HAZARD STATEMENT
TO BE COMPLETED BY TRANSFEROR

TIME OF TRANSFER INSPECTION TOT# 1094 ROBB HARTER CERT # 9343

Parcel Description: **160360205800**Address: **27727 219th Street, Earlville, IA 52041**County: **Delaware**

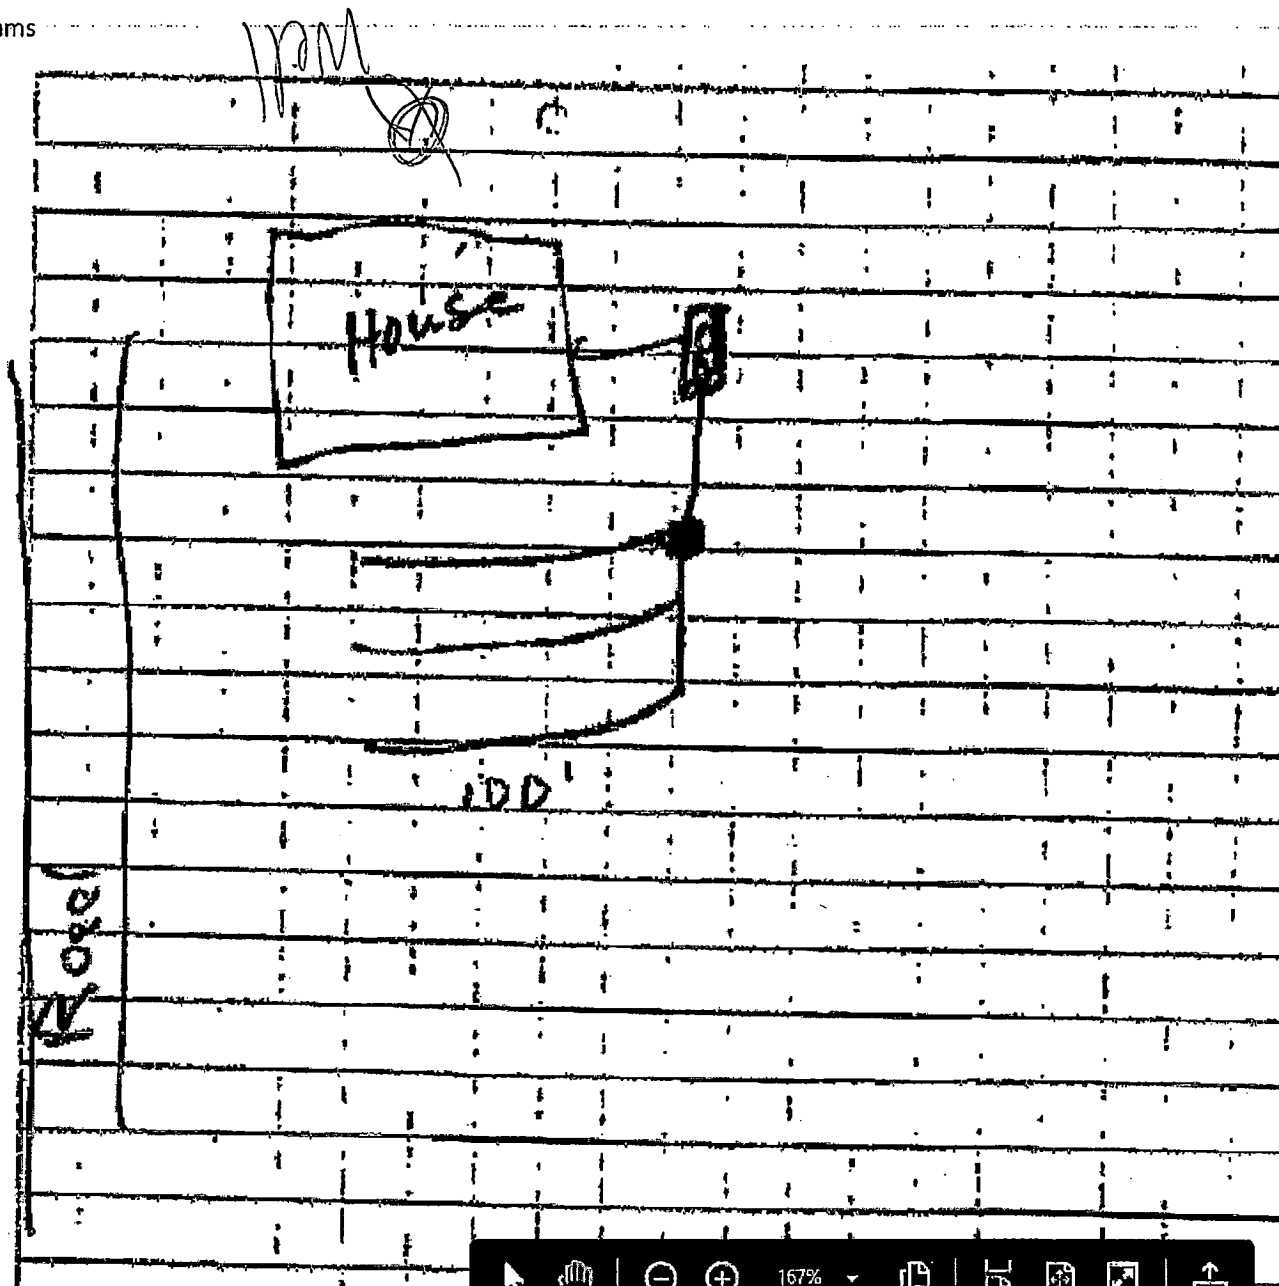
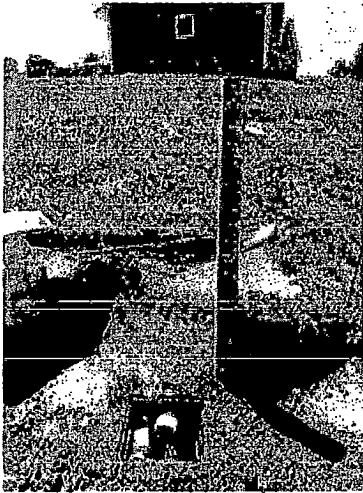
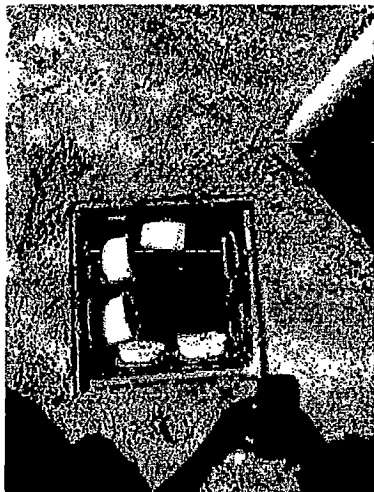
TOT Inspection Report Overall Narrative Comments: **All in good working condition. Pump every 3-4 years.**

Tank has filter, must be cleaned every year. See photos.
