REAL ESTATE TRANSFER - GROUNDWATER HAZARD STATEMENT

**TIME OF TRANSFER INSPECTION TOT# 3945 LUKE OGDEN CERT # 6715**

Parcel Description: **240040001750**Address: **2274 185th ave, Manchester, IA 52057**County: **Delaware**

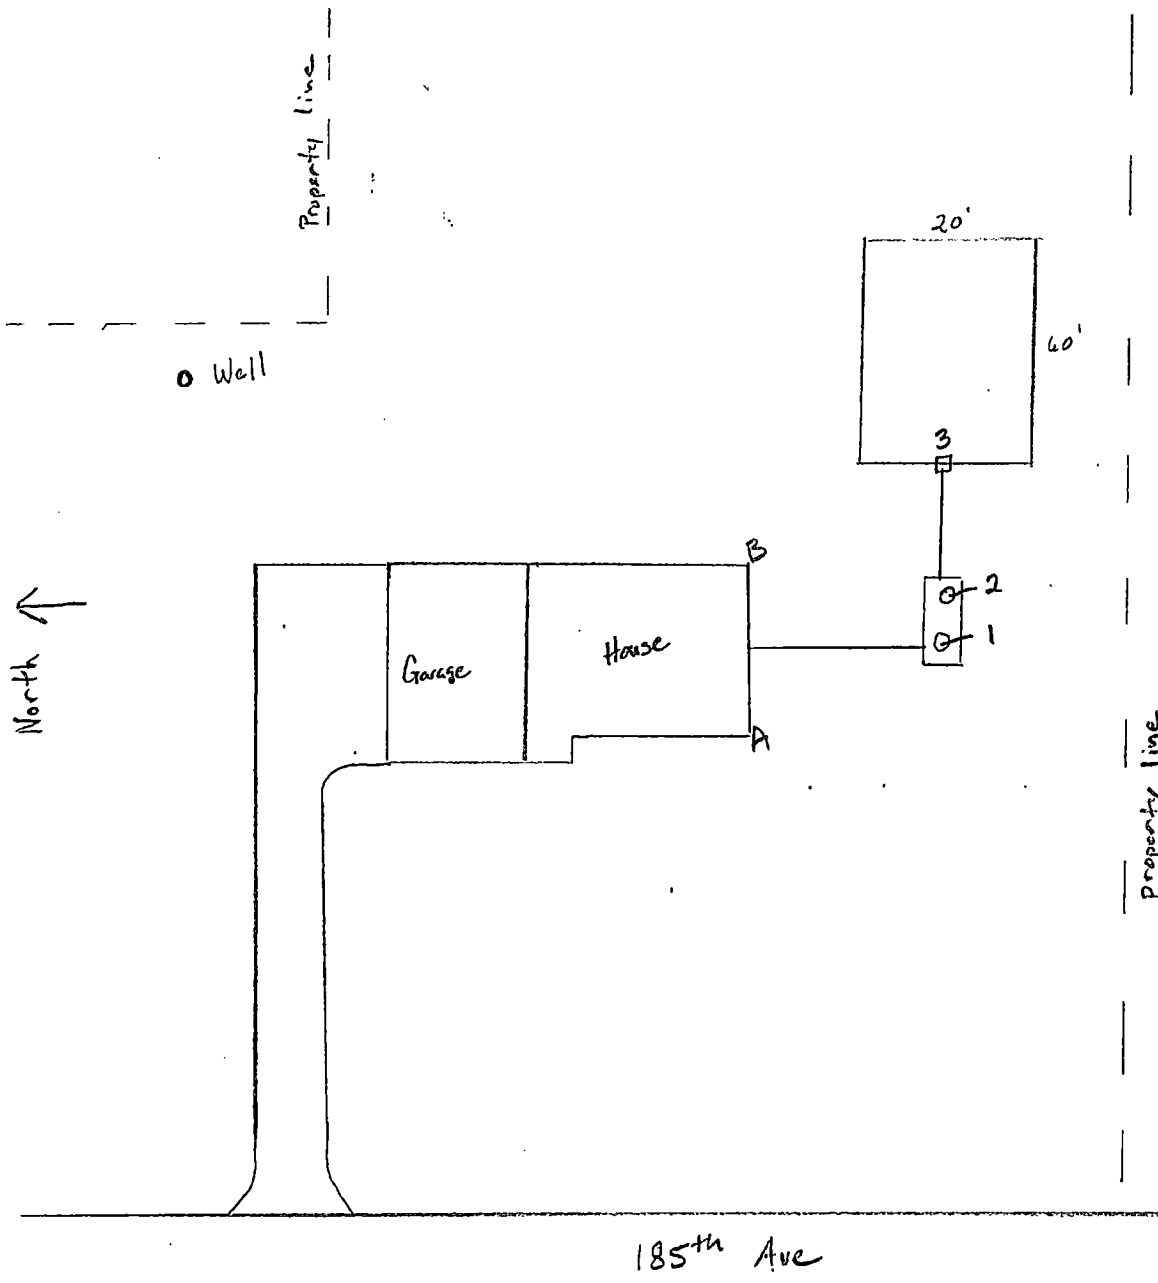
TANK SIZE: 1500 Plastic OR Concrete

SECONDARY TREATMENT: 20'x60' Rock + Pipe Bed. with 6-60' lines

D-BOX: (7) or 9 OUTLETS USED: 6

A-1 = 78'
A-2 = 87'
A-3 = 98'
B-1 = 43'
B-2 = 46'
B-3 = 51'
