**REAL ESTATE TRANSFER - GROUNDWATER HAZARD STATEMENT  
TO BE COMPLETED BY TRANSFEROR**

1924 Hwy 13, Manchester, Iowa 52057

**TIME OF TRANSFER INSPECTION TOT# 12048 BILL DOWNS CERT # 8880**

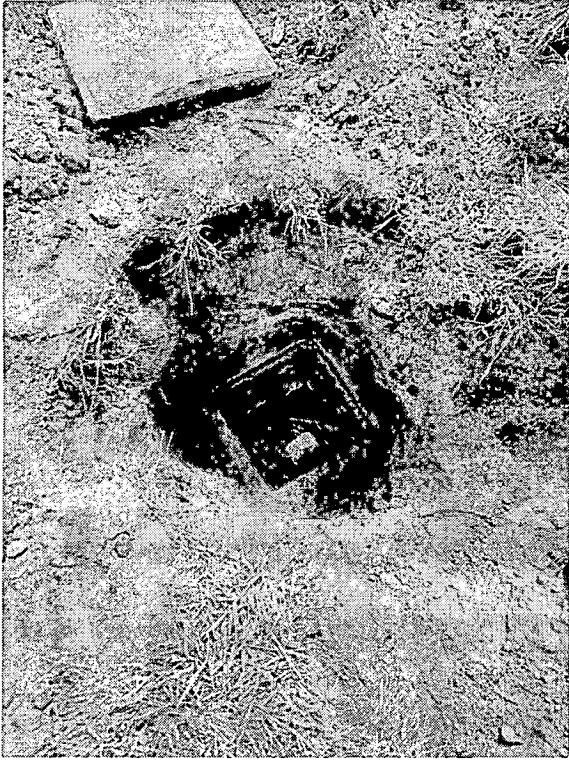
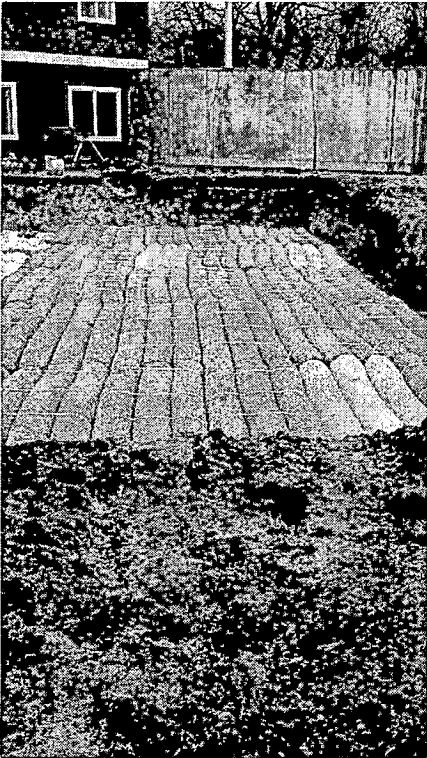
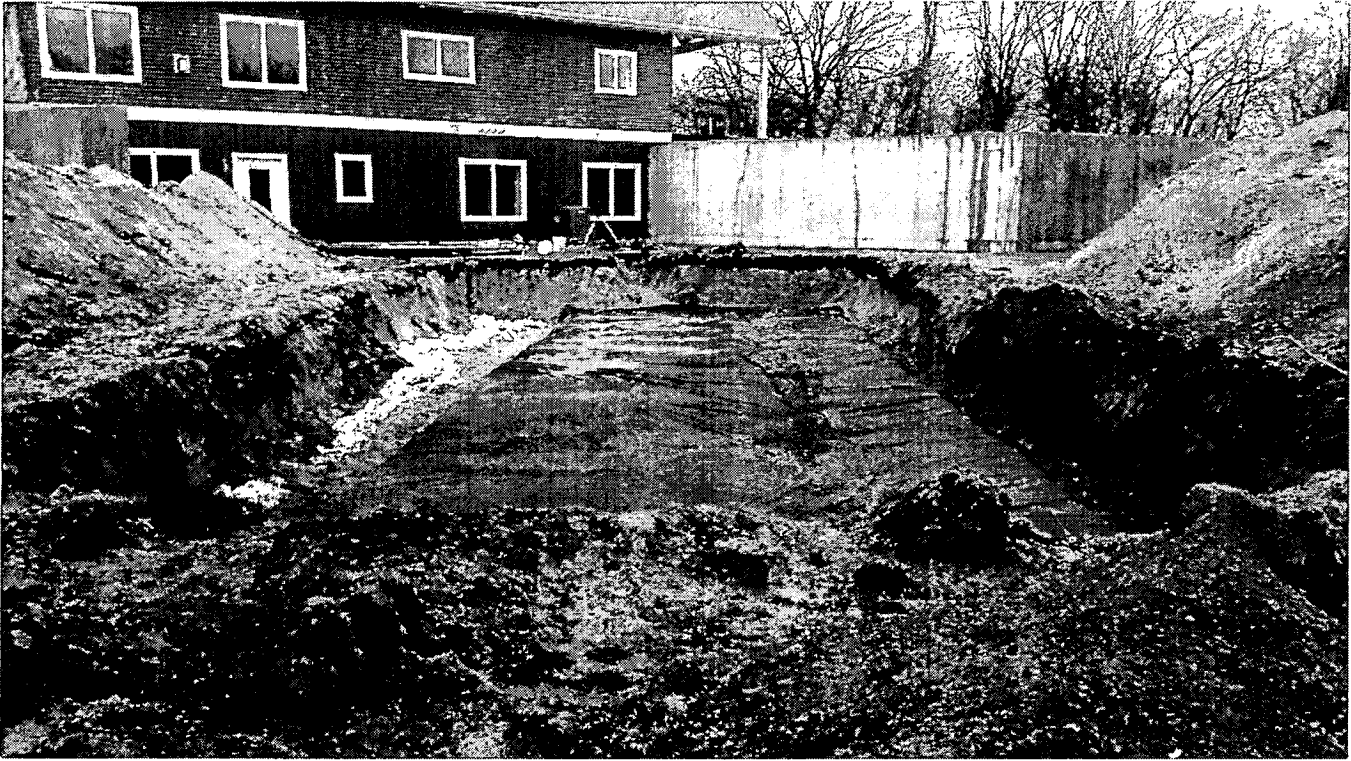
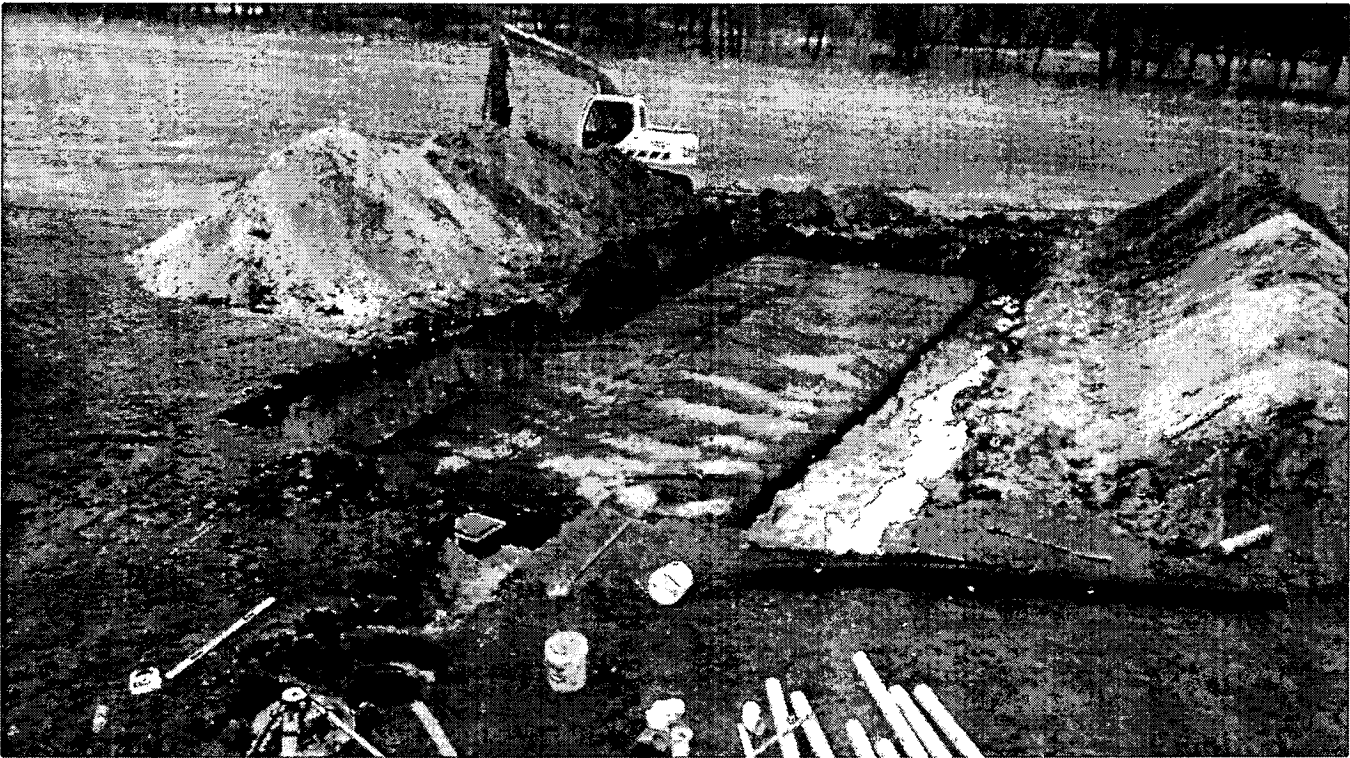
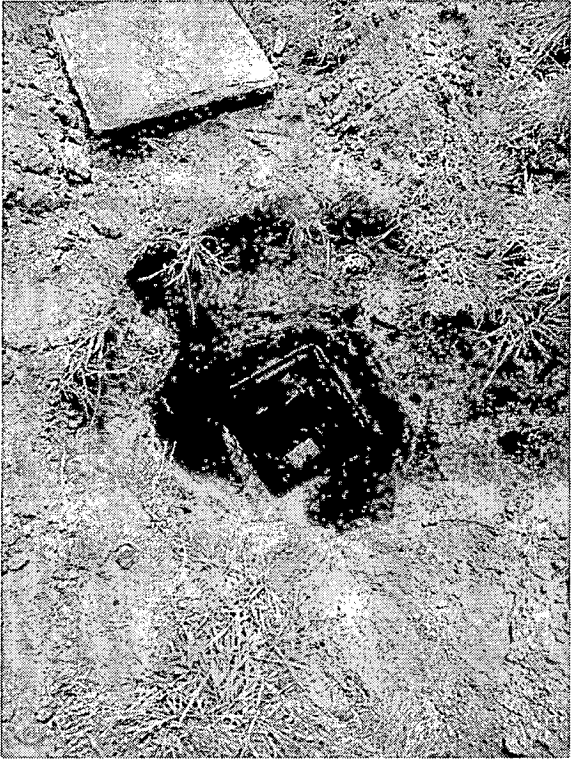
Tank/Vault Pumped: **Yes**      Inlet Baffle Present: **Yes**      Outlet Baffle Present: **Yes**      Functioning as Designed: **Yes**  
Tank Comments: **system looks like new**

TOT Inspection Report Overall Narrative Comments: **System working well at time of inspection. Ground is very sandy. Pictures attached with report.**
