REAL ESTATE TRANSFER - GROUNDWATER HAZARD STATEMENT
TO BE COMPLETED IN FULL BY TRANSFEROR

TIME OF TRANSFER INSPECTION TOT# 18802 ROBB HARTER CERT # 9343

Address: **2274 185th Ave, Manchester, IA 52057**

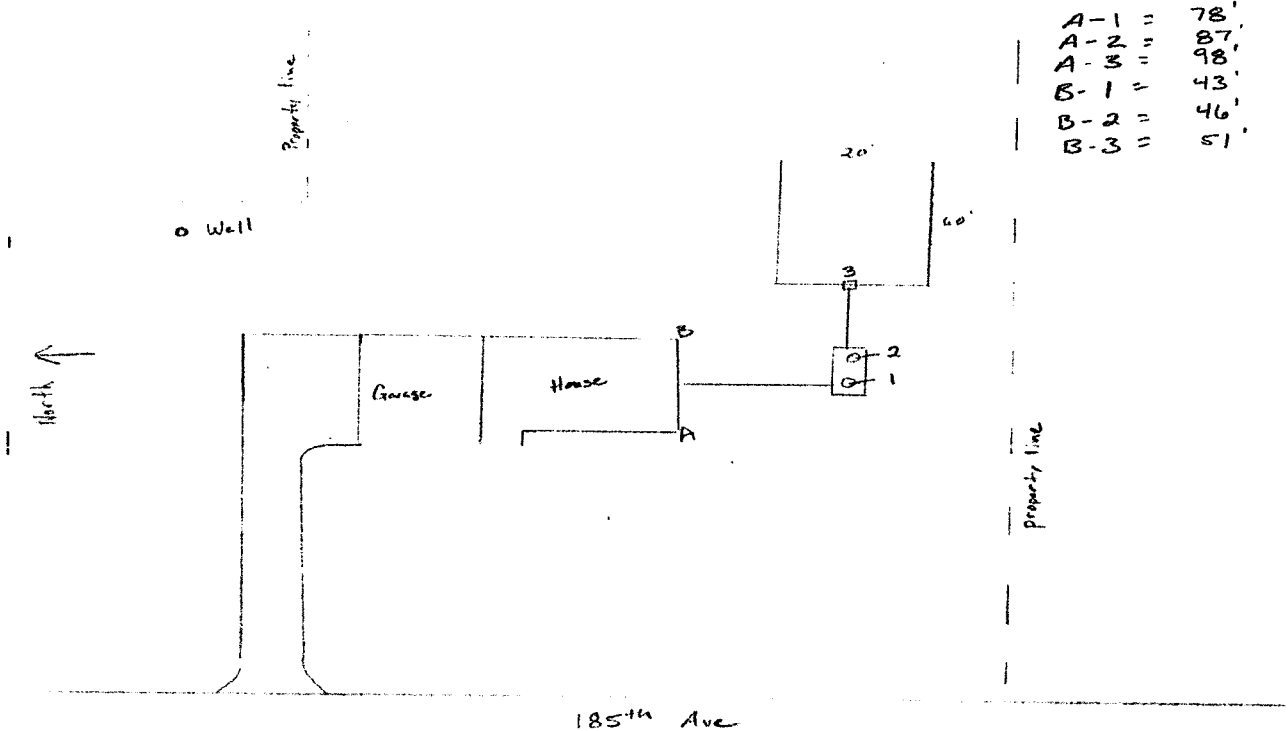
OWNER: Ryan + Emily Peyton
 SITE ADDRESS: 2274 185th Ave
 GPS: Long: _____ Lat: _____
 TANK SIZE: 1500 Plastic OR Concrete
 SECONDARY TREATMENT: 20' x 60' Rock + Pipe Box with 6" 185' lines

D-BOX: 9 or 9 OUTLETS USED: 6

A-1 = 78'
 A-2 = 87'
 A-3 = 98'
 B-1 = 43'
 B-2 = 46'
 B-3 = 51'
