REAL ESTATE TRANSFER - GROUNDWATER HAZARD STATEMENT
 TO BE COMPLETED IN FULL BY TRANSFEROR

1413 255th St	Manchester	Iowa	52057
Number and Street or RR	City, Town or PO	State	Zip

TIME OF TRANSFER INSPECTION TOT# 19723 BILL DOWNS CERT # 8880

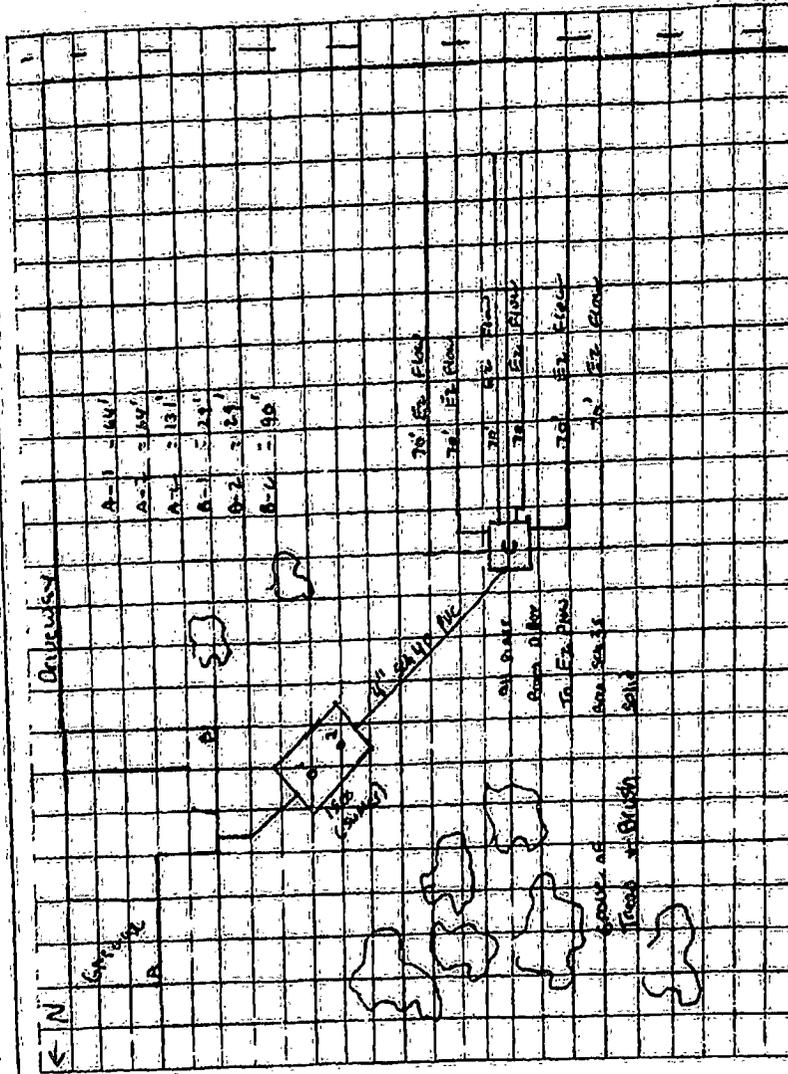
2267

OWNER: Greg Whelan / Scott Funke
 DATE: 2-17-14
 TOWN/COUNTY: Manchester / Dallas Co
 SITE ADDRESS: 113 255th St
 GPS: Long: Plastic OR Concrete
 TANK SIZE: 150 (2 tanks)
 D-BOX: 0 of 9 OUTLETS USED: 6
 SECONDARY TREATMENT: INSD 4. A. 6-2 Flow

NOTES: See Dimensions 20' x 70' COMPASS OF 4' TO LOCATE OF
 Ex Flow
