**REAL ESTATE TRANSFER - GROUNDWATER HAZARD STATEMENT**  
TO BE COMPLETED IN FULL BY TRANSFEROR

## TIME OF TRANSFER INSPECTION TOT# 19038 ANDY LOCKWOOD CERT # 12418

Address: **3323 Cumming Rd., Cumming, IA 50061**

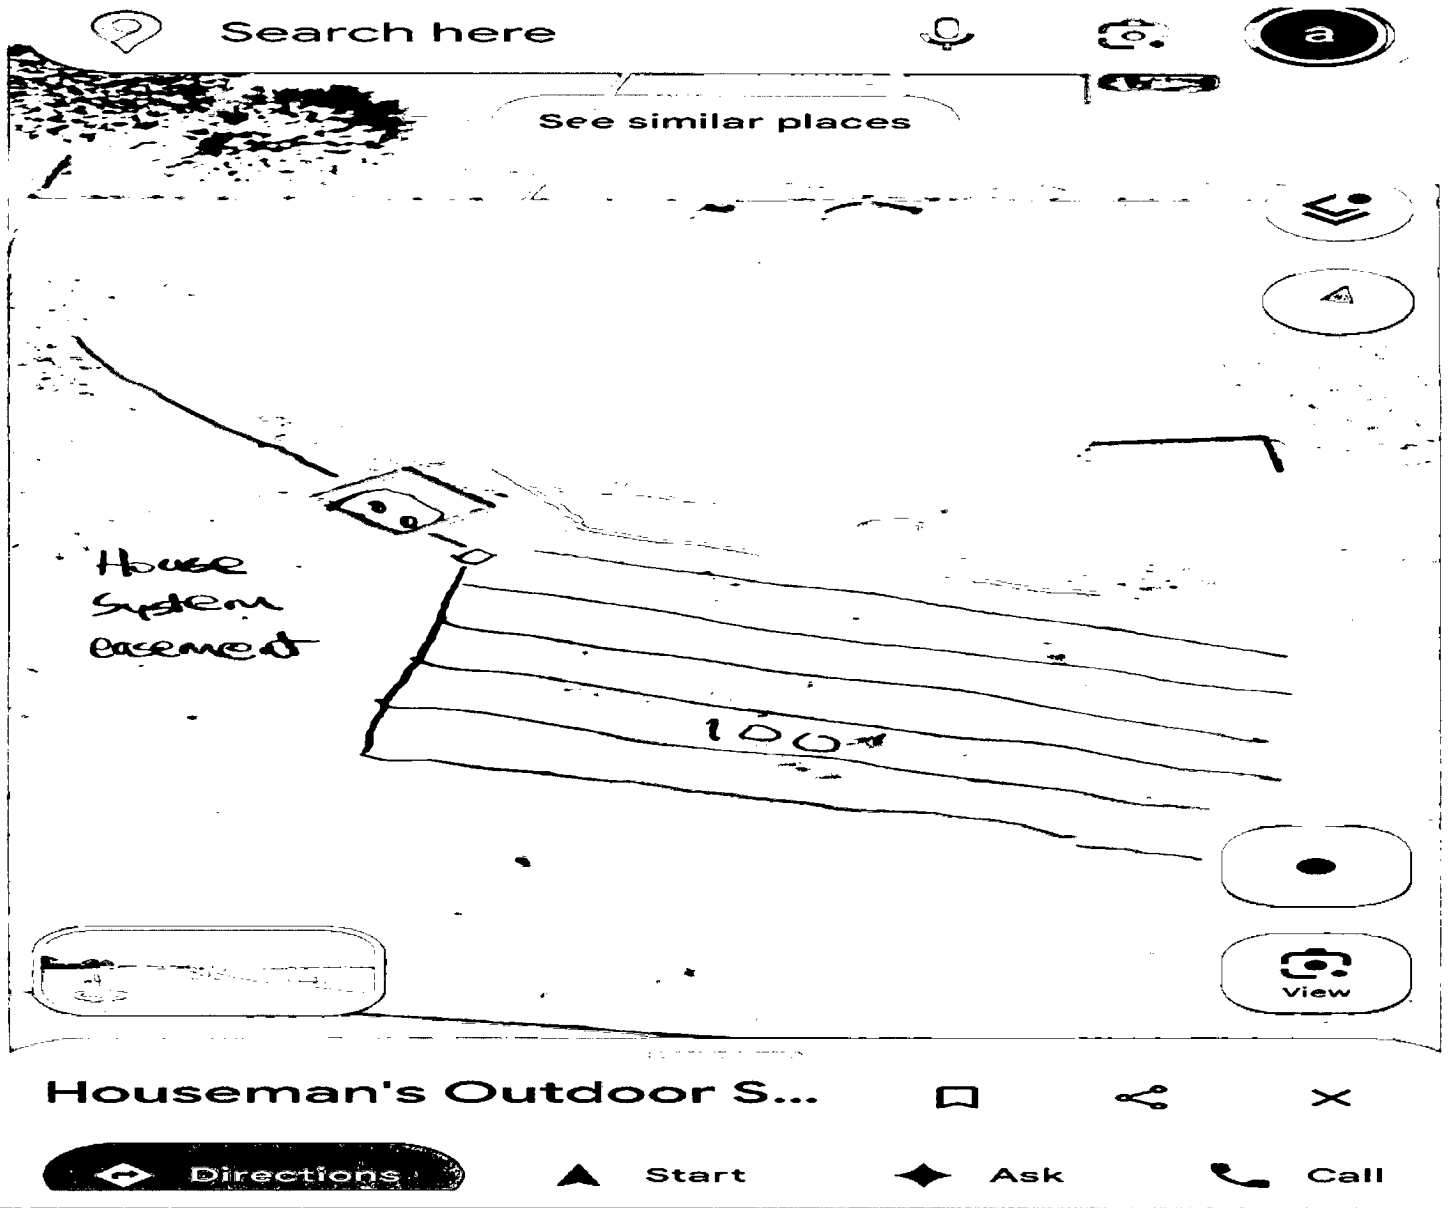
TOT Inspection Report Overall Narrative Comments: **I did the TOT for the property. The water from the bathroom and the horse area wash rack goes to the septic tank that was found in the front horse pasture to the south of the barn. The tank is a 1000-gallon Lister concrete tank and is in good shape with no major deterioration. The concrete distribution box was deteriorated and not watertight. There are 3 lateral lines present that are approx. 60' long and about 9 feet apart. the lateral lines are rock and pipe. There is a second system on file with the county for the house next door with an easement on file for it. I tried to draw both on the map to show approx. where they are at.**
