**REAL ESTATE TRANSFER - GROUNDWATER HAZARD STATEMENT**  
**TO BE COMPLETED BY TRANSFEROR**

## Time of Transfer Inspection Report (DNR Form 542-0191)

### **REAL ESTATE SEPTIC INSPECTION**

On April 13, 2017 Anytime Septic Services II did Time of Transfer Real Estate Inspection on the septic tank, distribution box and lateral field at 2326 Holliwell Bridge Rd., Winterset, IA 50273. Sharon Hart residence.

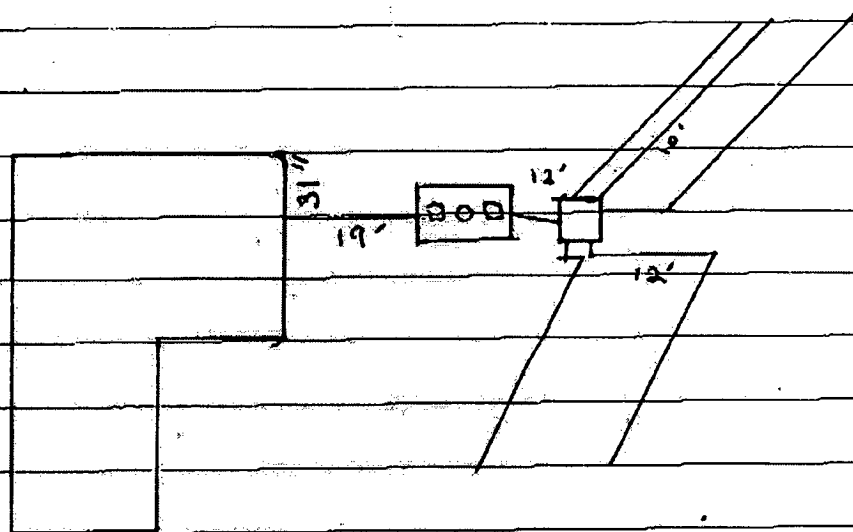
2326 Holliswell Rd Winterset Ia

Septic tank is 1,000 gallon two compartment concrete Booneville tank that is 15 inches below ground surface. On both inlet and outlet ends of tank are 11 inch squared concrete beveled access lids that sit flush to the top of tank above concrete baffles that are attached to the inside walls with some deterioration around the tops of both baffles. Primary clean out lid is a 24 inch round concrete beveled lid 3/4 length of tank that also sits flush to top of tank located in front of separation wall. Separation wall is leaning slightly towards inlet side of tank with some deterioration between sidewalls of septic tank. I pumped and cleaned septic tank with clean water and is in fair condition.

Distribution box is a concrete Booneville box I also pumped and clean with water it is 11 inches below ground surface with deterioration on the inside walls of box. Distribution box is holding water and isn't leaking, also not distributing effluences equally through 5 open schedule 35 piped lines leaving box. At this time of inspection wasn't causing an issue of ponding or surfacing above lateral field but may cause an issue in the future.

Lateral field is on slightly sloped ground with 5 runs of schedule 35 perforated pipe and septic rock appears each run is 88 feet in length totaling 440 feet of laterals at this time no evidence of any ponding, surfacing, or popping sound from probing all 5 laterals above absorption field.

Comments: Have septic tank pumped and cleaned  
every 3 to 5 years
